ITI Treatment Guide  
Volume 1

# Treatment Guide

Volume 1

Implant Therapy in the Esthetic Zone  
Single-Tooth Replacements

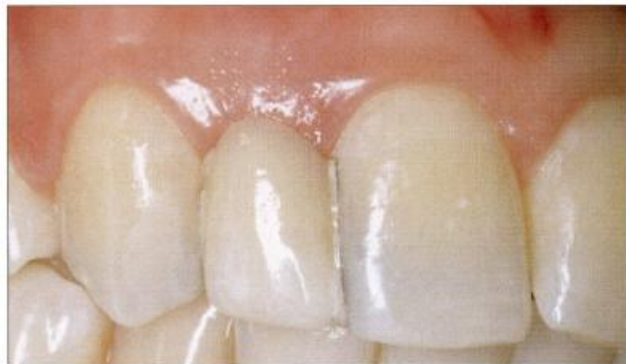
Fig 1a Pre-treatment examination. Too little restorative space for a dental implant at site 12.

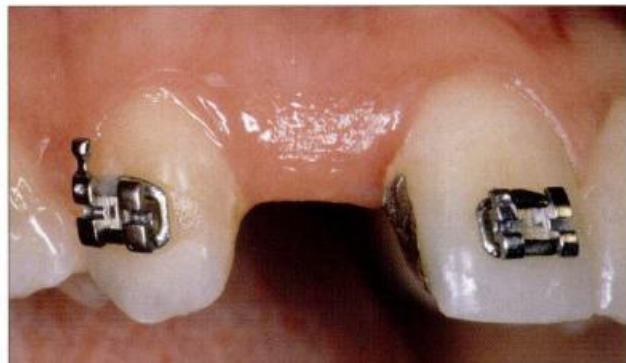
Fig 1b Post-orthodontic treatment. Ideal space for a dental implant and restoration.

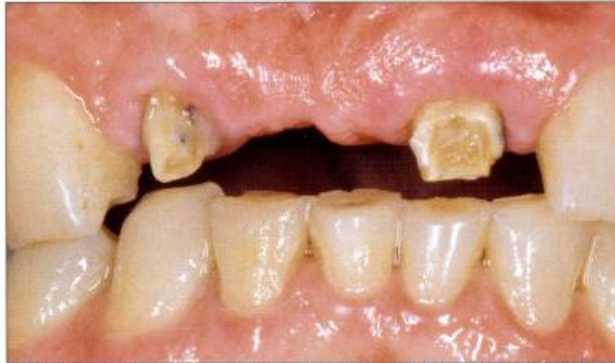
Fig 2 Pre-treatment examination. A lack of available interocclusal space for restoration using dental implants. Treatment of the opposing dentition may be required to achieve long-term implant success.

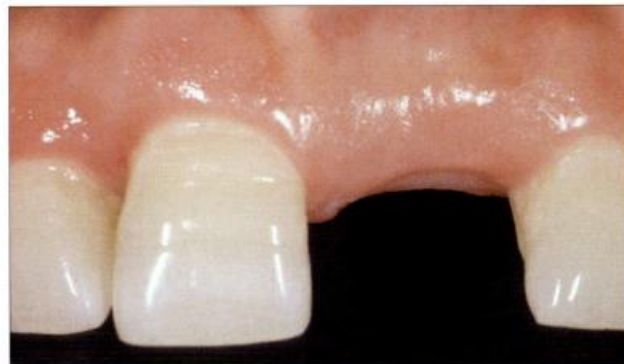
Fig 6 Thick-gingiva biotype characterized by a broad band of thick keratinized tissue and blunted papillae.

A thick-gingiva biotype can be low-risk when replacing single missing teeth in the anterior area. The gingival tissues in these patients are characterized by a predominance of a thick, broad band of attached gingiva, typically resistant to recession (Cardaropoli and coworkers, 2004; Kan and coworkers, 2003; Kois and coworkers, 2001; Weisgold, 1977) (Fig 6).

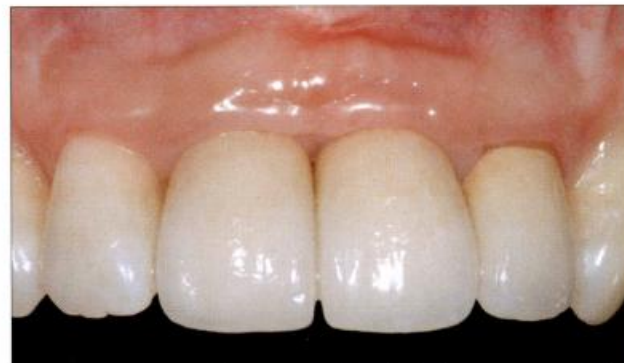
Fig 7 Restoration of adjacent spaces 11 and 21 with crowns supported by dental implants in a patient with a thick-gingiva biotype.

For patients with multiple adjacent missing anterior teeth, a thick-tissue biotype can be both favorable and detrimental. Thick gingiva remains predictable in terms of position and appearance and resistant to recession. However, the character of the tissue reduces the likelihood of papillae developing when multi-tooth edentulous areas are present (Fig 7).

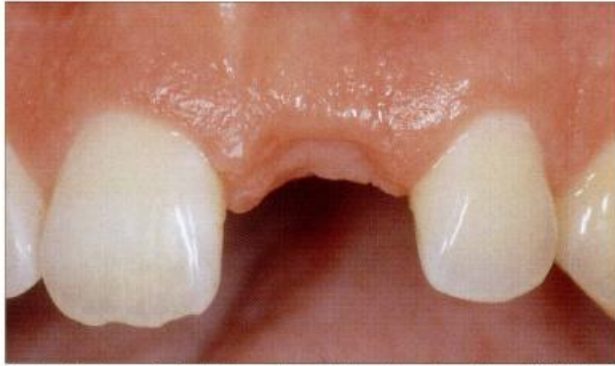
Fig 8 Medium-gingiva biotype characterized by a broad band of thin keratinized tissue with blunted papillae.

For patients with a medium-gingiva biotype, esthetic restoration of missing teeth is more challenging in the long term, and the esthetic risk is increased. Medium-gingiva biotypes display some characteristics of a thick biotype—most often the presence of thick attached gingival tissues. In addition, however, they can display characteristics of a thin-gingiva biotype, including long, thin, and blunted dental papillae (Fig 8).

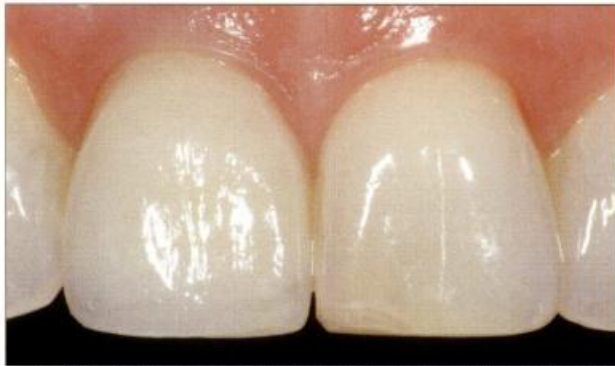
Fig 9 Restoration of a dental implant at site 11 in a patient with a thin-gingiva biotype.

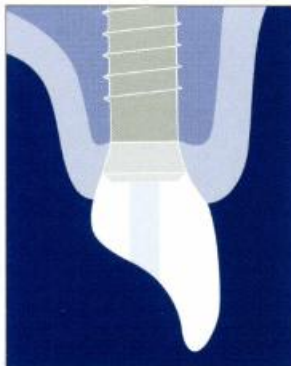
Fig 10 Slightly palatalized position of the dental implant allowing for maximum hard-tissue and soft-tissue thickness on the facial surface.

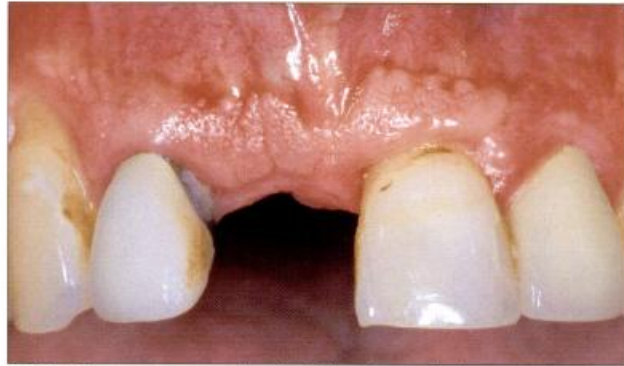
Fig 11 Pre-treatment examination. Triangular tooth shape associated with localized periodontal disease. A high esthetic risk is associated with this type of a clinical status.

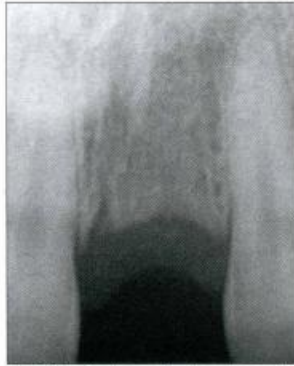
Fig 13 Radiograph showing adequate interproximal bone support.

For single missing teeth, the support for interproximal dental papillae is related to the height of the bone crests on adjacent teeth (Choquet and coworkers, 2001; Kan and coworkers, 2003). Therefore, the contours of the restoration (specifically the positions and extent of the contact areas), in addition to the presence of interdental papillae and the esthetic outcome, depend on the height of the crestal bone adjacent to the implant site (Fig 13). Where local infections have resulted in vertical bone loss around adjacent teeth, the risk of a compromised esthetic outcome is greatly increased (Fig 14). The probability of a space (black triangle) arising between a properly contoured restoration and the adjacent tooth increases with greater observable crestal bone loss on adjacent roots. Furthermore, the regeneration of crestal bone along a previously infected root surface is not predictable, and is unlikely with currently available treatment options.

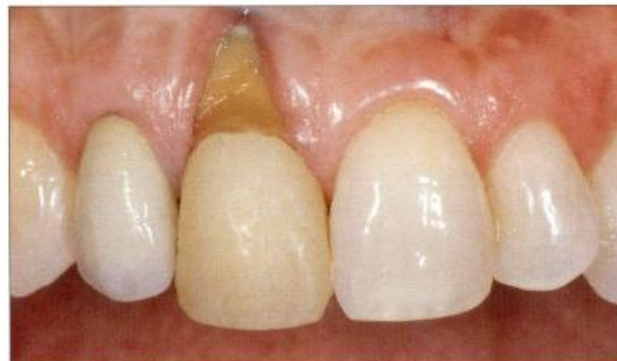
Fig 16 An existing restoration at site 12 adjacent to a future implant site should be scheduled for replacement in conjunction with the implant restoration.

When teeth adjacent to an edentulous area are healthy from a restorative perspective, no additional risk to the esthetic outcome is predicted. Adjacent teeth with restorations extending into the gingival sulcus, however, represent a serious threat. Subgingival margins are often associated with recession subsequent to the placement of an implant, and esthetic complications can be associated with exposed restorative margins or an altered gingival architecture (Fig 16). For these patients, meticulous treatment planning is vital and may include the replacement of the adjacent restoration as part of the treatment, or modification of the surgical incision to reduce risk.

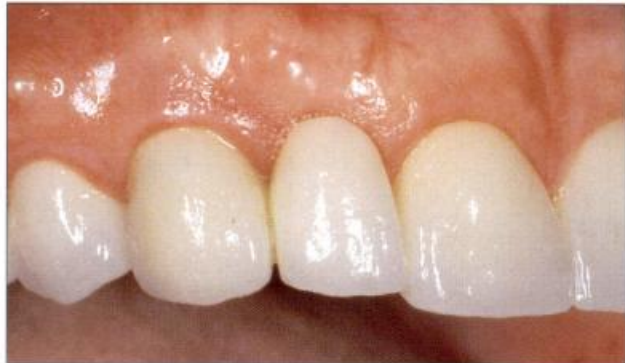
Fig 18 A mesially cantilevered restoration from a dental implant at sites 13 and 12.

lateral incisors and canines presents the same difficulties. Treatment options should be explored to prevent the placement of adjacent implants in these areas where possible. In general, when a lateral incisor is involved adjacent to a missing central incisor or canine, a cantilevered restoration into the lateral site should be considered (Fig 18).

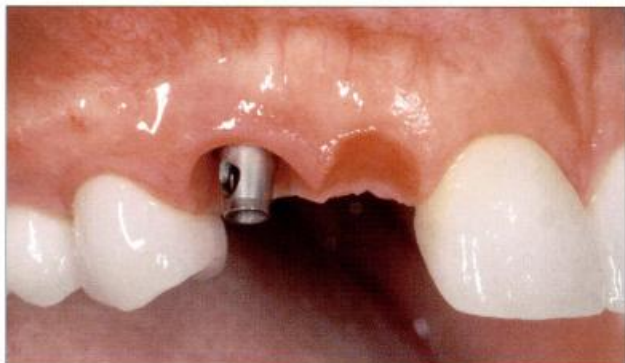
Fig 19 An ovate pontic created at site 12 to help maximize interproximal tissue support.

This will allow the implant team to capitalize on a single implant position while creating an ovate pontic into the lateral site, potentially maximizing interproximal tissue support (Fig 19).

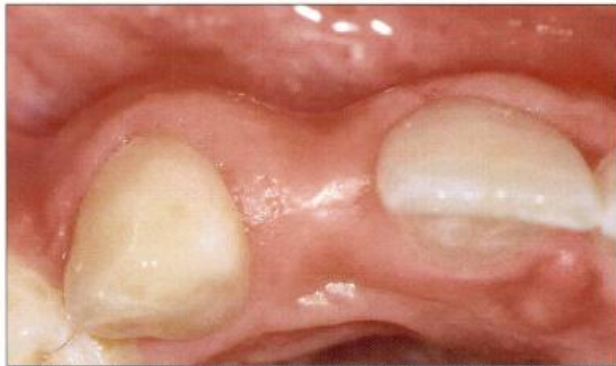
Fig 20b Occlusal view of the missing lateral incisor highlighting deficient horizontal width of hard tissue.

Tissue deficiencies in the horizontal dimension can pose an increased esthetic treatment risk. The risk can be low if adjacent structures are healthy and if extractions (where required) are performed with a minimum of trauma to the bone and surrounding soft tissues. If the defect is restricted to the horizontal dimension and other conditions are satisfied (such as the periodontal and restorative integrity of the adjacent teeth), site enhancement is predictable, and an esthetic outcome can be expected (Hämmerle and coworkers, 2003; Hermann and Buser, 1996) (Figs 20a-c).

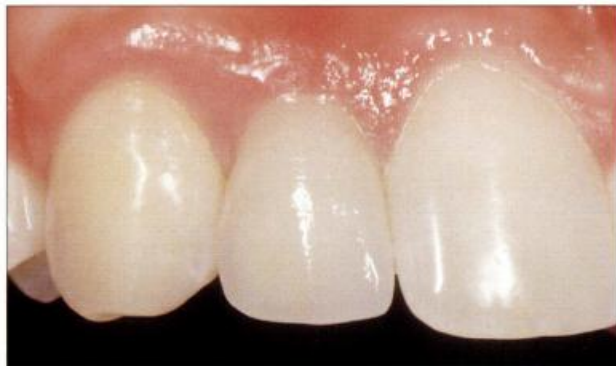
Fig 20c Replacement of the missing lateral incisor with a dental implant and ceramo-metal restoration.

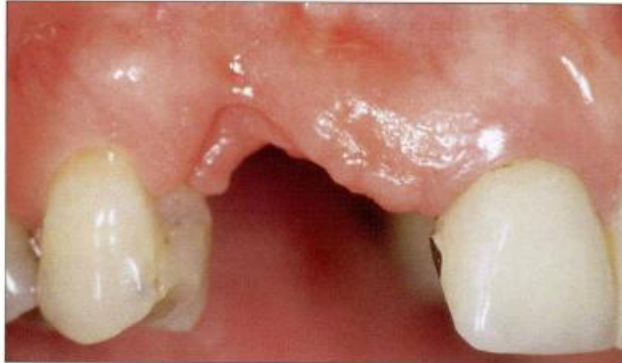
Fig 21a Frontal view of a missing canine and lateral incisor highlighting a vertical bone deficiency.

Small deficiencies in vertical bone height greatly increase the risk of not achieving an esthetic outcome, as augmentation procedures are still not entirely predictable (Fig 21a). Under most circumstances, regenerative procedures increase the width of the implant sites but do not recapture adequate height. This results in a compromised gingival and restorative appearance (Fig 21b).

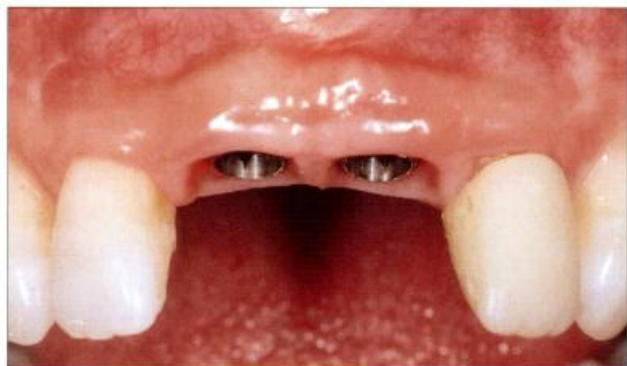
Fig 23 A circumferential implant shoulder depth of less than 2–3 mm would allow for access to a cement line on the shoulder of the implants.

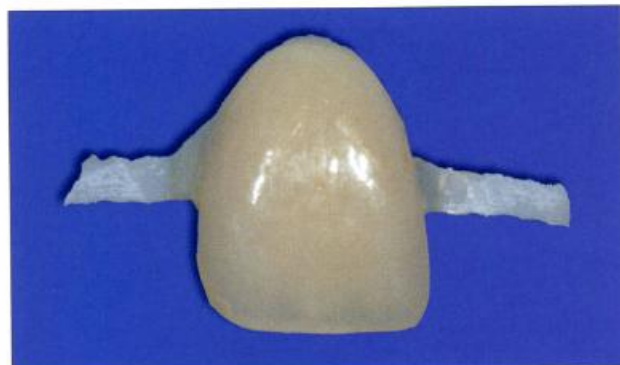
Fig 24a Laboratory-processed fiber-reinforced fixed partial denture.

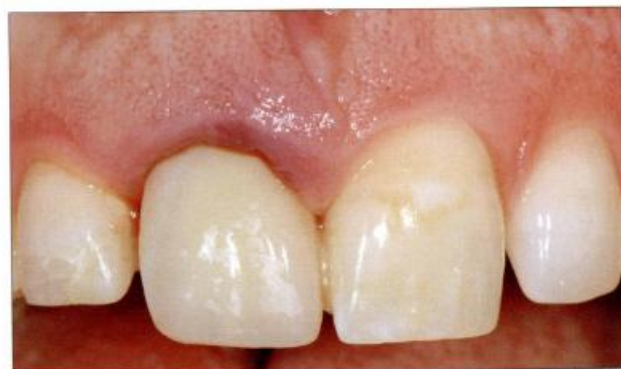
Fig 24b Frontal view of the resin-reinforced fixed partial denture bonded in place immediately following extraction of tooth 11.

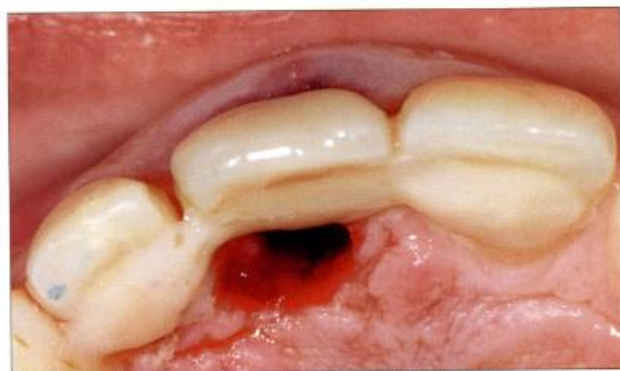
Fig 24c Occlusal view of the resin-reinforced fixed partial denture in place highlighting the flowable composite used to anchor it in place.

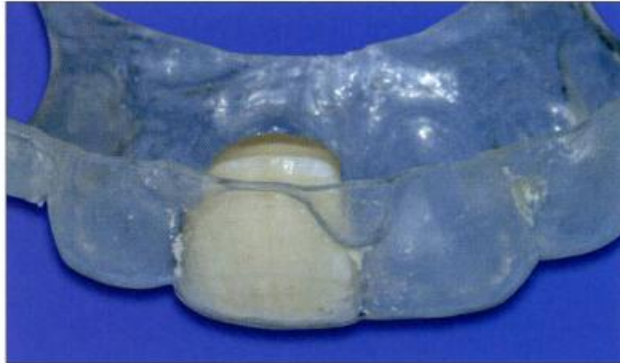
Fig 25 Vacuform retainer with a retained extracted tooth modified to an ovate form.

4. *Vacuform retainer* – If interocclusal space is limited and orthodontic treatment is not an option, a vacuform retainer with an ovate pontic can provide an interim restoration that will have controllable pressure on the graft site (Moskowitz and coworkers, 1997) (Fig 25). Vacuform retainers are not recommended for extended use, since occlusal interference and excessive denture wear must be expected.

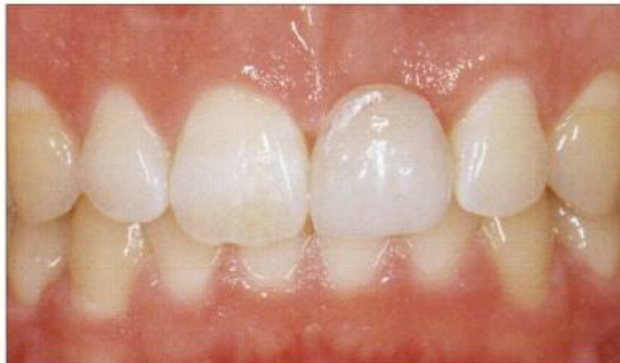
Fig 26a Removable partial denture replacing tooth 21 in a patient who requires horizontal augmentation in conjunction with implant placement.

5. *Removable partial denture (RPD)* – Patients can benefit from a removable prosthesis when a vertical deficiency does not exist. An acrylic-resin RPD gains its support from the palatal tissue and allows for the pontic to be designed in an ovate form for tissue shaping (Figs 26a, b).

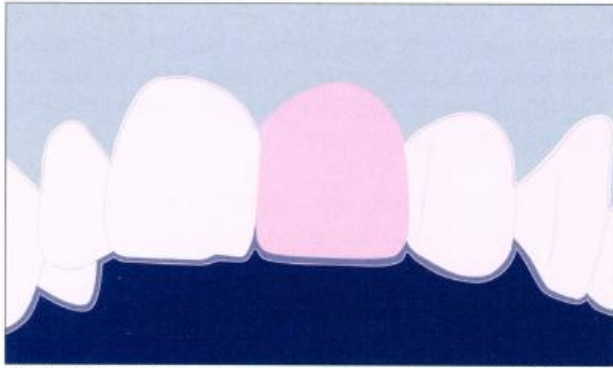
Fig 4 Schematic diagram of a waxup that can be used for the fabrication of a surgical template.

In complex cases, a diagnostic waxup can be beneficial as a basis for fabricating a surgical template (Fig 4), which facilitates correct three-dimensional implant placement during surgery. Here, the cervical end of the template in the tooth-gap position indicated the desired future soft-tissue margin at the implant-supported crown.

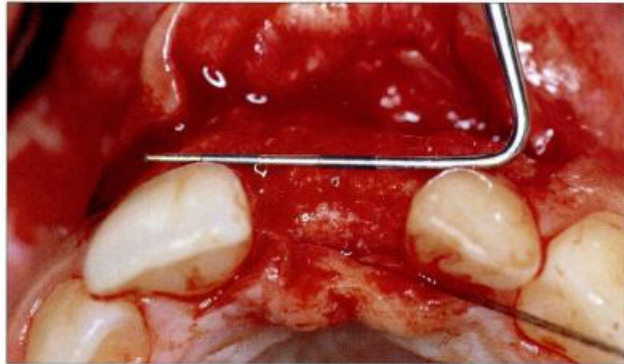
Fig 9 Periodontal probe indicating no horizontal bone deficiency. The site did not require horizontal bone augmentation.

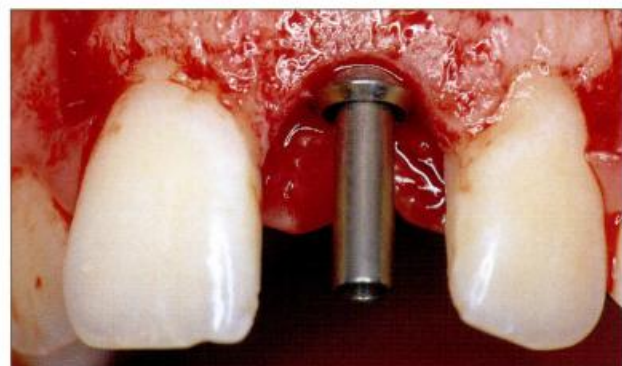
Fig 14 Status following implant insertion. The implant shoulder is positioned in the comfort zone.

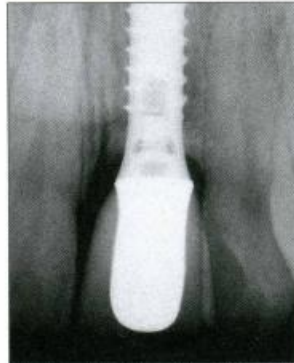
Fig 16 The typical radiographic appearance of a bone saucer around a Straumann implant with a vertical and a horizontal component.

Placing the implant shoulder too close to an adjacent tooth can cause the resorption of the interproximal alveolar crest to the level of that of the implant (Esposito and coworkers, 1993). With the loss of the interproximal crest height comes a reduction in papillary height. This also creates restorative problems: poor embrasure forms and emergence profiles will result in restorations with long contact zones and a compromised clinical outcome. The loss of crest height at adjacent teeth is caused by the bone saucerization routinely found around the implant shoulder of osseointegrated implants. Bone loss occurs in both the horizontal and vertical dimensions, creating a circumferential bone saucer around the implant.

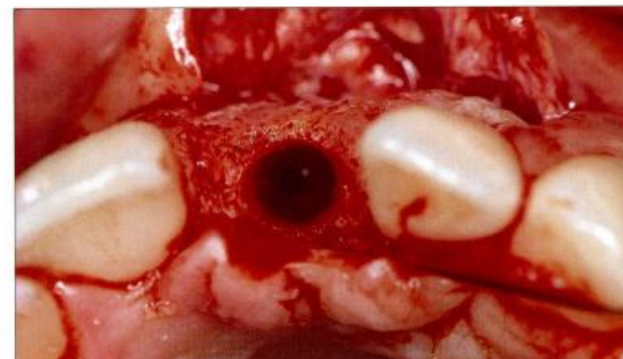
Fig 19 Occlusal view following implant bed preparation with a proper orofacial implant position and an intact facial bone wall.

After the implant bed is prepared, the facial bone wall should be intact. It should ideally measure at least 2 mm in thickness. This is important to ensure proper soft-tissue support and to avoid the resorption of the facial bone wall following restoration (Fig 19).

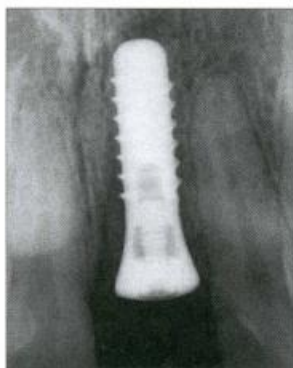
Fig 31 Post-surgical radiograph indicating a correct implant position.

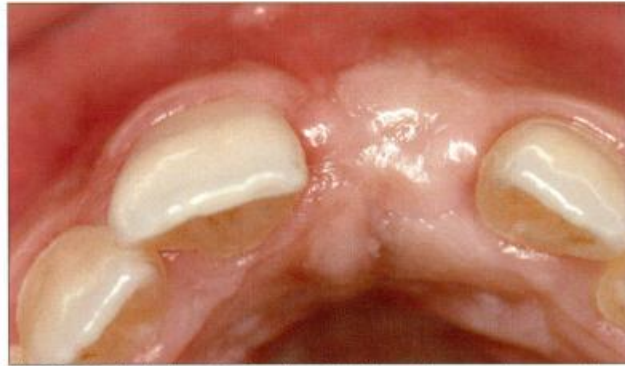
Fig 32 Occlusal view of the implant site before the reopening procedure.

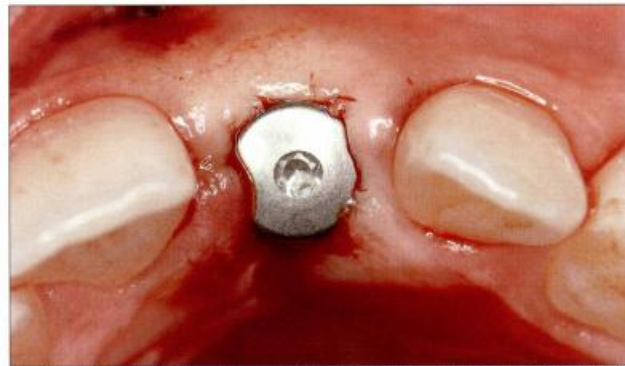
Fig 33 Status following the reopening procedure and insertion of a long titanium healing cap.

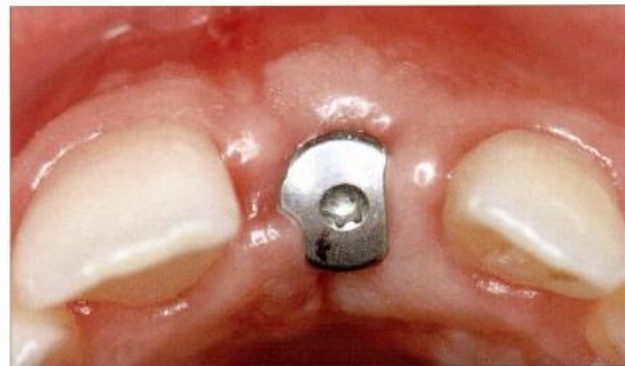
Fig 34 Clinical status a few days after the reopening procedure.

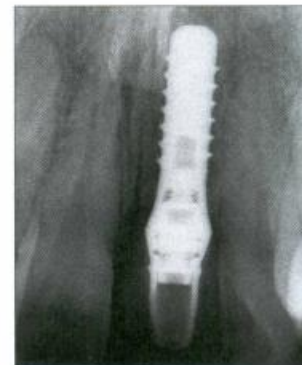
Fig 35 The periapical radiograph shows a good fit between the implant and the screw-retained provisional restoration.

The periapical radiograph demonstrates the precise seating of the screw-retained provisional crown (Fig 35).

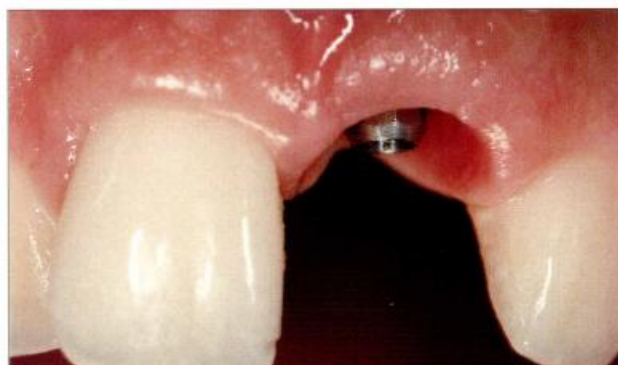
Fig 37 Facial view with nicely scalloped gingival margin.

In this patient, the provisional crown remained in place for three months to create ideal contours (Figs 36, 37). The final treatment outcome with a screw-retained ceramo-metal crown was pleasing for the patient, and integrated harmoniously into the natural dentition (Fig 38). The periapical radiograph demonstrated stable peri-implant bone crest levels (Fig 39).

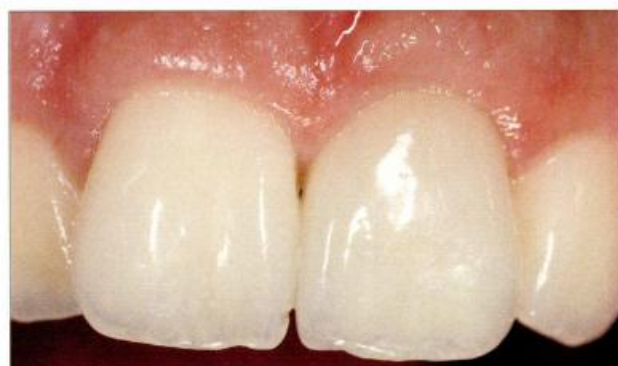
Fig 38 Esthetically pleasing treatment outcome with the implant-supported ceramo-metal crown.

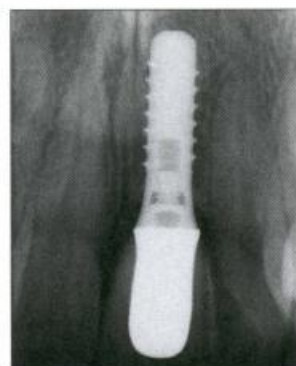
Fig 39 Periapical radiograph showing excellent precision between the implant and the restoration.

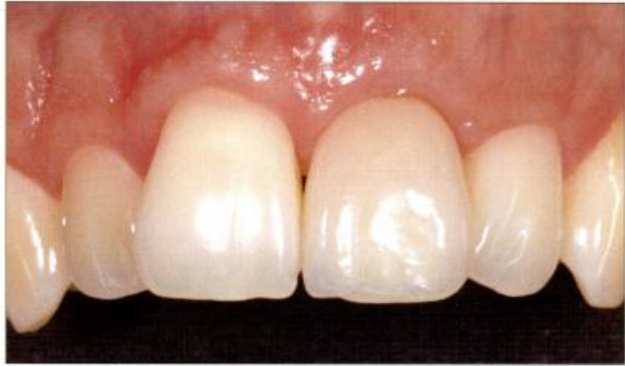
Fig 40 Clinical status eight years after implant placement.

The long-term follow-up demonstrated excellent stability of esthetic peri-implant soft tissues for up to nine years. In particular, the facial mucosa maintained its convex contour and the height of the midfacial gingival margin without any recession (Figs 40 – 43).

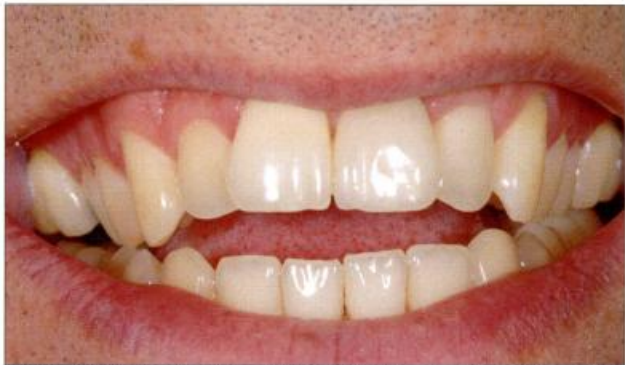
Fig 42 Clinical smile. The esthetic treatment outcome continues to be pleasing (December, 2005).

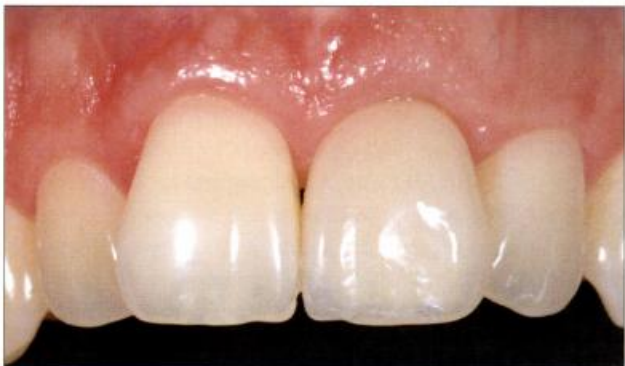
Fig 43 The detail view confirming the stability of the esthetic result at the nine-year follow-up.

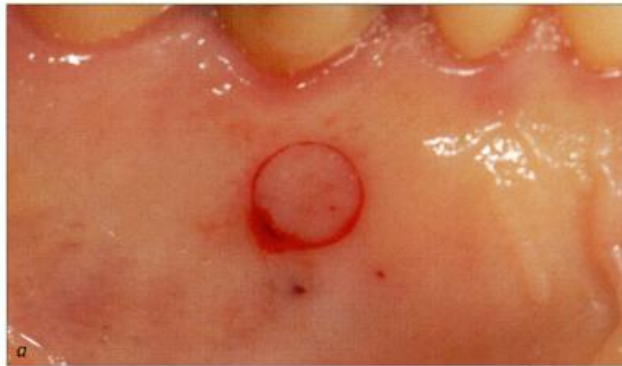
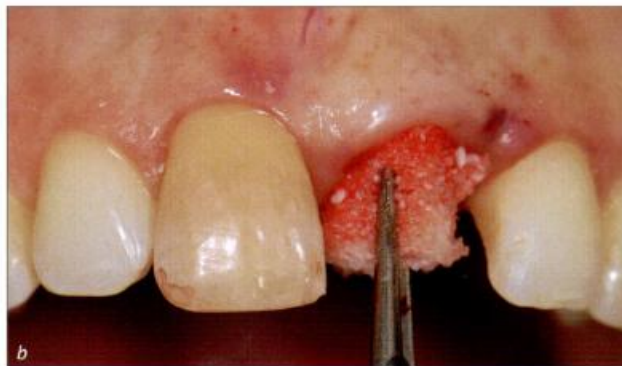
Figs 1a-c A punch graft transfers keratinized tissue from the palate to the alveolus. A collagen allograft is used to fill the extraction socket for supporting the graft.

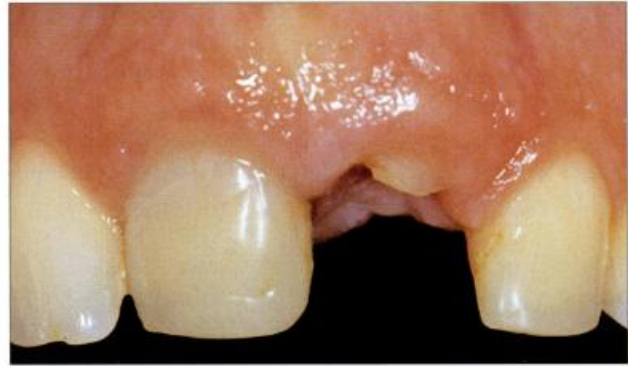
Fig 3 Soft-tissue access allowing for transmucosal healing.

1. In esthetically demanding areas with a thin, highly scalloped gingiva or where extensive soft-tissue or hard-tissue defects are present, submerged healing is recommended in order to establish soft-tissue access (Fig 2).
2. In esthetically demanding areas with a thick, low scalloped gingiva and soft-tissue access of at least 1 – 2 mm compared to the contralateral tooth, transmucosal healing can be chosen (Fig 3).

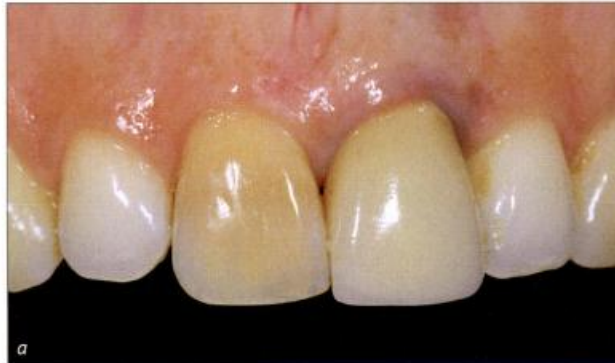
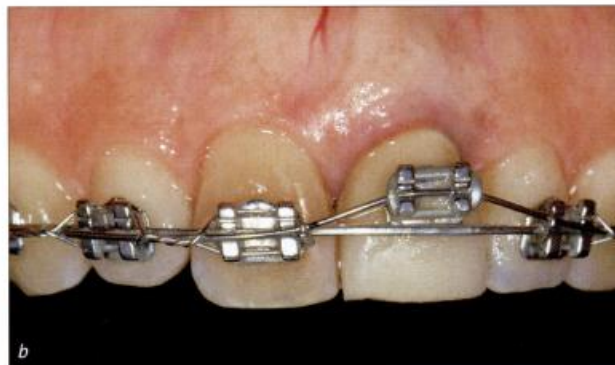
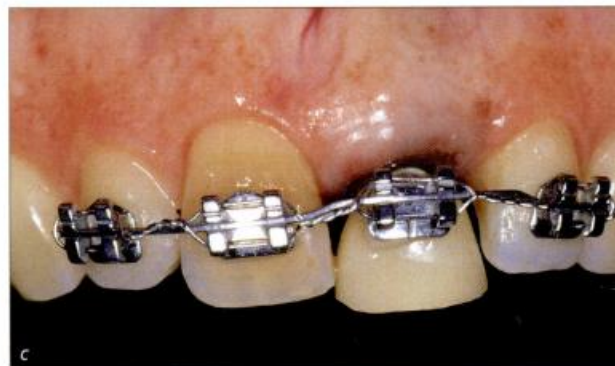
Figs 4a-c Forced orthodontic eruption is applied to enlarge soft-tissue and hard-tissue volume.

1. Before implant placement: in situations with extensive soft-tissue deficits (Figs 4a-c).
2. At implant placement with submerged healing: standard procedure for the correction of soft-tissue problems.

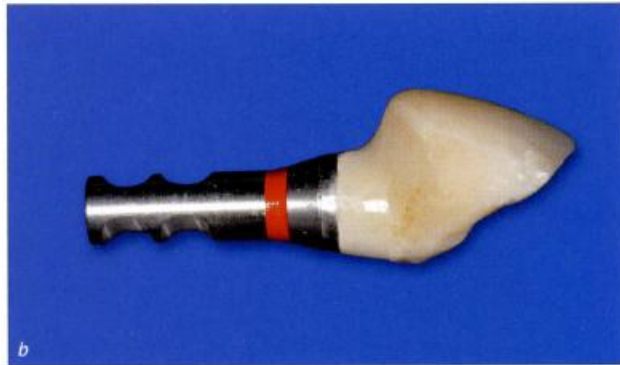
Figs 7a, b The cervical portion of the provisional crown is reshaped at chairside.

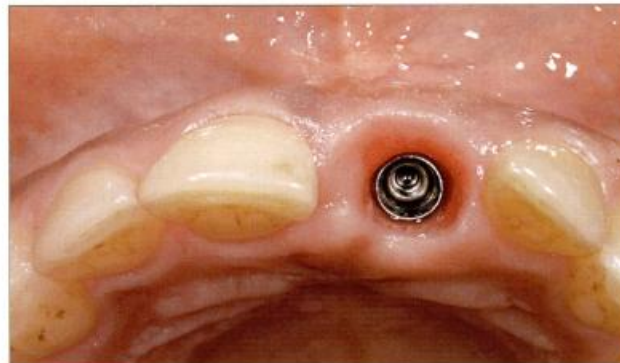
Fig 8 The contours of the mucosa for a natural emergence profile, which were shaped by the provisional, can now be captured with the impression.

When the desired shape and emergence profile are achieved (Fig 8), the impression for the master cast and the final crown fabrication is taken.

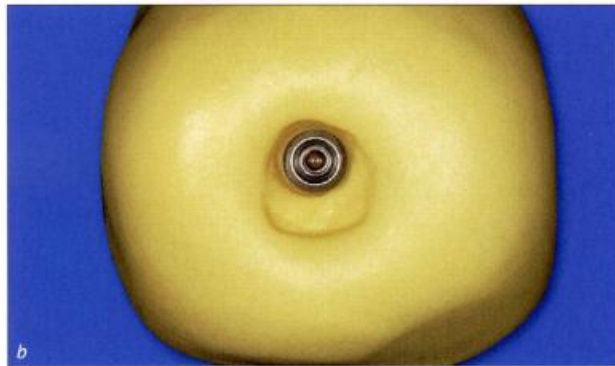
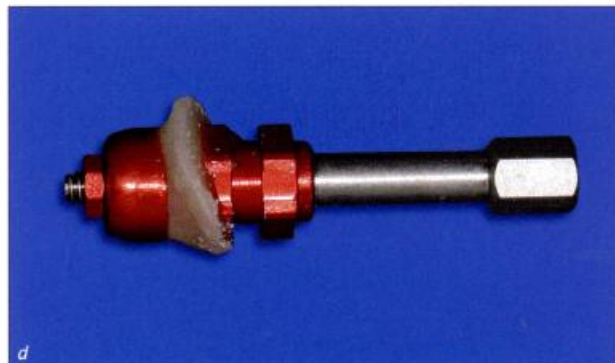
*Figs 9a-d An extraoral impression of the provisional crown is used to transfer the desired emergence profile to the impression cap.*

A so-called individualized impression that transfers the emergence profile by use of an impression cap is advantageous in esthetic sites (Figs 9a-d).

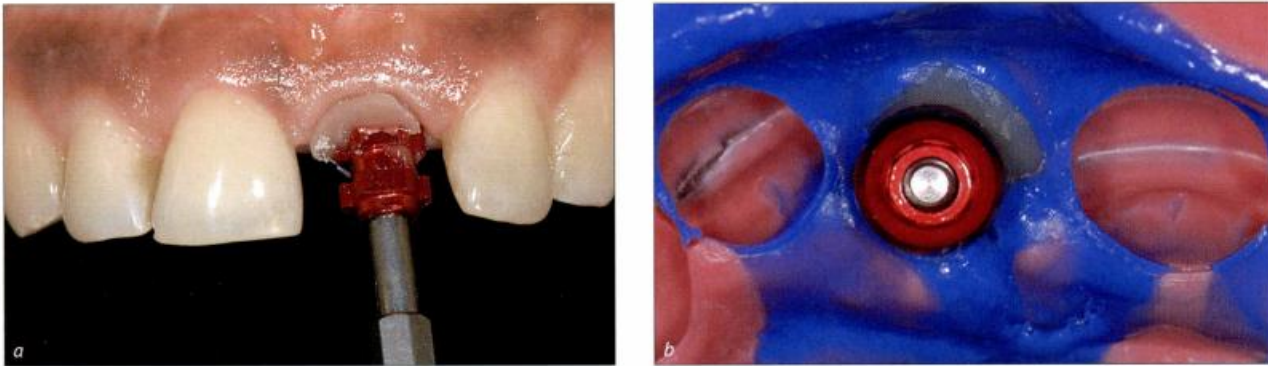
Fig 10a-b The individualized impression cap supports the mucosa during impression taking and enables the dental technician to fabricate the optimal shape of the final crown.

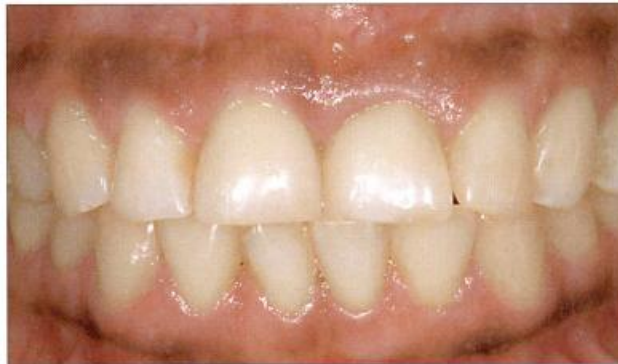
Fig 13 After adhesive cementation of the all-ceramic crown 21, harmonious integration into the natural dentition could be observed.

When a mesostructure is used, it is recommendable to try in this mesostructure in order to optimize the position and shape of the future crown margin (Fig 13). This ensures pleasing esthetics and facilitates thorough cement removal.

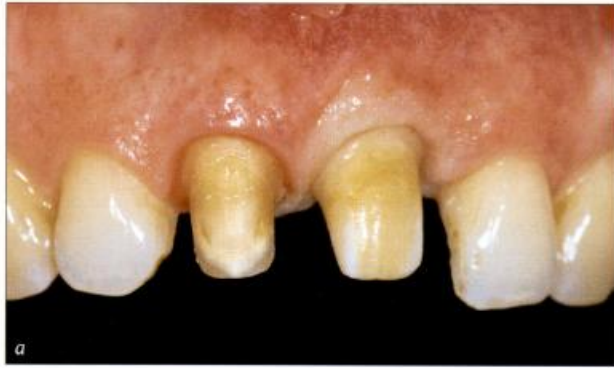
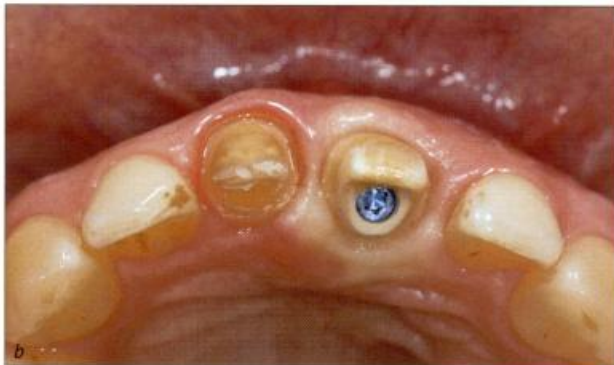
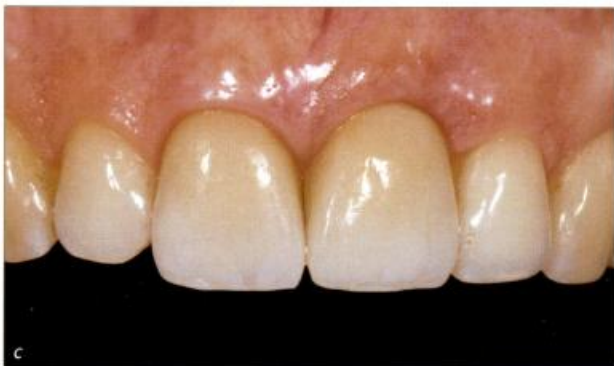
*Figs 14a-c In-Ceram blank at site 21, frontal and incisal view, and final situation with all-ceramic crown on tooth 11 and all-ceramic implant-supported superstructure at site 21.*

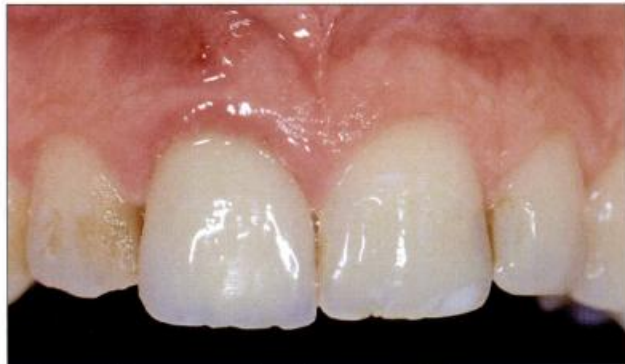
Fig 1 The fistula buccally of tooth 11 is clearly visible.

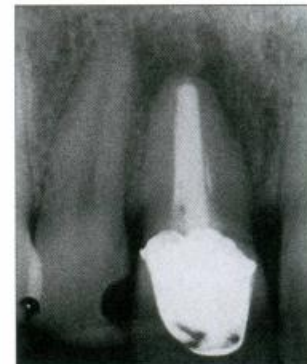
Fig 2 Radiograph of tooth 11 with periapical pathology.

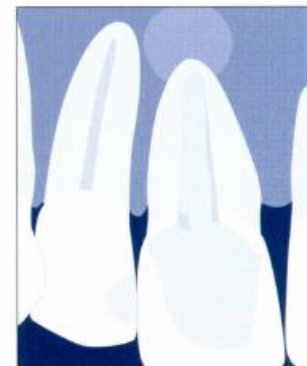
Fig 3 The interproximal bone levels are intact. Because of the large periapical radiolucency, however, an extensive bone defect had to be anticipated.

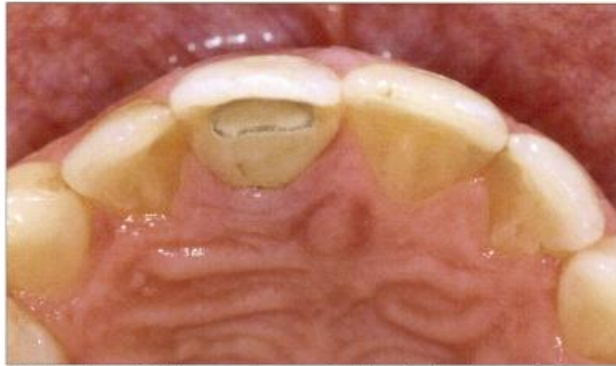
*Fig 4 A bony defect was to be expected despite the harmoniously contoured bony arch.*

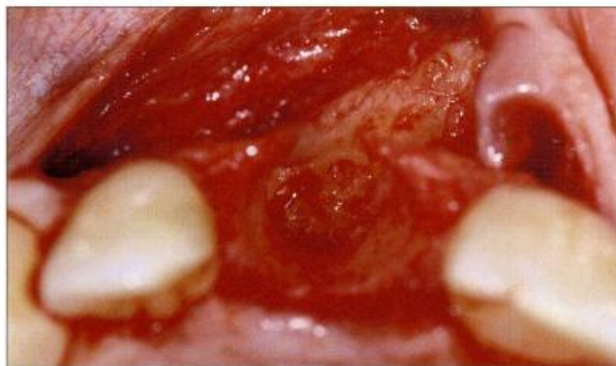
*Fig 6 After the extraction and removal of the granulation tissue, a large bone defect was present that did not allow for primary implant stability.*

A large bone defect was present after the extraction and removal of the granulation tissue. Due to the severe bone resorption caused by the infection, a bone-augmentation procedure needed to be performed before implant insertion (Fig 6). Thanks to the favorable anatomy of the defect and the protective walls of the extraction socket, a bone-augmentation procedure with particulate grafting material and a resorbable membrane was chosen.

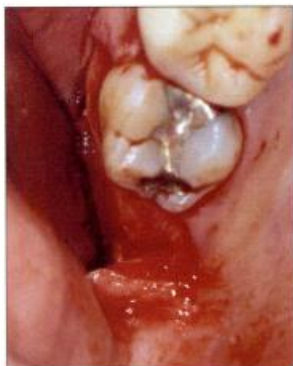
*Fig 7 Access to the donor site at the tuberosity area was gained with horizontal (tuber), vertical (mesial to tooth 17), and sulcular (tooth 17) incisions and mucoperiosteal flap elevation.*

Autogenous bone was harvested from the tuberosity area of the left upper quadrant using forceps and chisels (Figs 7, 8). Access to that area is similar to the procedure for extracting a third molar.

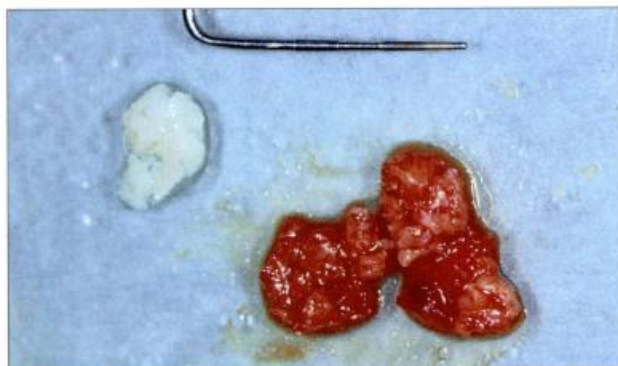
*Fig 8 Particulate autogenous bone harvested from the tuberosity area.*

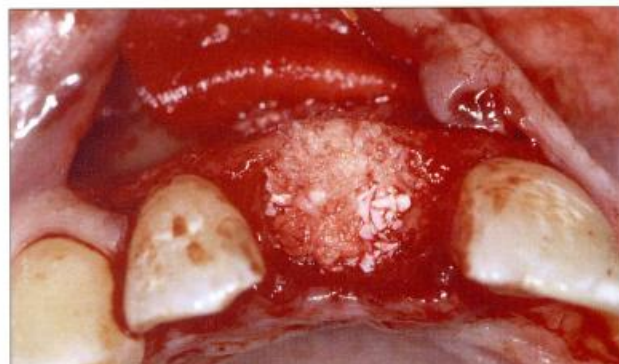
*Fig 9 Alveolar defect filled up using the GBR technique and autogenous bone and particles of DBBM as supporting material.*

The autogenous bone was then applied to the alveolus and subsequently covered with a layer of deproteinized bovine bone mineral (DBBM) (Fig 9).

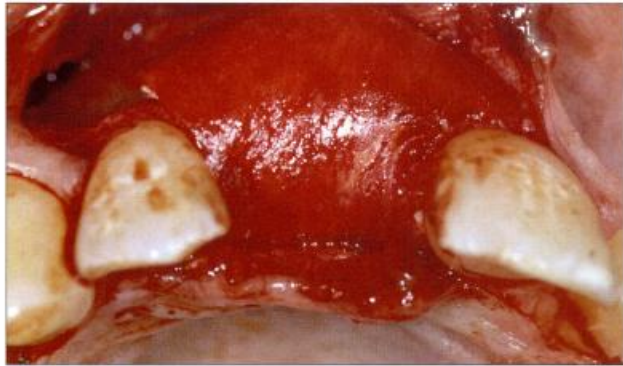
*Fig 10 The augmented area was covered with a resorbable collagen membrane stabilized with two resorbable pins in the apical region. Note the overcontoured labial aspect of the prospective implant site.*

The augmented area was carefully shaped to the desired contour. The labial aspect of the future implant site was slightly overcontoured to create a favorable bone volume and shape (Fig 11).

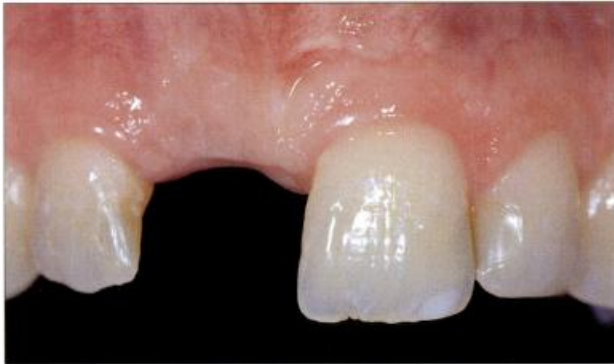
Fig 14 Site 11 six months after primary augmentation.

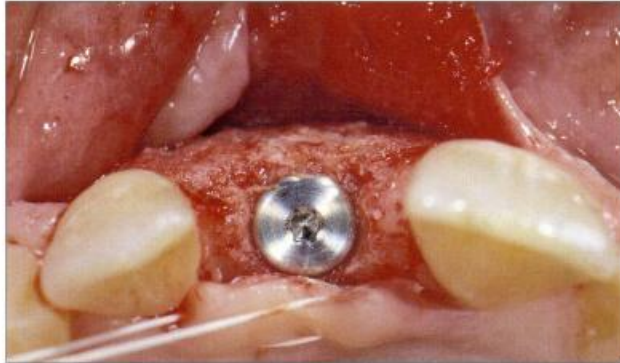
Fig 19 Occlusal view of the correct orofacial position of the implant.

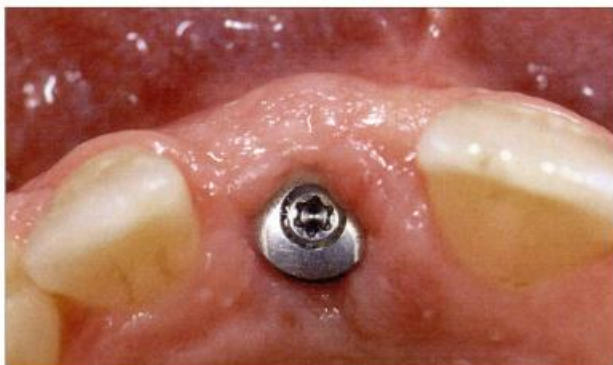
Fig 22 Clinical situation two weeks after abutment insertion.

Twelve weeks after implant placement, the closure screw was replaced by a labially beveled healing cap in order to start the mucosa-conditioning phase and to facilitate soft-tissue contouring. Two weeks later, remarkably good soft-tissue access was seen at the facial aspect of the implant site. An impression was taken for a provisional crown (Fig 22).

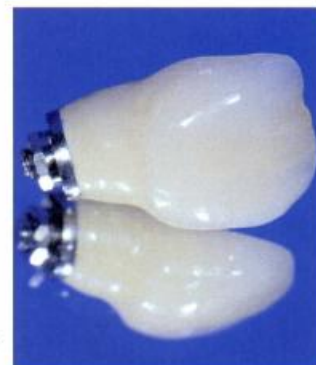
Fig 23 Temporary crown with moderate emergence profile.

Four months after the implant was placed, a temporary crown with a moderate emergence profile was fabricated by the dental technician using a titanium post for temporary restorations (Fig 23). At the time of integration of the temporary crown, it is important not to put too much pressure on the soft tissue. Instead, the emergence profile should be moderate, so that it can be modified in one or two subsequent steps. This step-by-step procedure prevents soft-tissue retraction and helps build a perfectly conditioned mucosa to match the emergence line and the contour of the marginal gingiva of the contralateral tooth as closely as possible.

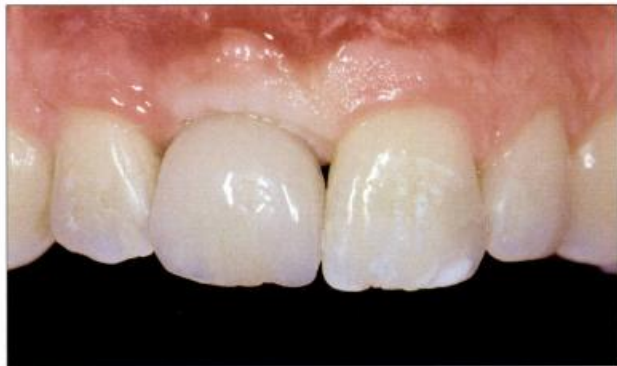
Fig 24 The pressure of the inserted temporary crown caused soft-tissue blanching.

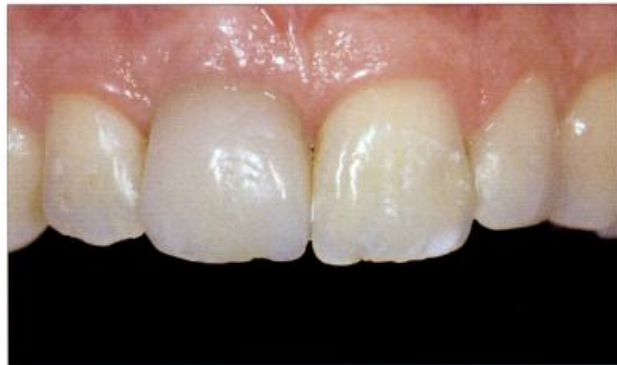
Fig 25 Emergence profile of the provisional as improved by chairside step-by-step modification with light-curing composite.

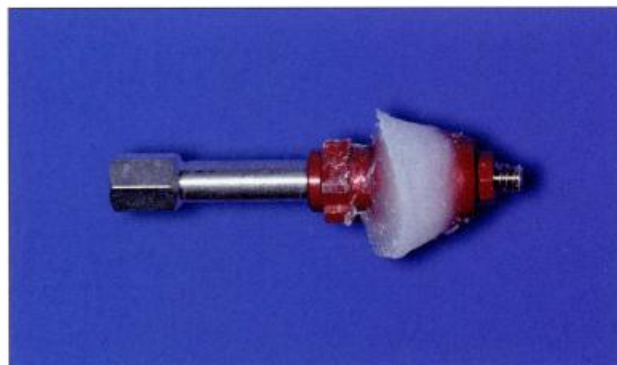
Fig 26 Modified impression cap capturing the shape of the provisional crown.

At impression-taking, this customized impression coping prevented soft-tissue collapse and ensured optimal support of the emergence profile (Fig 27).

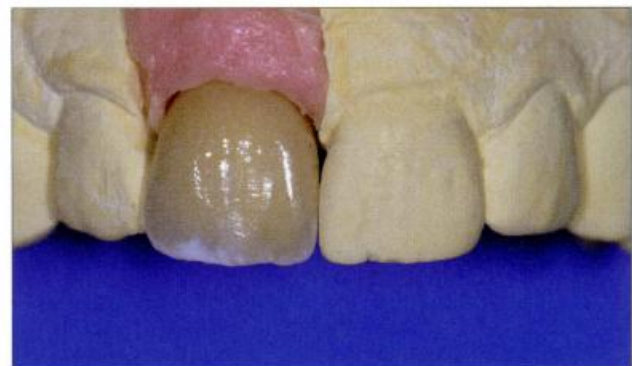
Fig 28 Frontal view of the all-ceramic crown (synOcta In-Ceram blank).

The final crown was fabricated at the dental laboratory using a synOcta In-Ceram blank (Fig 28).

For crown fabrication, the In-Ceram blank was ground to the shape of a miniature copy of tooth 11, which was subsequently glass-infiltrated and directly veneered with a veneering ceramic.

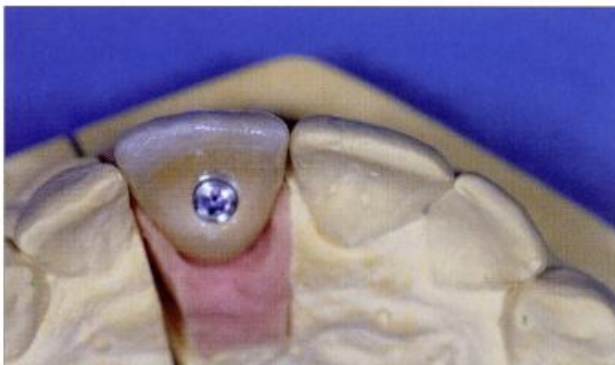
Fig 29 Occlusal view of the screw-retained all-ceramic crown (synOcta In-Ceram blank).

Thanks to the ideal implant axis, a screw-retained crown could be fabricated (Fig 29).

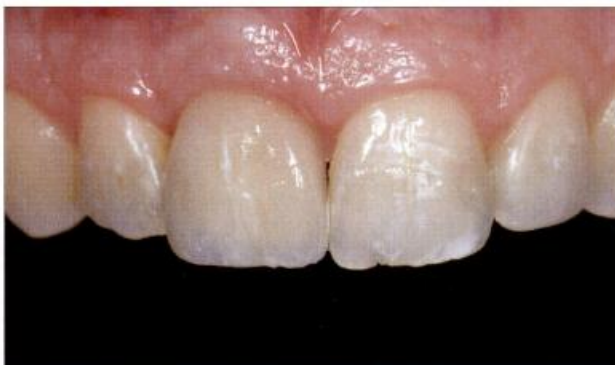
Fig 30 Frontal view of the all-ceramic implant-supported restoration at site 11.

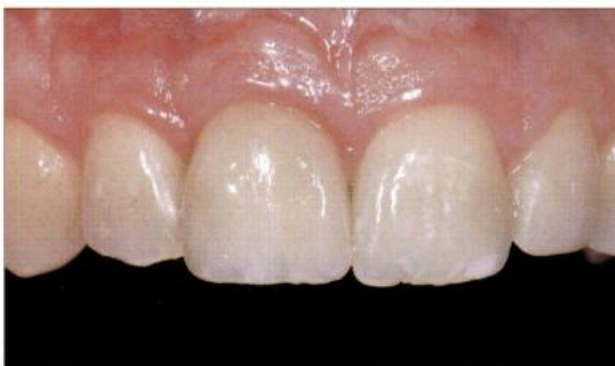
Fig 31 Clinical situation showing favorable soft-tissue contours 2.5 years after crown insertion.

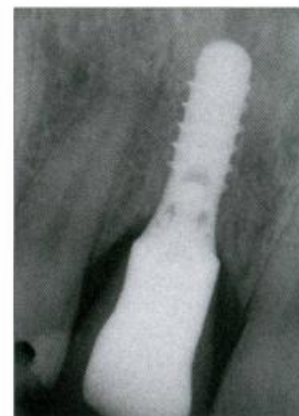
Fig 32 Stable peri-implant bone levels 2.5 years after crown insertion.

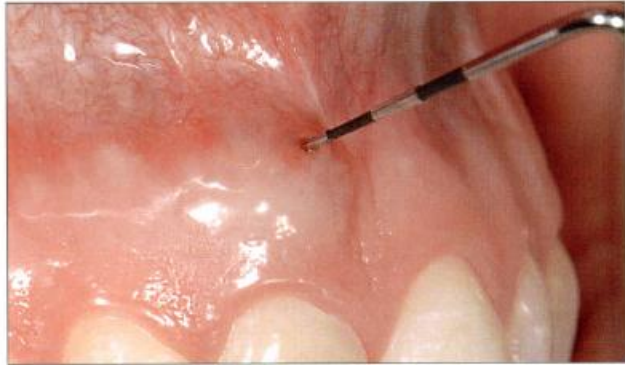
Fig 3 Periodontal probe, confirming the presence of a chronic fistula at the mucogingival border labial of root 11.

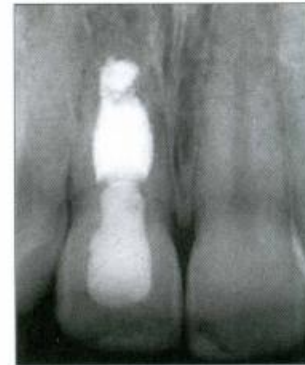
Fig 4 Initial periapical radiograph. Status after extensive conventional root-canal therapy on tooth 11, including an unsuccessful attempt at periapical endodontic surgery. Advanced apical and lateral root resorption. The vertical bone height at adjacent teeth was within two millimeters of the cemento-enamel junction.

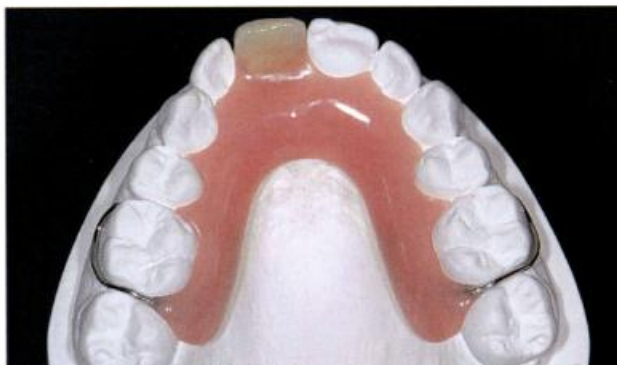
Fig 5 Occlusal view of the maxillary study cast with the simple removable partial denture, which was to serve as an interim restoration after the extraction of tooth 11.

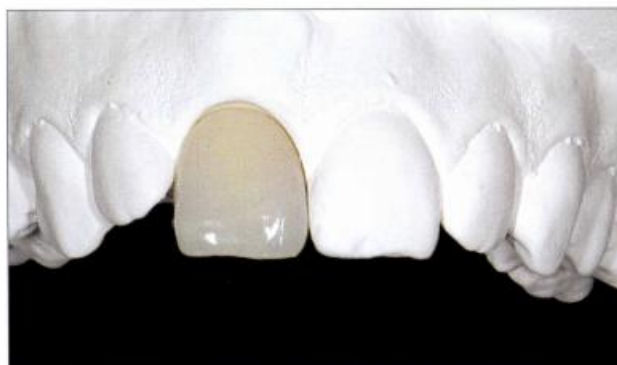
Fig 6 Labial aspect of the provisional removable partial denture (RPD). The laboratory technician had tried to respect, as much as possible, the symmetry-related esthetic parameters gathered from the contralateral site (21). In particular, the cervical aspect of temporary tooth 11 had been designed as an ovate pontic of a conventional fixed partial denture (FPD) without a labial denture flange.

With the tooth to be extracted still in place, the laboratory technician precisely anticipated on the study cast the local site configuration expected after tooth removal. In this process, the tooth was hemisected exactly at the gingival level. A discrete concavity was created at the same site in order to adapt a prefabricated acrylic denture tooth as an ovate pontic. The landmarks provided by the contralateral tooth helped create a simple but esthetically pleasing provisional that did not have a buccal denture flange, as no soft-tissue deficiencies had to be compensated for at this stage of treatment (Fig 6).

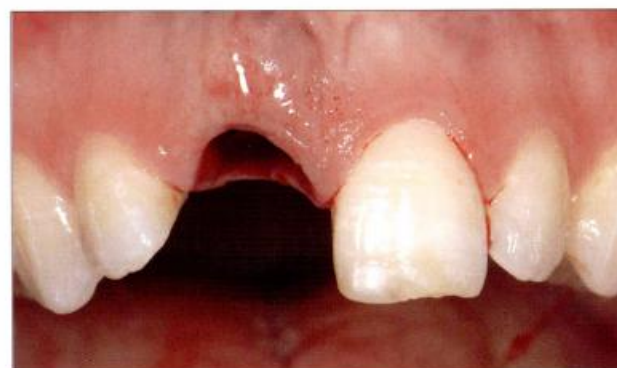
Fig 7 Clinical view immediately after extraction of tooth 11. This procedure was performed without elevating a mucoperiosteal flap.

During the second appointment, tooth 11 was carefully and gently extracted without elevating a flap, using small desmotomes. Particular care was taken to avoid any mobilization of the root in a vestibular direction in order to preserve as much of the remaining buccal bone plate as possible (Fig 7).

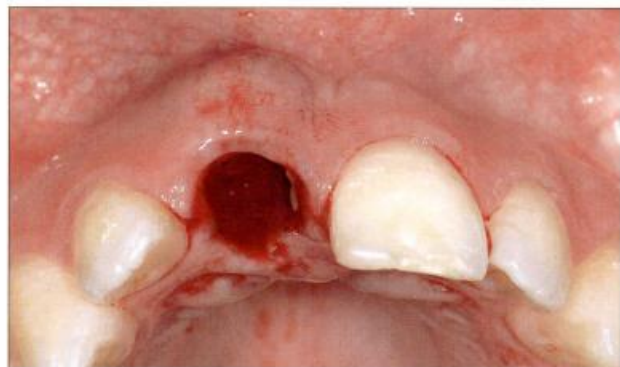
*Fig 8 Occlusal view of site 11 immediately after tooth extraction showing the amount and extent of the vestibular soft-tissue swelling due to the active periapical inflammatory process.*

The presence of an active periapical inflammatory process with associated pain, swelling (Fig 8), and a persisting fistula was incompatible with a more progressive and more rapid approach, such as the immediate placement of an implant.
