ITI Treatment Guide  
Volume 1

# Treatment Guide

Volume 1

Implant Therapy in the Esthetic Zone  
Single-Tooth Replacements

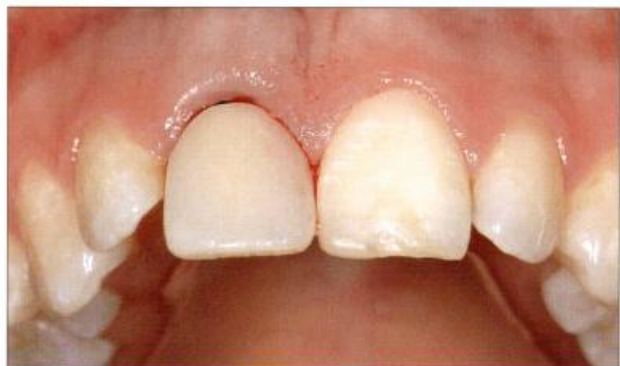
*Fig 10 Care was taken not to compress the soft tissue at the fresh extraction site with the removable provisional partial denture, while also providing minimal tissue support in the interproximal areas.*

Following the extraction, the previously fabricated provisional RPD was carefully inserted and checked for any excessive soft-tissue contact and compression in order to guarantee uneventful healing. Besides assuring function, phonetics, and esthetics, the objective was to establish slight soft-tissue contact, especially at the interproximal aspects, to provide minimal support to the papillary tissue, preventing excessive collapse towards the center of the extraction site (Fig 10).

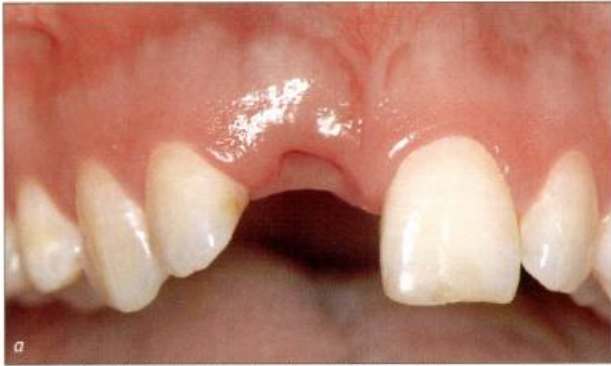
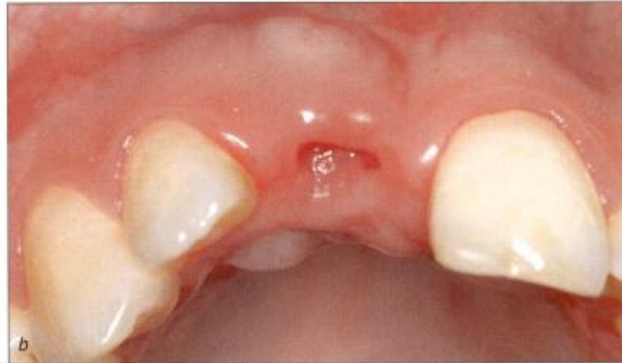
*Figs 11a, b Vestibular (a) and occlusal (b) views of the extraction site six weeks after the right central maxillary incisor had been removed. Only minimal soft-tissue loss in an orofacial and a coronoapical direction could be observed, and the scalloped course of the gingiva was maintained. A marked concavity still existed in the center of the former extraction site.*

Six weeks after the extraction, the soft tissue of the future implant site had uneventfully healed and the respective wound surface was completely epithelialized (Figs 11a, b). As expected, only minimal loss of soft-tissue height at the interproximal aspects and of soft-tissue width in an orofacial direction was observed. The harmonious course of the gingiva could largely be maintained.

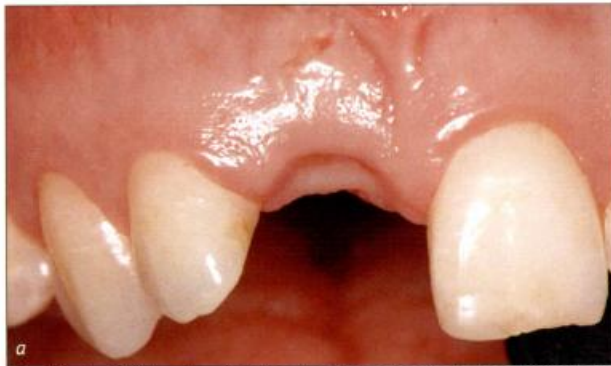
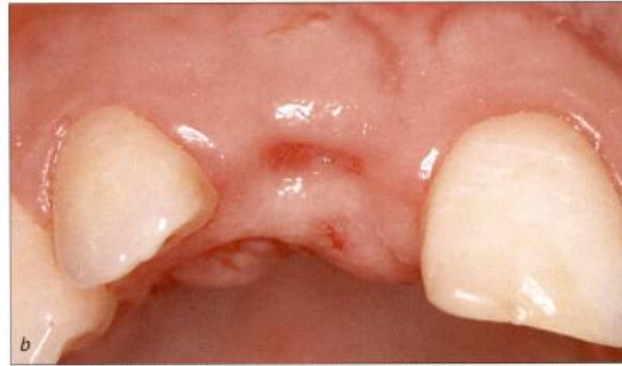
*Figs 12a, b Eight weeks after the extraction of tooth 11, the soft-tissue situation at the site of implantation was considered adequate according to the preferred early placement/early loading protocol.*

This additional healing time contributed to a more favorable soft-tissue situation from a surgical point of view, eight weeks after the extraction (Figs 12a, b).

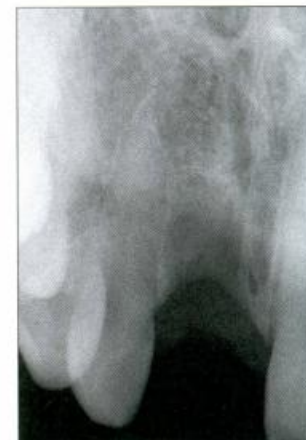
*Fig 13 Eight-week post-extraction apical radiograph documenting favorable bone height at the interproximal aspects of the adjacent teeth.*

At this stage, a periapical radiograph was taken to examine the osseous status at the future implantation site (Fig 13). This two-dimensional diagnostic document confirmed that the vertical bone level at the interproximal aspects of the two neighboring teeth was maintained at a

height similar to that before the tooth was removed. As this height corresponded to a physiological distance from the CEJ of the adjacent teeth and as this parameter had been proven to represent a key factor for soft-tissue support around implants, the esthetic prognosis was excellent.

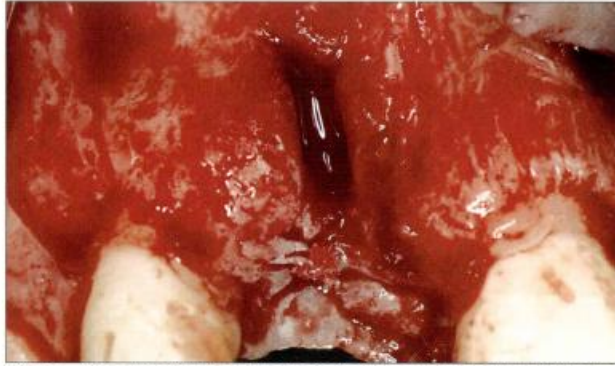
*Fig 14* After elevation of a mucoperiosteal flap with mesial and distal relieving incisions, the absence of the buccal bone plate at the center of the prospective implantation site became apparent.

Based on the clinical and radiographic examinations that had confirmed that the optimal situation for early implant placement had been reached, the decision was made to proceed to the surgical phase of the treatment. A slightly palatal crestal incision was chosen and a mucoperiosteal flap with two relieving incisions was elevated. As expected, part of the buccal bone plate was missing, but without affecting the width of the orofacial crest at adjacent teeth further apically (Fig 14).

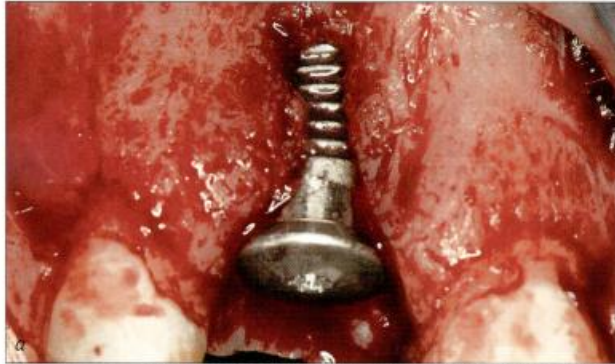
*Figs 16a, b* Labial (a) and occlusal (b) views of site 11 immediately after placement of a Regular Neck (RN) Tapered Effect (TE) implant. Adequate three-dimensional implant position, completely within the alveolar housing and fully compatible with a simultaneous localized GBR procedure.

As documented by Figures 16a and b, an adequate three-dimensional implant position, resulting in a two-wall bony defect at the buccal aspect, was achieved. The entire circumference of the implant body and the implant shoulder were located within the alveolar bone crest (Buser and coworkers, 2004).

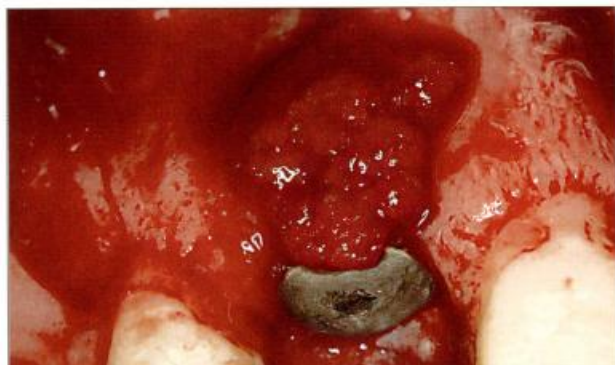
Fig 17 The persisting localized dehiscence-type defect on the labial aspect of the freshly inserted implant was covered with small bone chips harvested next to the implant site.

Once the appropriate three-dimensional implant position had been reached and its primary stability confirmed, the localized GBR procedure was undertaken. It consisted first of the harvesting of autogenous bone grafts ("chips") in the close vicinity of the implant site and then of an adaptation to the exposed buccal implant surface to fill in the small dehiscence-type defect (Fig 17).

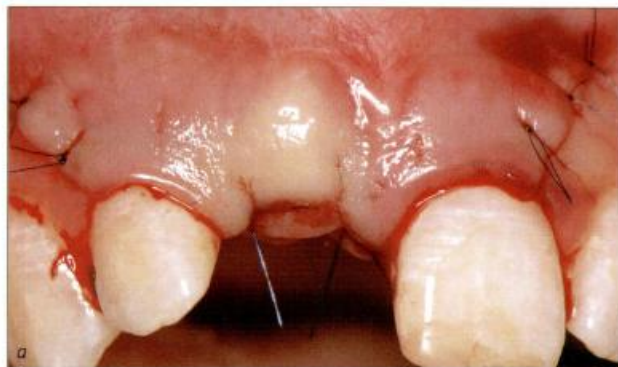
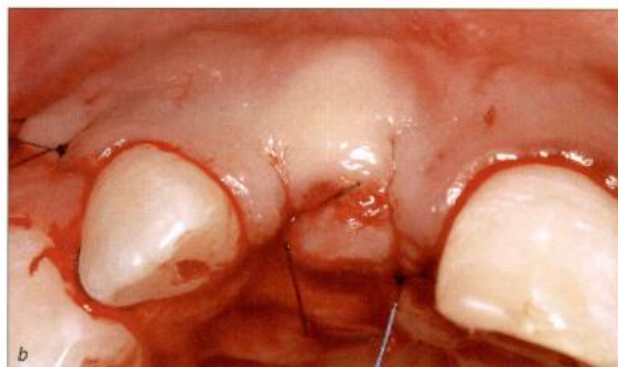
*Figs 20a, b Primary wound closure was achieved with incision of the periosteum at the basal level of the flap, compensating for the significant "over-build" of the labial aspect at the implant site.*

In order to permit optimal, tension-free flap adaptation in view of a complete primary wound closure (Figs 20a, b), the periosteum was split at the basis of the flap.

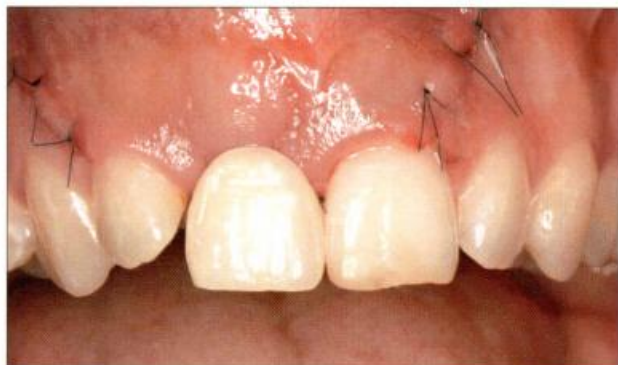
*Fig 22 The provisional RPD was shortened at site 11 to minimize the risk of interference with the healing process.*

The GBR procedure required a significant cervical reduction of the provisional RPD to avoid any excessive tissue compression in the region of the freshly inserted implant (Fig 22).

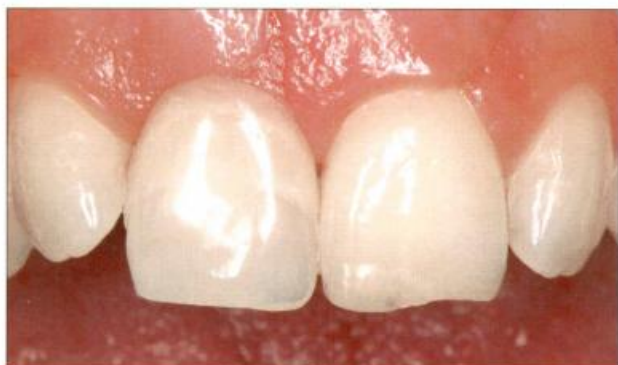
*Fig 23 As soon as the process of soft-tissue healing permitted, the temporary RPD was carefully relined to establish optimal tissue contact and to improve the esthetic appearance of the anterior maxilla.*

After ten days of uneventful soft-tissue healing, the temporary restoration was relined for the patient's subjective comfort and to improve the esthetic appearance in the region of the anterior maxilla (Fig 23).

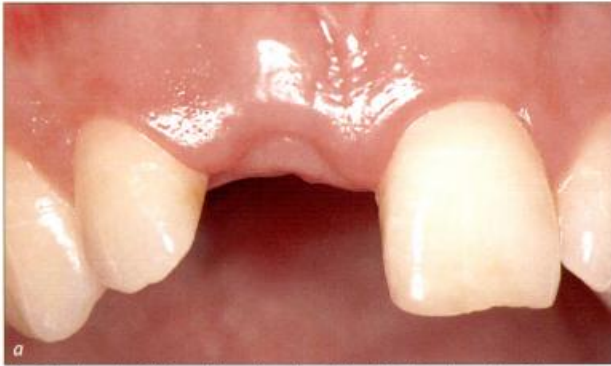
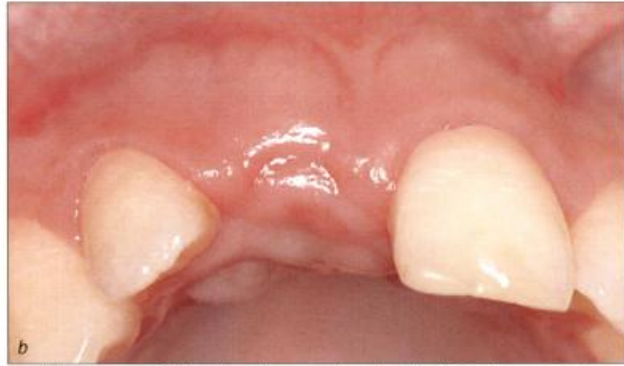
*Figs 24a, b Vestibular (a) and occlusal (b) of the implant site after a ten-week period of uneventful healing, documenting that the first phase of post surgical soft-tissue maturation was completed. Only minimal vertical tissue loss had occurred compared with the pre-surgical situation.*

In accordance with an early loading protocol and taking into account the individual extent of GBR performed, the prosthodontic procedure could be initiated in this patient ten weeks after implant placement. At that time, the phase of primary soft-tissue healing was considered completed (Figs 24a, b).

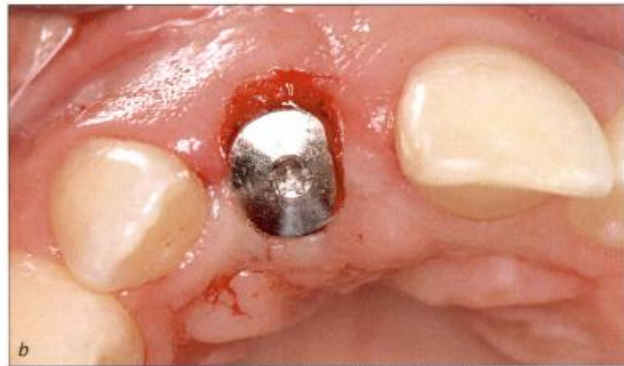
*Figs 26a, b A CO<sub>2</sub> laser technique was applied to create access to the underlying implant shoulder (a). The original short healing cap was subsequently replaced by a longer one to maintain the newly established restorative access (b).*

The first step of the restorative phase consisted of establishing access from the soft-tissue surface to the underlying implant shoulder. In this patient, a CO<sub>2</sub> laser technique (Fig 26a) was used and the short titanium healing cap replaced with a longer one (Fig 26b) in order to maintain the freshly created restorative access.

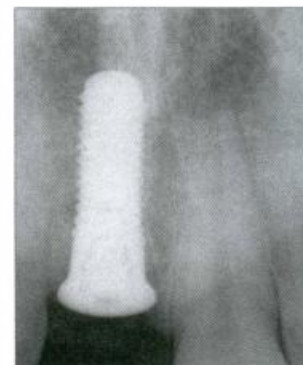
*Fig 25 Intraoral radiograph, documenting the anticipated stable peri-implant bone.*

A periapical radiograph was taken to confirm a stable peri-implant bone situation (Fig 25). In particular, the interproximal height of the bone surrounding the adjacent natural teeth had been maintained at a level comparable to that before implant placement.

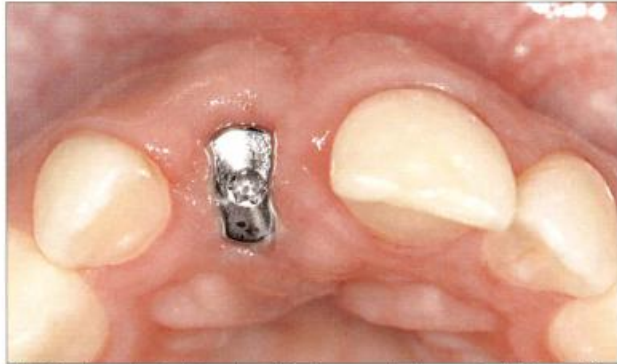
Fig 27 Approximately ten days after the second-stage surgical intervention, the soft tissue allowed proceeding to the next prosthodontic step.

Ten days later, the peri-implant soft tissue (Fig 27) was considered compatible with impression-taking or the fabrication of a chairside implant-supported provisional restoration.

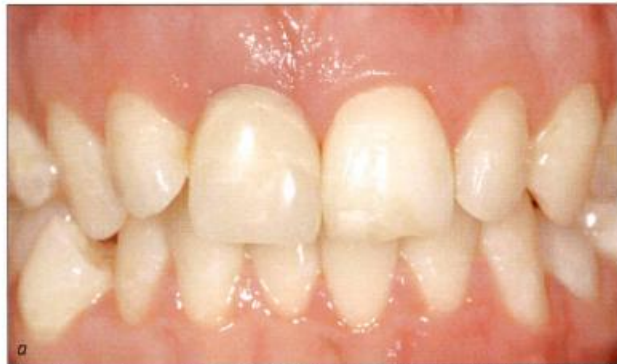
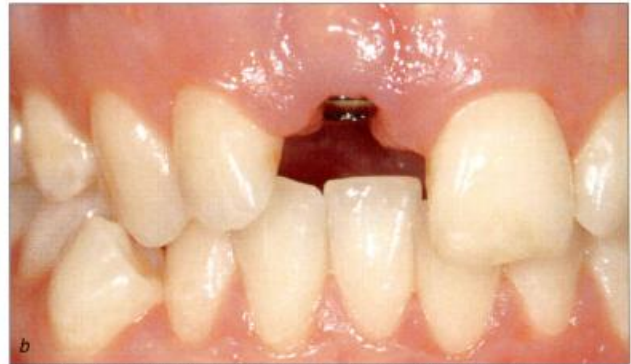
Figs 28a, b Comparison of the labial views with (a) and without (b) the provisional RPD, indicating that sufficient soft-tissue height was present at site 11 to create a symmetrical soft-tissue contour at the position of the two central maxillary incisors.

A direct comparison between the labial view with (Fig 28a) and without (Fig 28b) the provisional RPD in place gave rise to the expectation that the slight excess in soft-tissue height at site 11 would be sufficient to ultimately create a restoration emergence profile similar to that of the contralateral tooth (21).

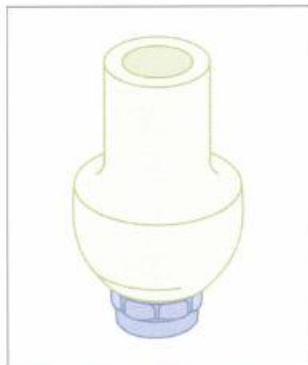
Fig 29 The RN synOcta temporary meso-abutment was used for chairside fabrication of an occlusally screw-retained temporary implant-supported crown. As the marginal area is prefabricated, the clinician only needed to adapt the cervical emergence profile (subtractively or additively) to the requirements of the clinical situation.

It was decided to proceed to the fabrication of a direct fixed implant-supported provisional in an attempt to establish optimal peri-implant soft-tissue contours prior to the implant impression. For the fabrication of the planned chairside provisional, a newly developed restorative component, the Regular Neck (RN) synOcta temporary mesoabutment, was used (Fig 29). It is possible to add acrylic resin directly to this substructure, fabricating a one-piece screw-retained implant provisional. The same component can also be used as a mesostructure, serving as a base for a cemented provisional restoration. This component could also be utilized — after substantial occlusal reduction — as a screw-retained tissue conditioner/healing abutment. Under these circumstances, a patient would continue to wear his or her provisional RPD.

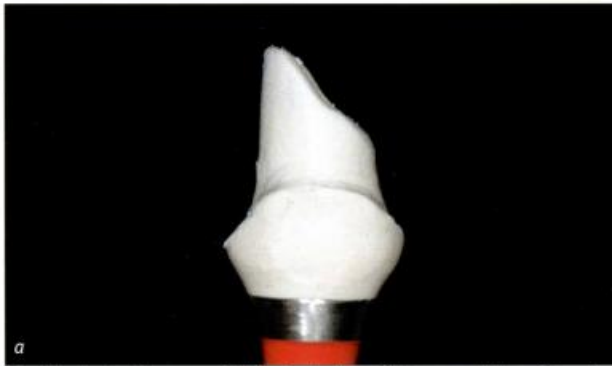
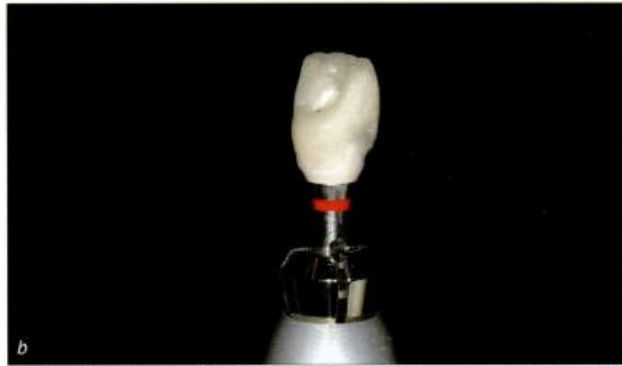
*Figs 30a, b In this case, with the implant axis fully compatible with occlusal screw retention, it was decided to connect the provisional crown directly to the implant. As the cervical part of the component is prefabricated and has an excellent marginal fit by definition, a significant number of the fabrication steps can be performed extraorally.*

The component described could subsequently be attached to a corresponding implant analog, facilitating the finishing procedures that were performed extraorally (Fig 30a). A special holder (Fig 30b) is available for the fixation of the analog.

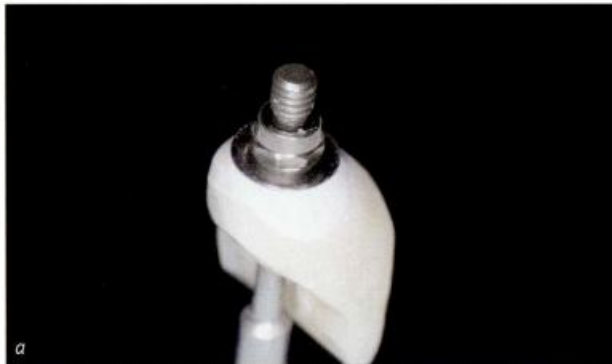
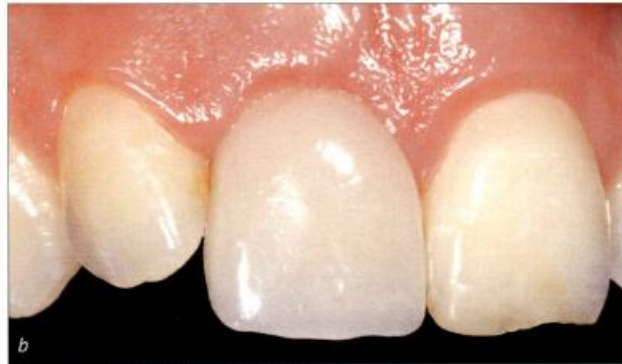
*Figs 31a, b After finishing and polishing, the temporary crown (a) produced at chairside was ready for insertion (b).*

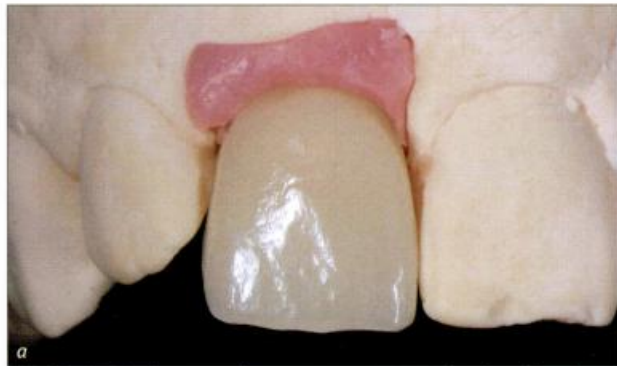
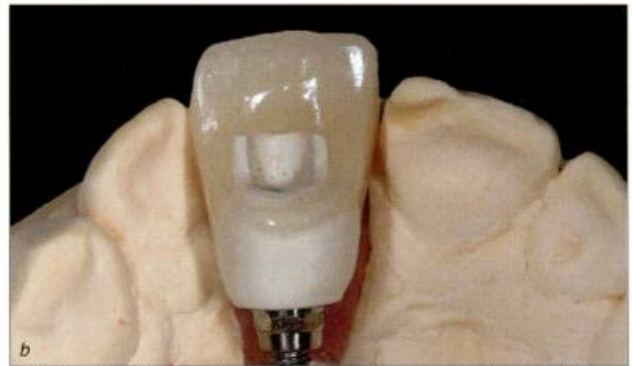
Figs 32a, b For demonstration purposes, a screw-retained provisional crown was fabricated in the dental laboratory, using the previously described RN synOcta temporary mesoabutment as its base.

The RN synOcta temporary mesoabutment can also be used as a base for a screw-retained provisional crown fabricated on a working cast in the dental laboratory (Figs 32a, b).

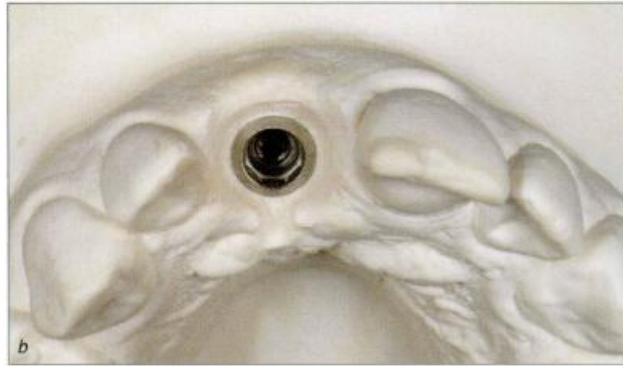
*Figs 34a-c Vestibular (a) and occlusal (b) views of the master cast, showing a satisfactory three-dimensional implant position and peri-implant soft-tissue contours optimized on the working cast by the laboratory technician. An access slot was created at the palatal aspect for better visual control of the margin and for ease of manipulation. The implant is ideally placed within the orofacial and mesiodistal comfort zones (c).*

A stone working model was produced to fabricate an occlusally screw-retained permanent implant-supported crown (Figs 34a, b).

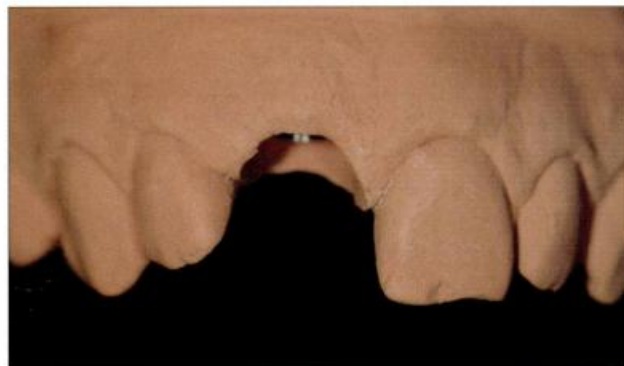
*Fig 35 Labial view of the working cast with the increased optical contrast required for the CARES system during the scanning process.*

The master cast was reproduced in a special dental stone that provided the strong optical contrast necessary for the scanning process essential to Straumann CARES, the Computer Aided REstoration Service (Fig 35).

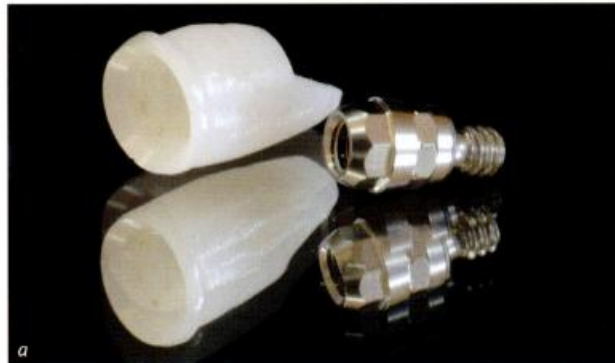
Figs 37a, b The computer-generated zirconium-dioxide custom abutment, to be connected to the synOcta 1.5 abutment (a) and displaying a slightly "whitish" appearance (b), required some preliminary modification to create optimal conditions for esthetic ceramic veneering.

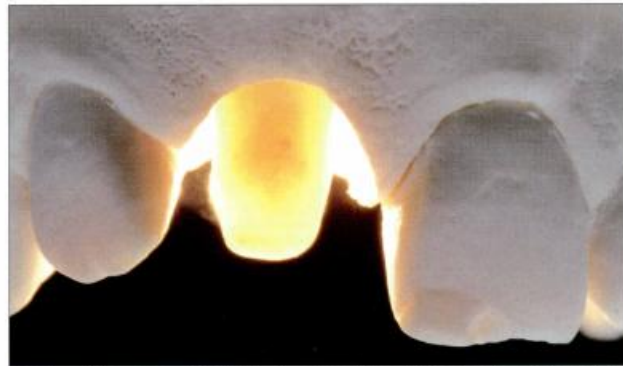
*Fig 39 After adding a thin layer of dentine-like ceramic, the remaining translucency of the ZrO<sub>2</sub> custom abutment was verified under light-transmission conditions.*

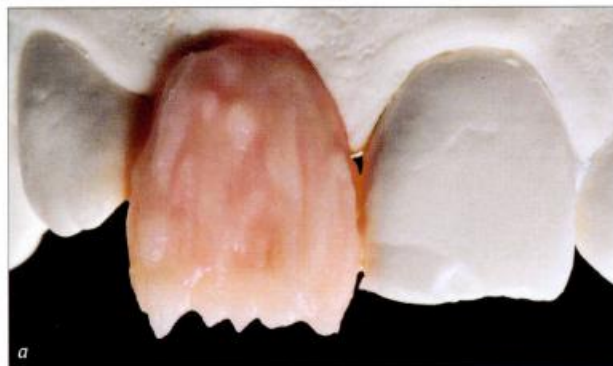
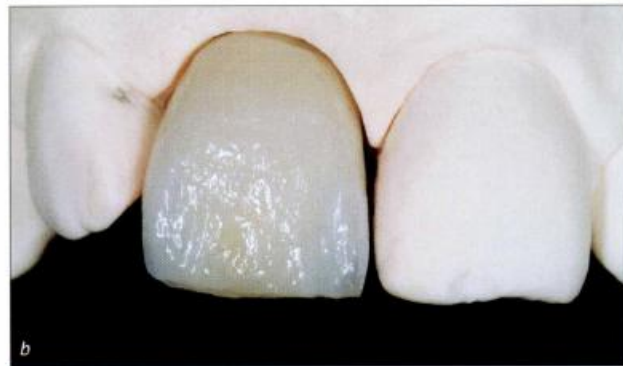
*Figs 40a, b In the first step, the clinical crown volume, composed of a complex sequence of layers of different opacities and shades, imitating the basic components—dentine, enamel, and incisal translucency—of a natural maxillary incisor, was established (a). After the first ceramic sintering, a significant volume contraction was observed, requiring at least one additional corrective step. The basic optical properties, however, were already clearly discernible.*

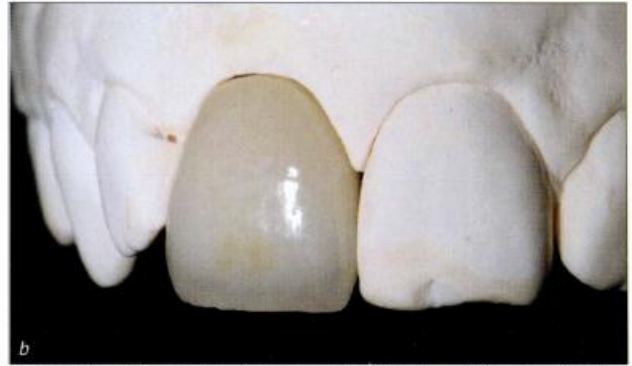
*Figs 41a, b* Precise addition of more translucent ceramic to compensate for the contraction after the first sintering and to integrate additional optical features from the contralateral natural tooth (a). After the second sintering process, some minor finishing with rotary instruments was performed before the subsequent clinical try-in (b).

Minute layers of more translucent ceramic material were added where necessary to compensate for the contraction that had occurred after the first sintering process (Fig 41a). After this second sintering process, followed by some final adjustments with rotary instruments, the implant-supported crown was ready for the clinical try-in (Fig 41b).

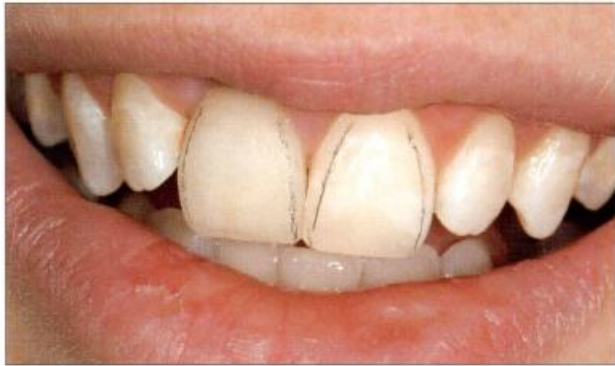
*Fig 42* The first clinical try-in of the all-ceramic implant-supported crown 11 revealed an acceptable integration into its natural surroundings and confirmed that the basic features of tooth and tooth volume and the localization of the mesial and distal transition line angles had closely duplicated those of contralateral natural tooth.

A clinical try-in of the ceramic implant-supported crown in its “biscuit stage” was needed to identify, by comparing the natural tooth and the ceramic crown, the optical and esthetic key parameters, such as interproximal ridges, mesial and distal transition line angles, and surface characteristics (Fig 42).

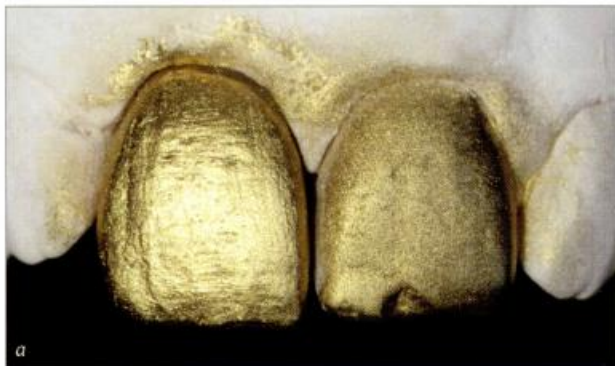
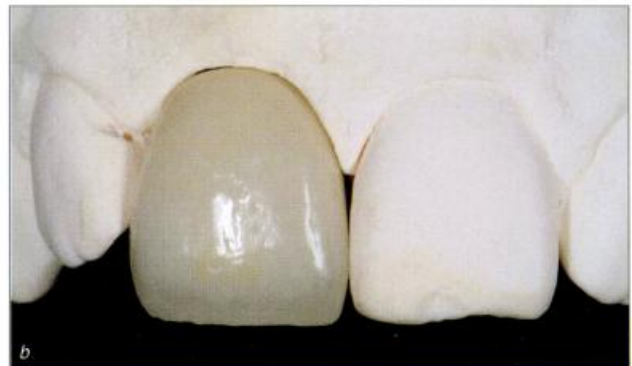
*Figs 43a, b* The labial surfaces of the implant-supported crown 11 and its contralateral natural tooth 21 were covered with a thin pellicle of gold spray to better highlight the basic features of tooth form and surface texture (a). This facilitated the last finishing steps, mainly carried out by rotary instruments (b).

In the dental laboratory, the final modifications, focusing primarily on the surface texture characteristics as seen in the contralateral natural tooth, were carried out (Figs 43a, b)

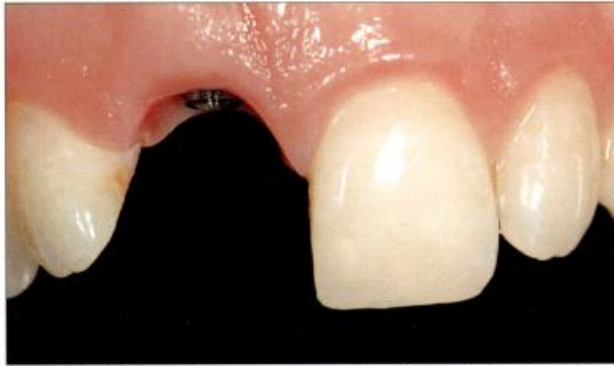
Fig 44 Labial view of the anterior maxilla after replacing the existing mesioincisal composite restoration.

At this stage, the existing composite restoration at the mesioincisal angle of tooth 21 was replaced (Fig 44). The final all-ceramic crown was inserted and its occlusal screw tightened to 15 Ncm (Fig 45), and the screw-access channel was closed with composite resin.

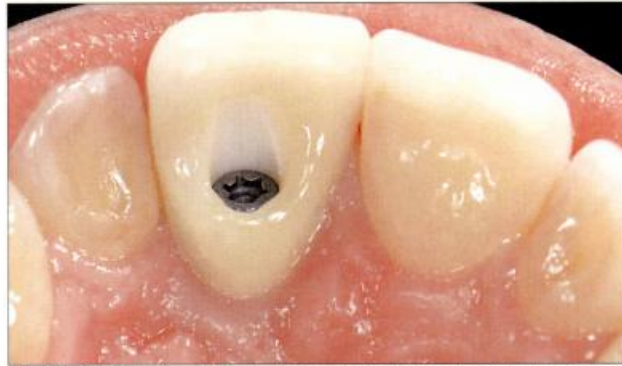
Fig 46 Palatal view of the newly inserted all ceramic implant-supported crown, showing that despite the considerable height and volume of this restoration type, a satisfactory contour was achieved compared to the adjacent dentition.

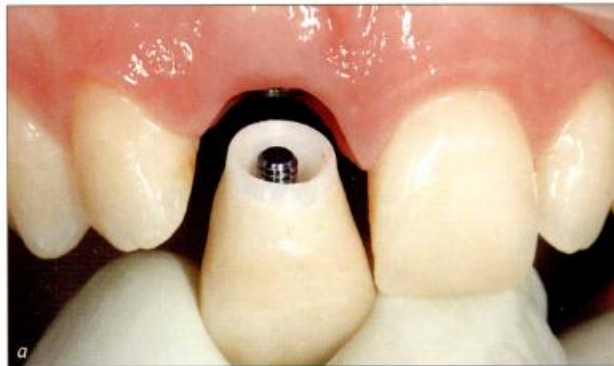
Figs 45a, b The all-ceramic implant-supported crown 11 was inserted (a) and its esthetic integration verified (b).

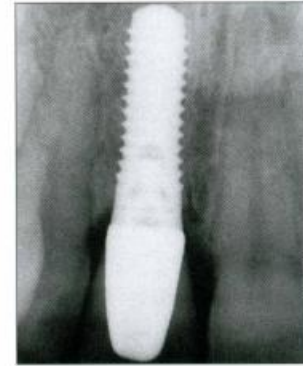
Fig 47 The final radiograph confirmed stable peri-implant bone conditions, excellent radio-opacity of the  $ZrO_2$  substructure, and a good marginal fit of the all-ceramic implant-supported crown.

The radiographic control confirmed stable bony peri-implant conditions, excellent radio-opacity of the zirconium-dioxide custom abutment, and adequate marginal adaptation of the all-ceramic implant-supported crown (Fig 47).

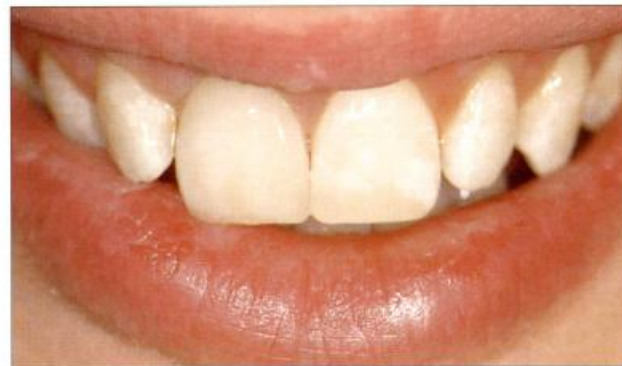
Fig 48 Clinical appearance of the anterior maxillary dentition (patient's unforced smile).

The patient's unforced smile at the end of treatment documented that the implant-supported crown blended in nicely with the surrounding natural dentition, matching quite satisfactorily the adjacent natural teeth in shape, texture, and color. Furthermore, the line of the marginal gingiva and the line of the incisal edges in relation to the border of the lower lip were harmonious (Fig 48).

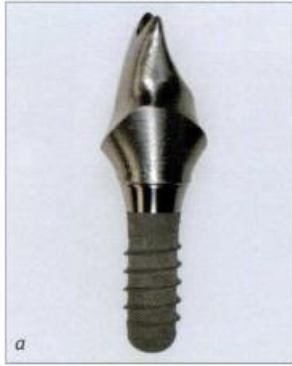
*Figs 49a, b For direct comparison, an additional CARES titanium custom abutment (a) was produced for this same implant, serving as a base for a cemented Auro-Galvano ceramo-metal crown (b).*

For demonstration and direct comparison purposes, a second crown was produced for implant 11 based on a CARES titanium custom abutment directly connected to the underlying implant (Figs 49–52).

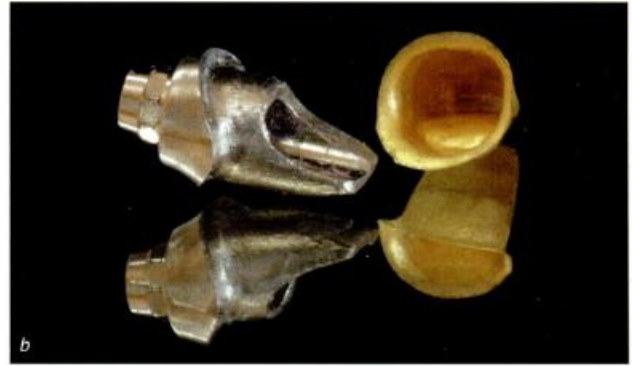
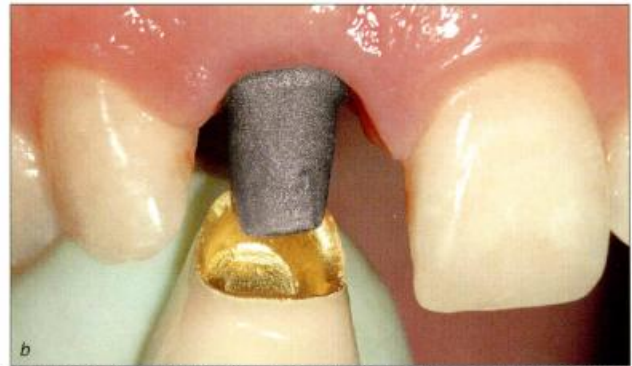
*Figs 50a, b The computer-generated titanium custom abutment, which had been previously sandblasted at the future abutment-to-crown interface, was connected directly to implant 11 and subsequently tightened to 35 Ncm (a). The cemented ceramo-metal crown was then tried in (b).*

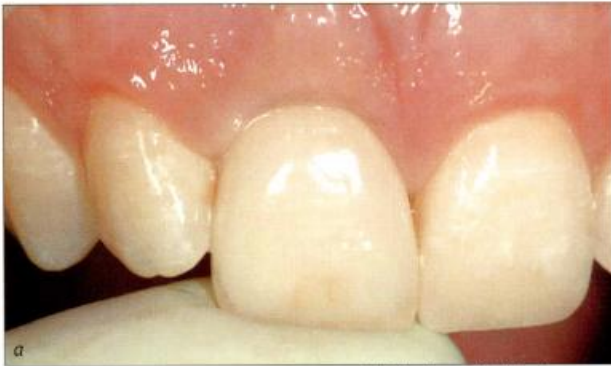
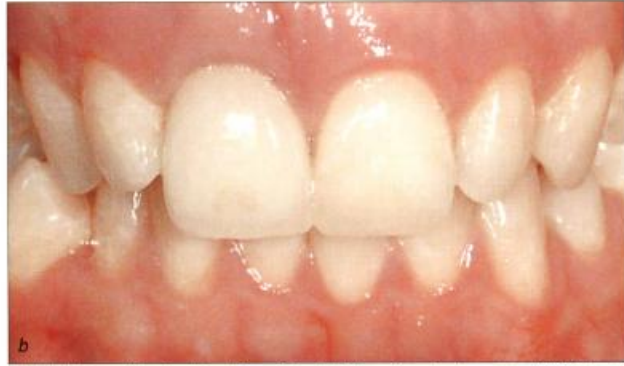
*Fig 51a,b The implant-supported crown was held in place with light finger pressure, which led to a discrete blanching of the labial peri-implant mucosa (a). Although still largely acceptable from an esthetic point of view, this second ceramo-metal crown — in contrast to the all-ceramic crown presented previously — showed a slight "grayish" shadow along the labial soft-tissue margin (b). This optical phenomenon was probably due to a decrease in light transmission caused by the metal framework.*

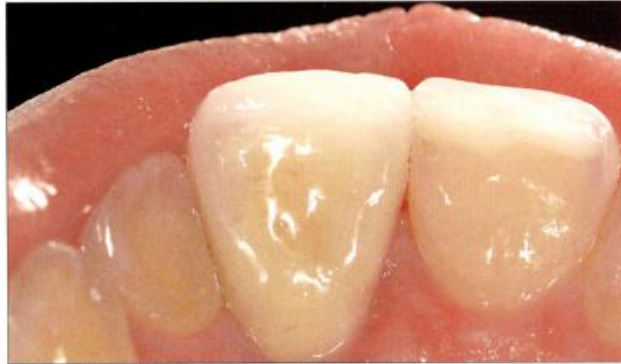
*Fig 52 The palatal view, however, demonstrated the more favorable cervical configuration of this type of implant-supported crown, which does not require a screw-access channel.*

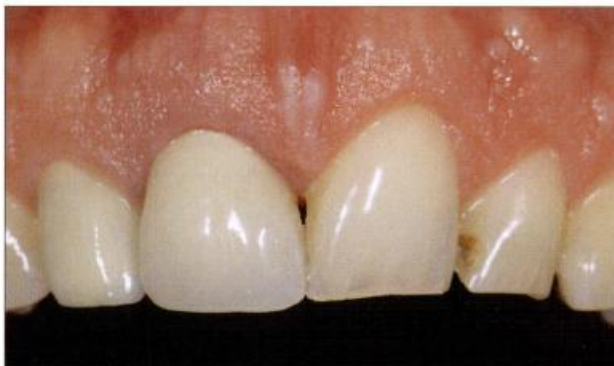
*Fig 2 Buccal view of the incisors revealing a thick-tissue biotype with soft-tissue excess to the buccal gingival margin of tooth 11.*

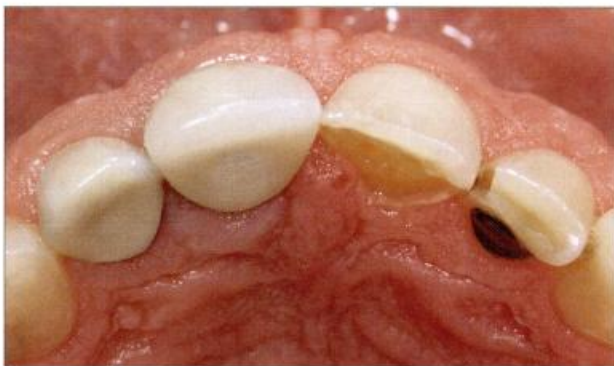
*Fig 3 Occlusal view of the incisors. Favorable buccal contour.*

The incisal view shows a harmoniously contoured arch without any horizontal deficiencies (Fig 3).

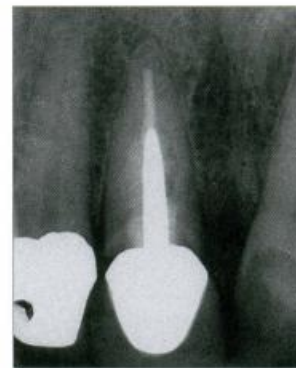
*Fig 5 Interproximal bone-crest levels of the adjacent teeth allowing the “5-mm rule” to be observed.*

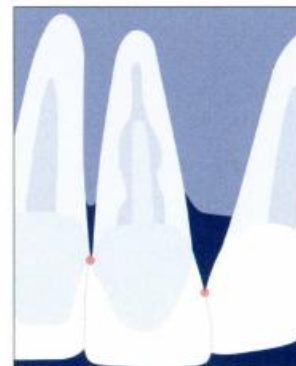
*Fig 6 Soft-tissue excess at the future implant site minimizing the risk of a compromised esthetic treatment outcome with regard to the height of the future peri-implant mucosa.*

After immediate implant placement, unpredictable remodeling processes at the hard-tissue and soft-tissue level had to be expected (Botticelli and coworkers, 2004). Favorable conditions as in this patient (Fig 6) will tolerate a certain amount of soft-tissue recession without compromising the esthetic treatment outcome.

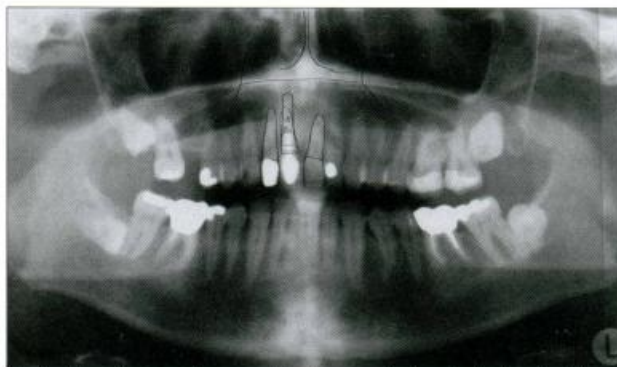
Fig 7 Visualization of preoperative treatment planning by drawing the adjacent roots, the anatomical structures, and the planned implant on a transparent foil on top of the OPT.

Based on the above analysis, it was decided to extract tooth 11 in a minimally invasive mode and to perform immediate implant placement (type 1) with transmucosal implant healing, using a Standard Plus implant with an endosseous diameter of 4.1 mm and a Regular Neck prosthetic platform of 4.8 mm in diameter and 12 mm in length. Figure 7 shows the pre-implantation treatment planning on the orthopantomograph (OPT).

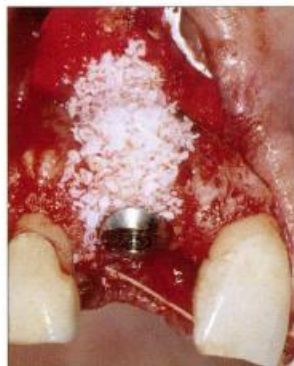
Fig 12 Buccal view after augmentation with a membrane-supporting material. The site was slightly over-contoured to ensure an adequate buccal root prominence after treatment.

The horizontal bone deficiency, including the apical fenestration defect, was covered with a deproteinized bone allograft (Fig 12), and the site was subsequently covered with a resorbable collagen membrane stabilized with two resorbable polylactide pins (Fig 13).

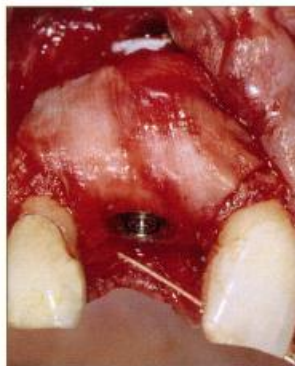
Fig 13 Buccal view after positioning and tacking the collagen membrane.

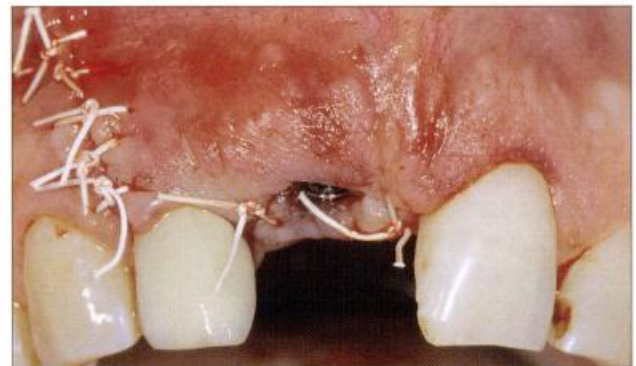
Fig 14 Buccal view after repositioning the flap to allow for a semi-submerged healing mode.

After a periosteal releasing incision, the flap was carefully mobilized, repositioned free of tension, and sutured with non-resorbable suture material, allowing the implant to heal in a semi-submerged mode (Fig 14). The use of a labially beveled healing cap allowed the placement of the buccal flap slightly further coronally to provide for soft-tissue excess at the prospective implant site.

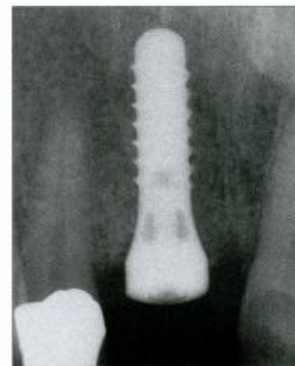
Fig 15 The radiograph after twelve weeks of healing showing successful implant integration.

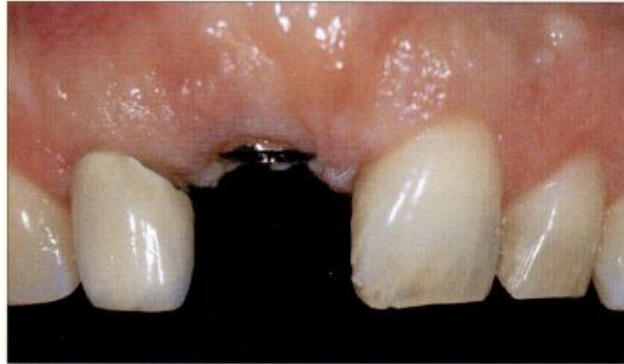
Fig 16 Buccal view of implant site 11 still showing some soft-tissue excess compared to the contralateral tooth.

Four weeks after implant placement, the clinical situation was inconspicuous (Figs 16, 17). Some soft-tissue excess was still present at the buccal aspect of the labially beveled healing cap (Figs 16, 17), which facilitated subsequent soft-tissue conditioning.

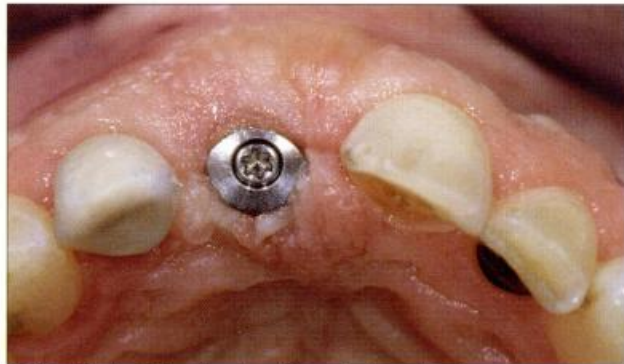
Fig 17 Occlusal view showing a favorable buccal contour.

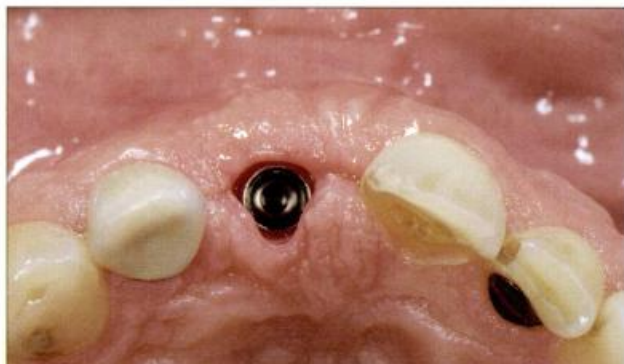
Fig 18 Status after removing the healing cap, showing a small cylindrical area of access to the implant.

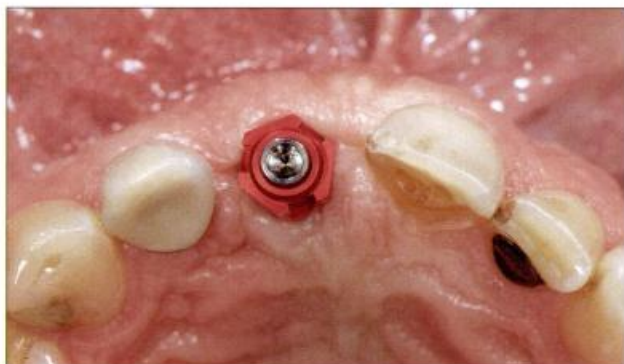
Fig 19 Occlusal view of the impression cap.

Figs 19 and 20 show the situation with the impression cap carefully screwed into place (hand-tight).

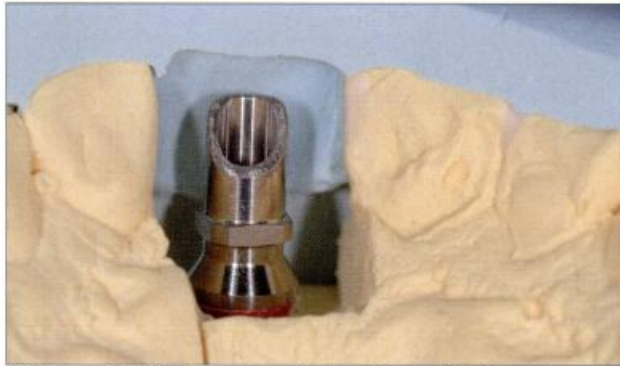
Fig 25 synOcta titanium post, customized for the clinical situation according to the diagnostic waxup.

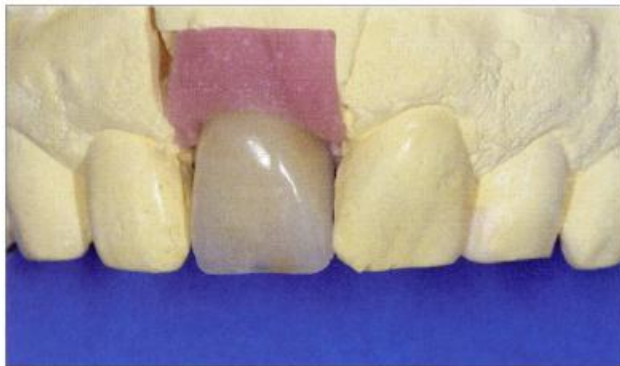
Fig 26 Buccal view of the final provisional crown.

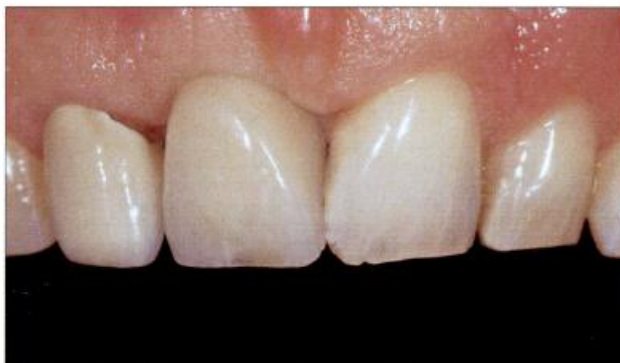
Fig 28 The provisional crown was inserted with slight pressure on the peri-implant mucosa.

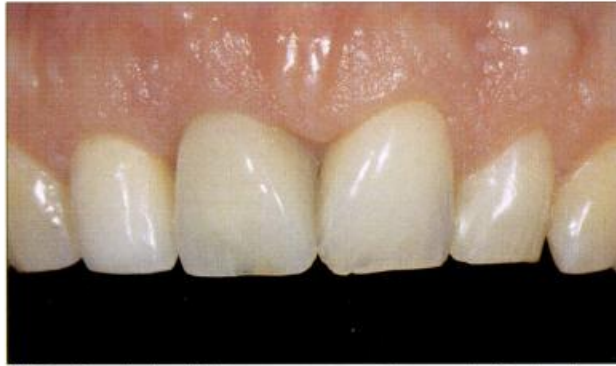
Fig 29 Buccal view of the temporary crown, three weeks after insertion.

Three weeks later, the mucosa was healthy and stable (Figs 29, 30). It had nicely adapted to the emergence profile of the implant-supported temporary crown. Meanwhile, the ceramo-metal crown on tooth 12 was replaced by an acrylic temporary crown. Note the improved papilla contours to the distal of tooth 11 as well as between teeth 11 and 21.

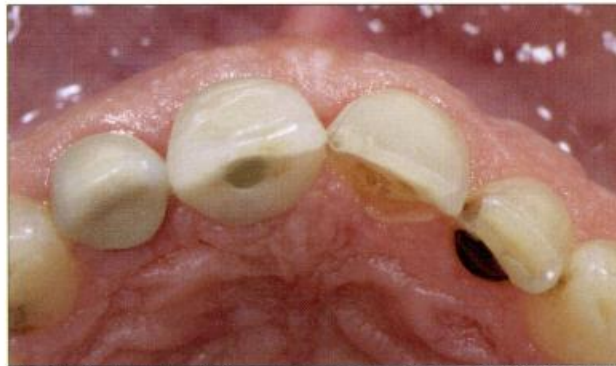
Fig 30 Occlusal view of the temporary crown, three weeks after insertion.

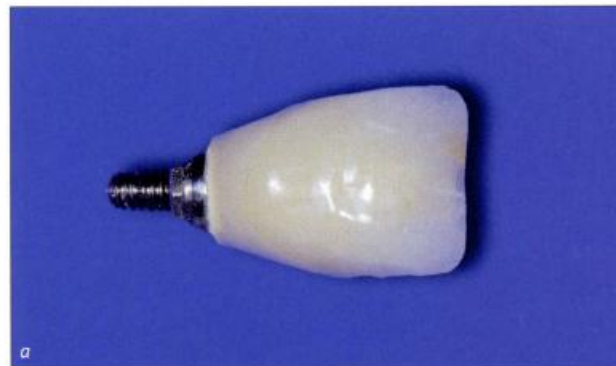
Figs 32a, b The temporary crown (a) screwed onto an implant analog (b).

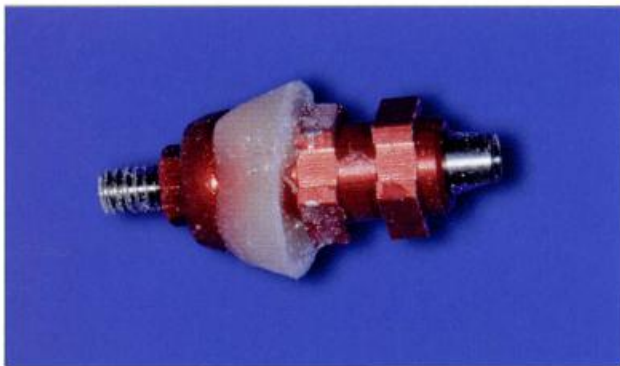
Fig 36 Individualized impression cap mimicking the final emergence profile.

This individualized impression cap not only prevented the conditioned peri-implant mucosa from collapsing when the temporary was removed, but it also provided ideal support for the mucosa during impression-taking (Fig 37) and captured the ideal emergence profile within the impression (Fig 38).

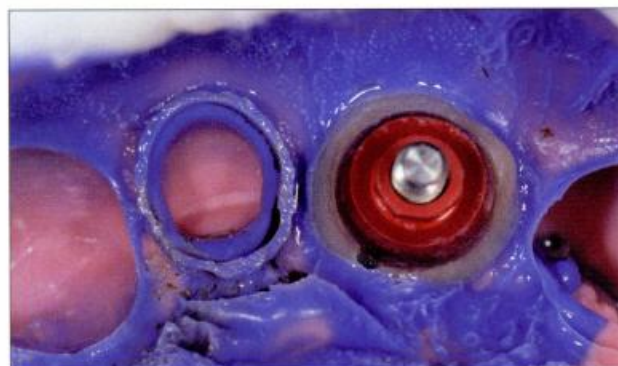
Fig 38 Final impression. Favorable situation at tooth 12 and implant site 11.

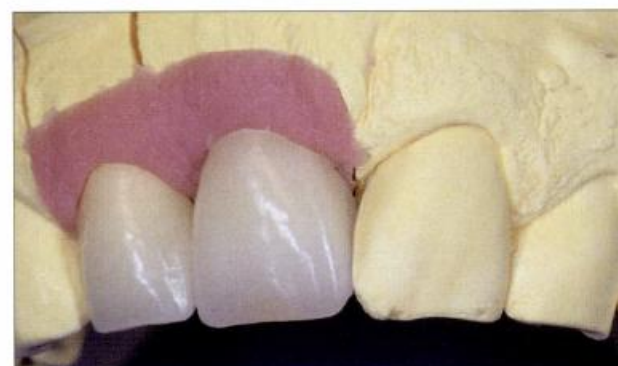
Fig 40 Diagnostic waxup crowns for teeth 12 and 11.

To determine the ideal shape and dimensions of the final crowns, a waxup was produced (Fig 40).

The diagnostic waxup helped select the right type of restoration and the right type of abutment.

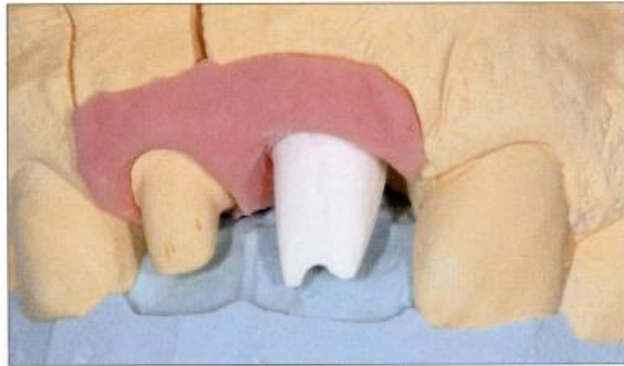
Fig 41 Silicone key representing the diagnostic waxup used to determine and control the shape and form of the individual abutment.

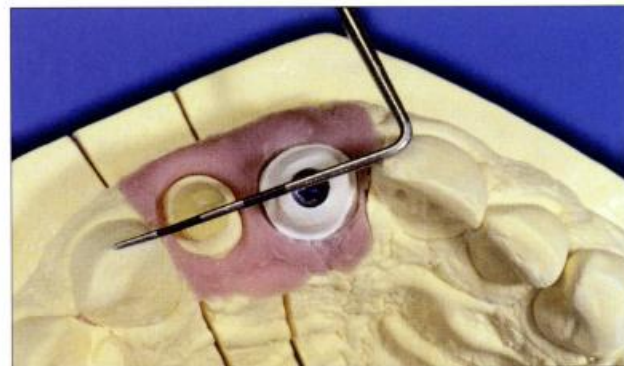
Fig 43 The incisal edge of the In-Ceram blank was located too far labially; this had to be corrected.

A check of the incisal edge positions revealed that the In-Ceram blank's incisal edge portion was located too far labially (Fig 43) and needed to be corrected (Fig 44). Note the special blue anodized occlusal screw used to tighten the In-Ceram blank on the synOcta abutment.

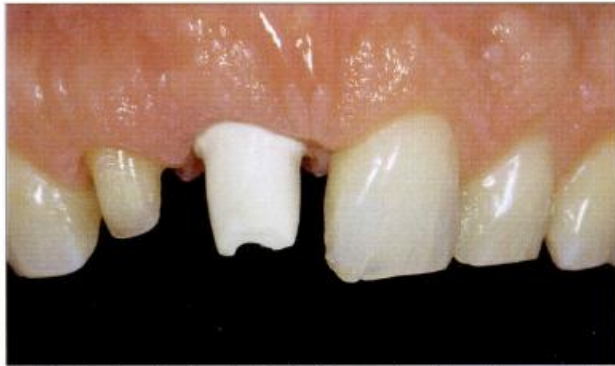
Fig 45 Abutment try-in, checking the form and position of the preparation margin. Adjustments can be performed directly in the mouth with a high-speed angled handpiece or by marking the correct position with a pen.

At try-in seven months after implantation and four months after installation of the first temporary abutment, the synOcta In-Ceram blank was carefully screw-tightened onto the synOcta abutment by hand. Again, special attention was paid to the evaluation of the position of the mucosal margin in relation to the preparation margin of the blank and its cervical, submucosal aspect (Fig 45). To ensure optimal cement removal, the cement line should be placed 1–2 mm submucosally.

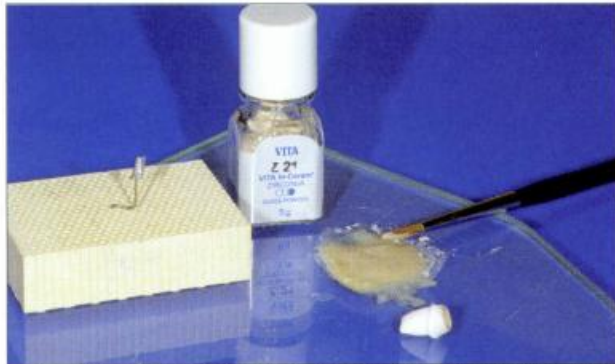
Fig 46 Glass powder mixed with distilled water for application to the blank.

In order to be able to adapt the shape of the blank based on the outcome of the try-in, the blank was tried in its porously sintered, non-infiltrated state and infiltrated after the chairside try-in session (Fig 46, 47).

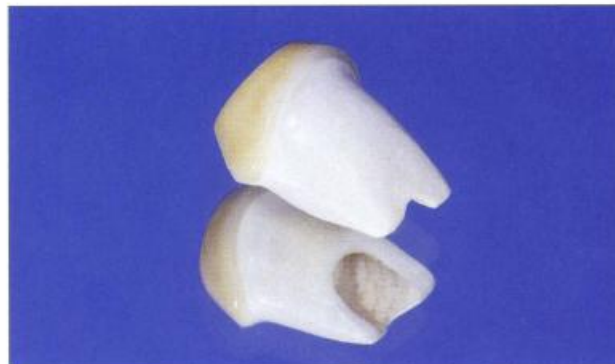
Fig 48 Final glass-infiltrated abutment with stained cervical aspect.

After the infiltration process that gave the porously sintered, chalky blank its final strength and stability, the cervical portion was stained according to the dentine color of neighboring tooth 12 (Fig 48).
