ITI Treatment Guide  
Volume 1

# Treatment Guide

Volume 1

Implant Therapy in the Esthetic Zone  
Single-Tooth Replacements

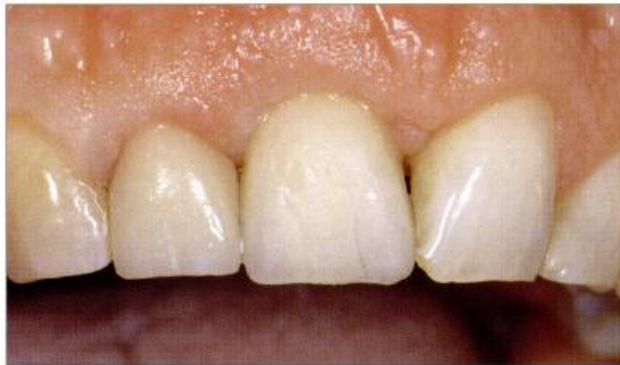
Fig 50 Try-in of the crowns after the second bake.

After the second bake, the crowns integrated harmoniously with the existing dentition (Fig 50). Note the natural color of the mucosa and the harmonious line of the marginal gingiva and mucosa.

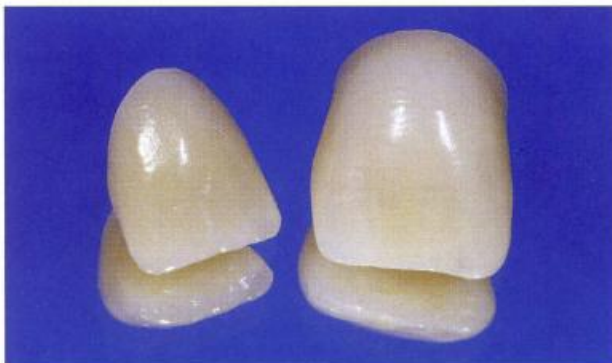
Fig 51 Final glass-ceramic crowns.

When the result of the try-in in the patient's mouth was found to be acceptable, the all-ceramic crowns were finalized in the dental lab (Figs 51, 52)

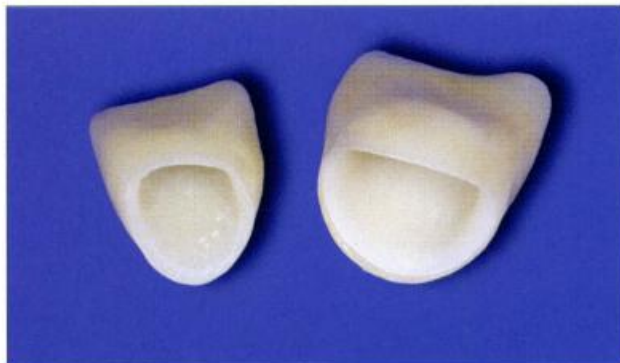
Fig 52 Final glass-ceramic crowns before cementation.

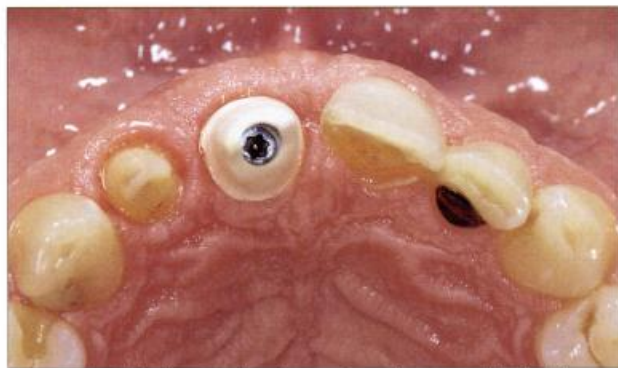
Fig 54 Final blank, placed on the synOcta abutment with the blue anodized occlusal screw tightened to 15 Ncm .

The In-Ceram blank was screwed in place on the synOcta abutment with the blue anodized occlusal screw tightened to 15 Ncm (Fig 54).

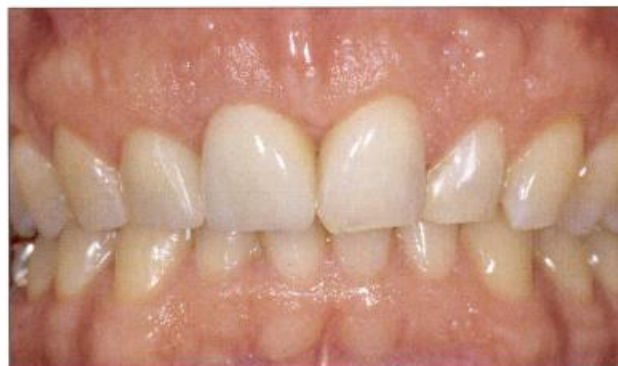
Fig 55 After adhesive cementation of the two crowns, harmonious integration into the natural dentition.

The final implant-supported superstructure integrated into the natural dentition harmoniously. The shape of the crown on tooth 12 as well as the shape of the implant-supported crown at site 11 perfectly matched the shape, texture, and size of the corresponding contralateral natural teeth. The lines of the marginal gingiva and mucosa were symmetrical. The gingival and mucosal colors were natural and matched that of the rest of the gingiva. The papillae filled the interdental spaces completely, without leaving “black triangles” (Figs 55, 56)

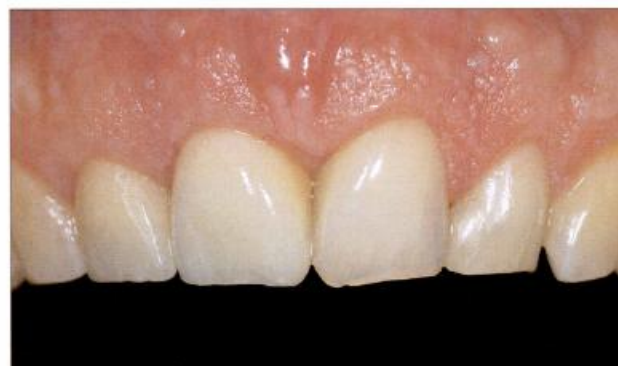
Fig 56 Final implant-supported all-ceramic crown 11 and tooth-supported all-ceramic crown 12.

The incisal edges were symmetrical to those of the contralateral natural teeth (Fig 56). At this point, the treatment could be considered an esthetic success.

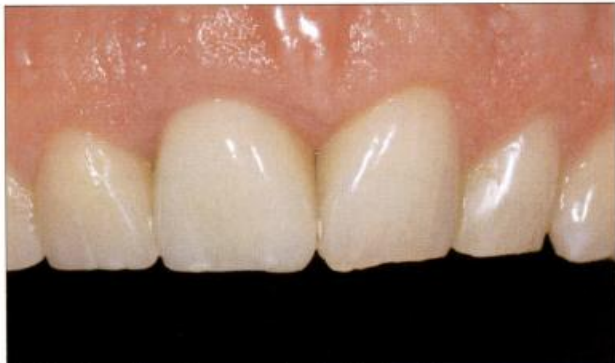
Fig 60 Buccal view three years after implant insertion.

The three-year follow-up photographs (Figs 60–61) demonstrate a stable esthetic treatment outcome.

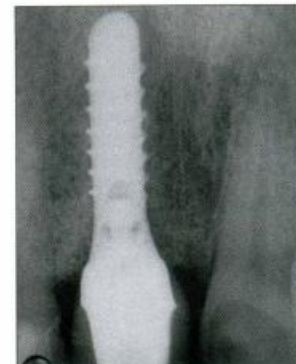
Fig 62 Periapical radiograph three years after implant insertion.

The three-year follow-up periapical radiograph demonstrated stable bone levels around the implant (Fig 62).

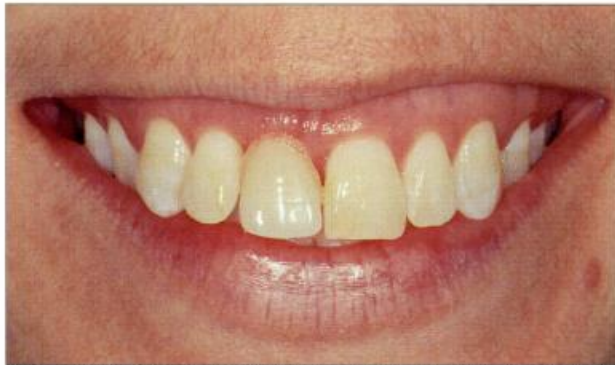
Fig 2 With the interim prosthesis in place, it was evident that teeth 13 and 12 were malpositioned.

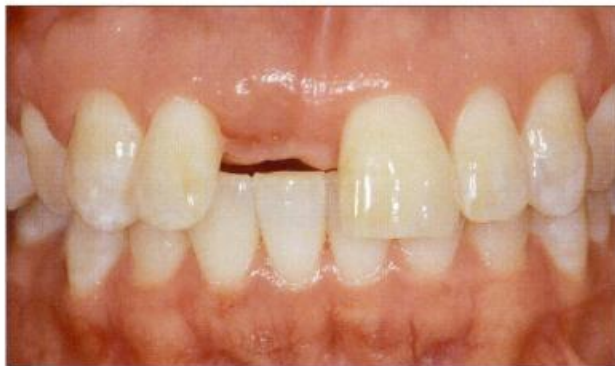
Fig 3 Retracted view showing the excessive overbite and malpositioning of teeth 13 and 12.

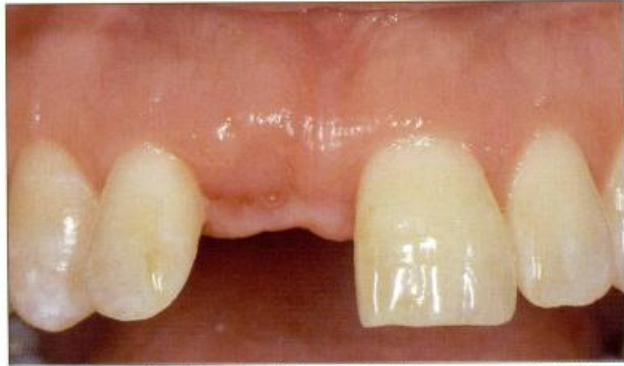
Fig 4 Frontal view of moderately tapered teeth, harmonious gingival margins, and papillary deficiencies on the mesiofacial aspect of teeth 12 and 21.

The gingival biotype was thin with moderately scalloped papillae, thin tissue, broad keratinized tissue, and slightly tapered teeth (Fig 4). Pontic tooth 11 was ovate in shape, indicating adequate facial tissue height in the edentulous space. A soft-tissue examination revealed a deficiency in papillary support on the mesiofacial aspect of teeth 12 and 21. Probing depths at teeth 12 and 21 were 2 mm palatally, 2 mm interproximally, and 1 mm facially. It was also apparent that an adequate horizontal tissue thickness existed, allowing for good "root-form" emergence of the proposed implant restoration (Fig 5).

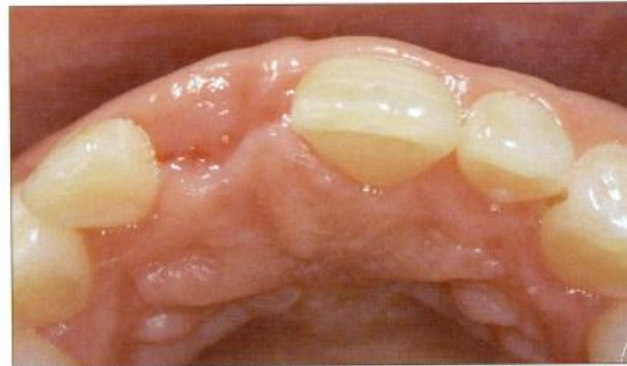
Fig 5 Occlusal view highlighting good horizontal ridge support in the edentulous space.

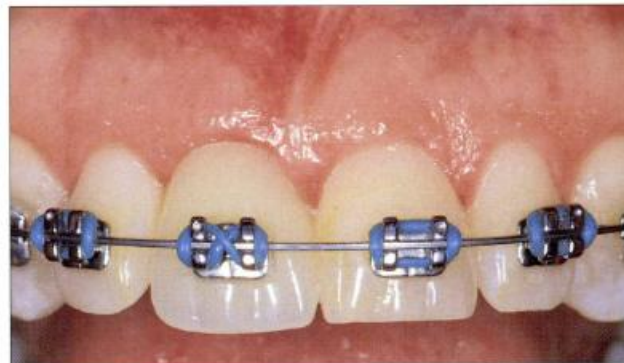
Fig 8 Denture tooth replacing tooth 11 attached to the orthodontic archwire throughout the orthodontic treatment.

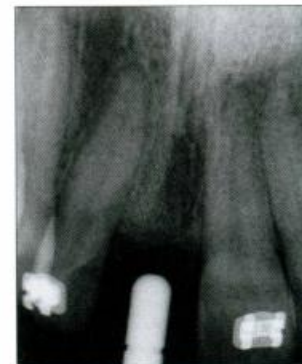
Fig 9 Periapical view with the radiographic template in place.

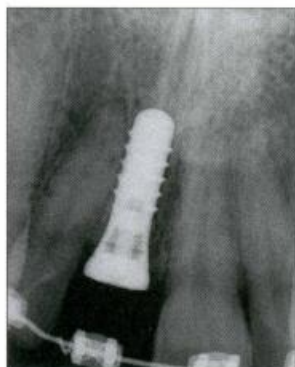
Fig 10 Periapical radiograph after implant placement.

A surgical template was fabricated based upon the results of the radiographic survey and utilized during the surgical procedure. At the surgical visit, a scalloping procedure was done to allow proper vertical placement of the RN SP implant. The vertical positioning template assured ideal coronapical positioning while template with the drill sleeve was utilized to prepare the osteotomy site. Once the implant had been placed, the vertical depth (shoulder 2 mm apically of the proposed mucosal margin) was confirmed once more before removing the implant mount. After placement of the labially beveled healing cap and suturing, a periapical radiograph was taken (Fig 10).

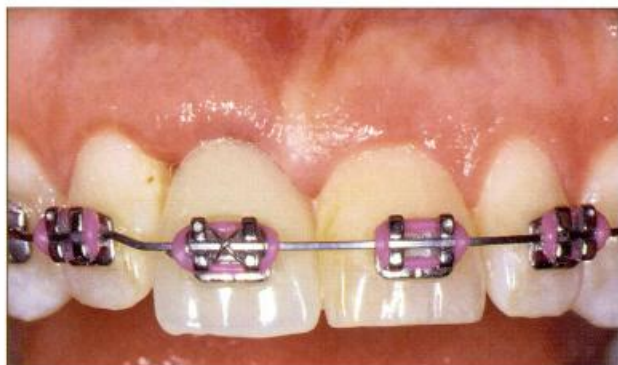
Fig 11 Six weeks after implant placement.

Six weeks after implant placement, the patient was scheduled for a loading visit (Fig 11). At this appointment, a provisional restoration was made that would initiate maturation of the transition zone. Upon removal of the orthodontic archwire, it became evident that the healing cap was semi-submerged (Figs 12a, b).

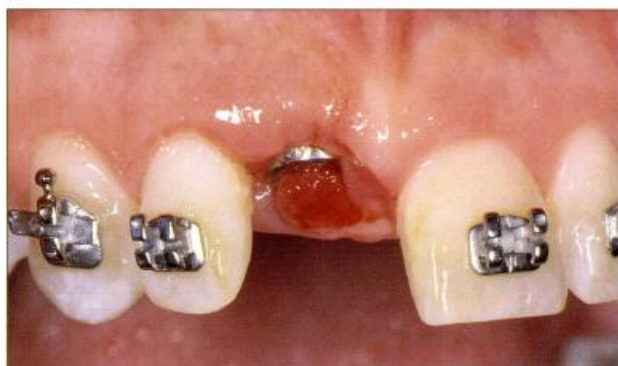
Fig 12a Upon removal of the archwire, the healing cap was slightly exposed, allowing for access to the implant shoulder with minimal tissue removal.

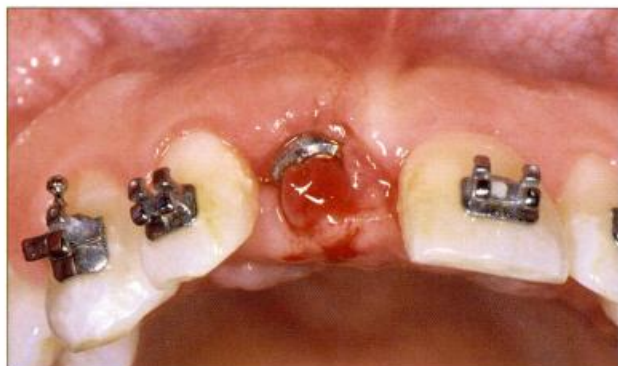
Fig 12b Occlusal view of the excess tissue that covered the palatal portion of the healing cap.

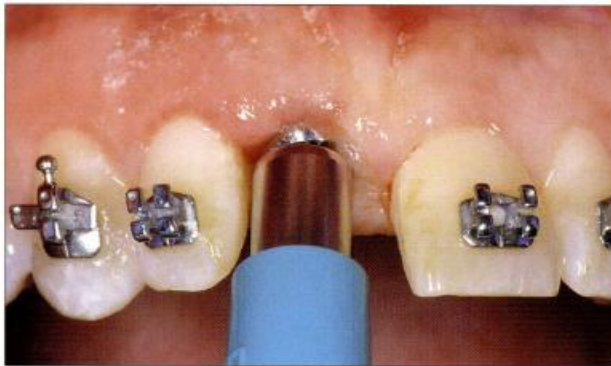
Fig 13a A 5-mm biopsy tissue punch was used to remove the tissue that covered the healing cap.

Excess tissue was located on the palatal surface of the healing cap. Upon examination, it appeared that there was no benefit in keeping the tissue, so a 5-mm biopsy punch was utilized to carefully remove that excess tissue (Figs 13a, b).

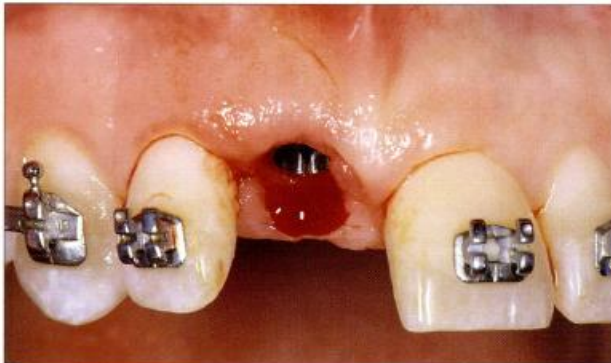
Fig 14a After removal of the healing cap, the implant was cleaned with an air-water syringe before placing the interim abutment.

Based upon its ease of use, a 5.5-mm solid abutment was used to fabricate the provisional restoration (Figs 14a, b). As reported in the ITI Consensus statements (Belsler and coworkers, 2004), when the shoulder of the implant is greater than 3 mm submucosally, a screw-retained machined margin connection is recommended to prevent entrapment of cement. While not in line with the ITI Consensus statements, a solid abutment was utilized due to the implant position (exiting through the incisal edge) and clinician preference. A preformed polycarbonate shell was relined with methylmethacrylate resin to fabricate the provisional restoration (Fig 15).

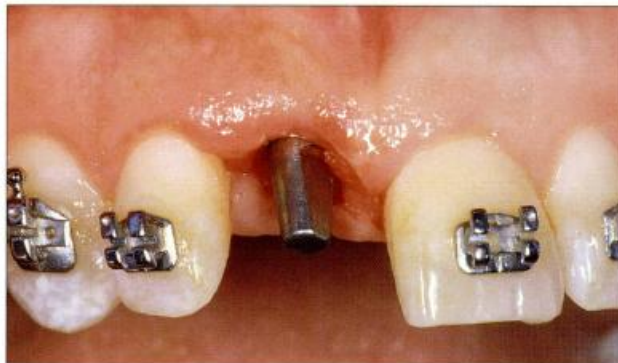
Fig 14b A 5.5-mm solid abutment was tightened to 15 Ncm to be utilized as an interim abutment.

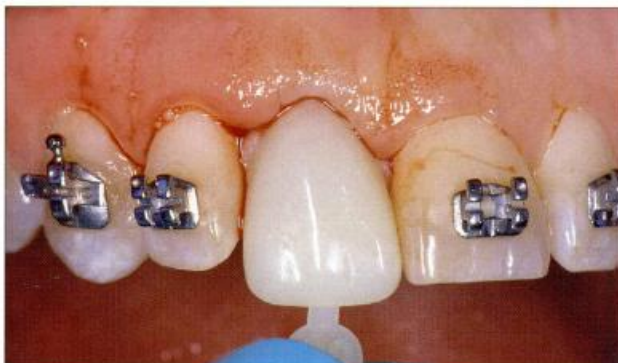
Fig 15 A polycarbonate shell was relined with methylmethacrylate resin over the solid abutment.

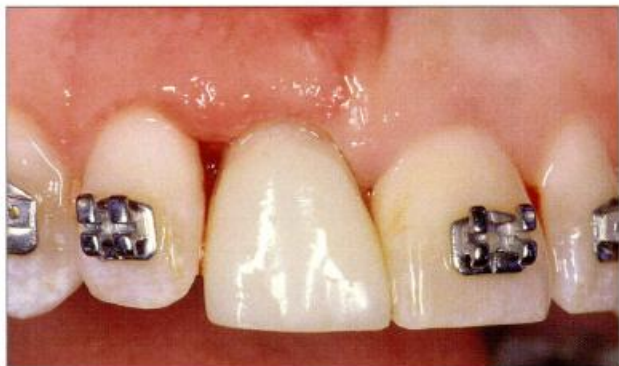
Fig 16 The emergence profile of the provisional restoration was slightly undercontoured in all dimensions to prevent movement of the tissue in an apical direction.

Once the provisional material had set intraorally, it was removed and placed onto a practice abutment and analog. Using some powder and monomer in dappen dishes and a brush, acrylic resin was added to the provisional to create an emergence profile from the implant shoulder into the oral cavity. Upon placement of the provisional in the mouth, tissue blanching subsided within 10 minutes. The provisional was cemented with temporary cement, and the occlusion was adjusted (Fig 16).

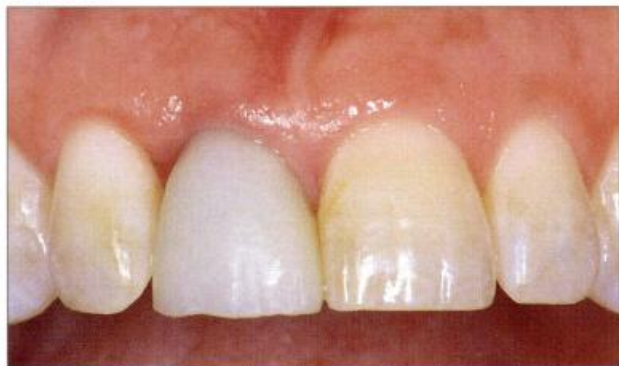
Fig 17 Two weeks post-loading with the provisional restoration.

At the return visit, a moderate amount of tissue inflammation remained around the facial mucosal margin (Fig 17).

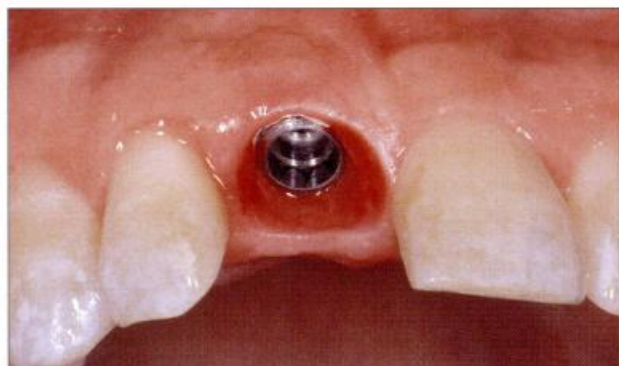
Fig 18 Occlusal view with trapped cement retained on the facial aspect of the implant shoulder.

Upon removal of the provisional and abutment, excess cement was located under the facial shoulder of the implant (Fig 18). It was decided at this visit to make a synOcta impression for the fabrication of an indirect provisional that would remove any possibility of cement entrapment by bringing the cement line closer to the tissue surface.

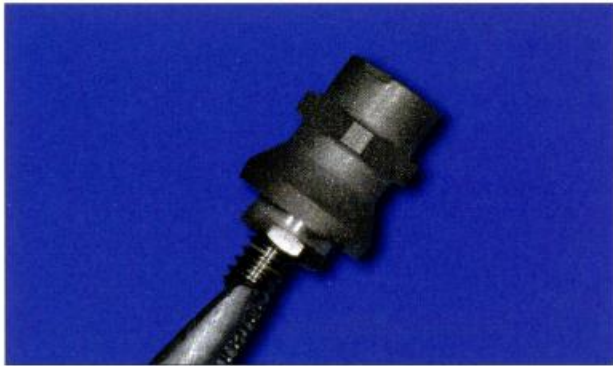
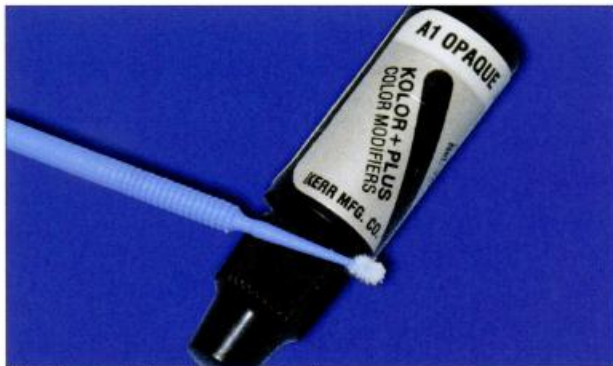
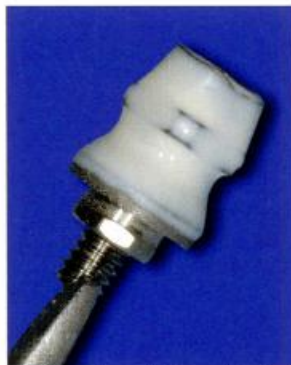
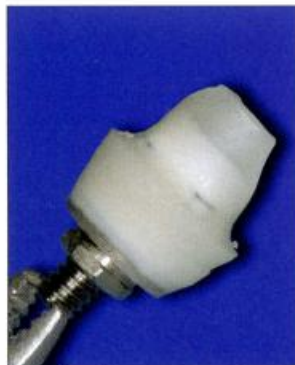
Fig 19a Modified synOcta post for temporary restorations.

Fig 19b Kerr Kolor Plus opaque (Kerr).

Fig 19c The synOcta post for temporary restorations after application of the opaque.

Fig 19d The synOcta post for temporary restorations built up with a composite resin.

In the laboratory, a synOcta post for temporary restorations was modified to create a custom temporary abutment (Figs 19a-d).

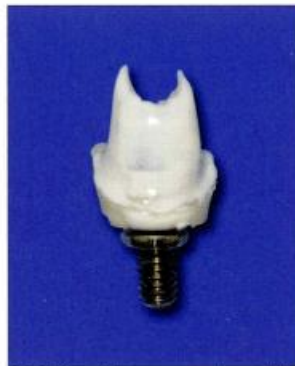
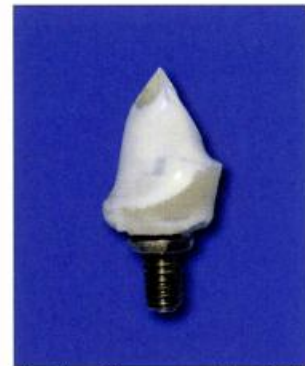
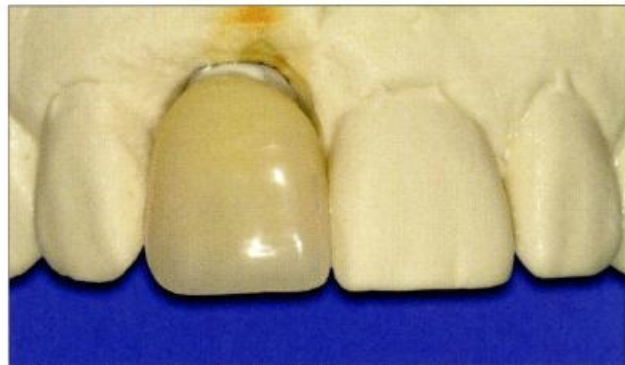
Fig 20b After preparation of the provisional abutment, facial view.

Fig 20c After preparation of the provisional abutment, lateral view.

Fig 20d The provisional restoration fabricated on the custom provisional abutment.

Once fabricated, the custom temporary abutment was placed on the cast and prepared to create restorative margins slightly below the proposed mucosal margin. Upon completion of the preparation, a cementable provisional restoration was fabricated utilizing an acrylic-resin laminate procedure (Figs 20a-d).

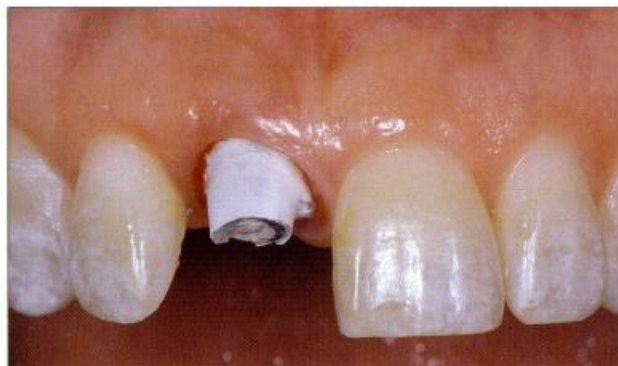
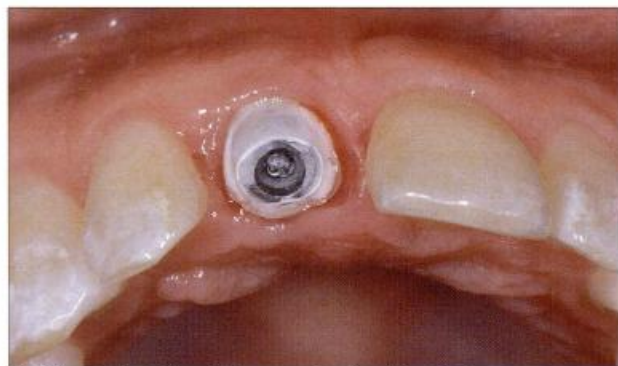
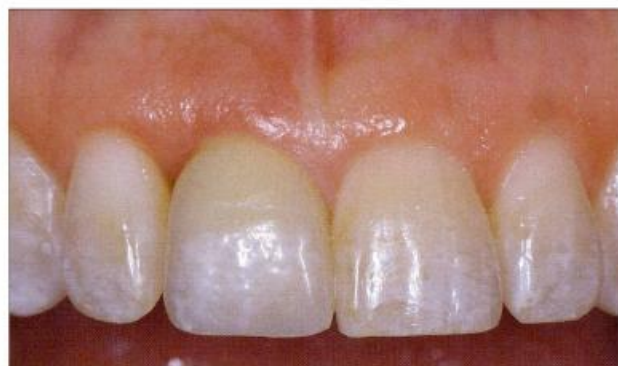
Fig 21a Facial view of the customized provisional abutment.

Fig 21b Occlusal view of the customized provisional abutment.

Fig 21c After cementation of the provisional restoration.

The patient returned to the clinic for insertion of the custom provisional abutment and provisional. After removal of the previous provisional and solid abutment, the custom provisional abutment was tightened to 15 Ncm, and the second provisional with improved emergence profiles was cemented with temporary cement (Figs 21a-c).

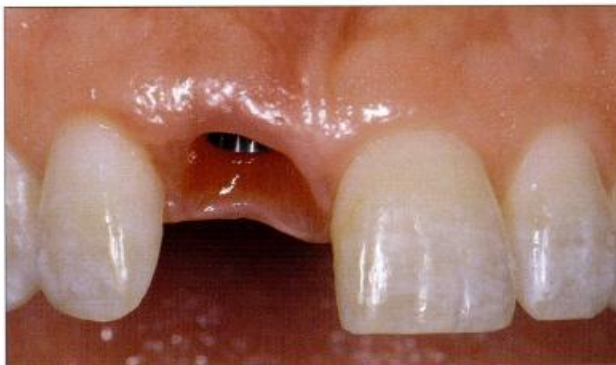
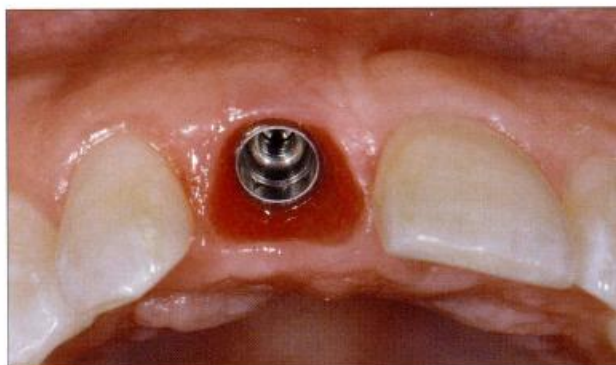
*Fig 23a Upon removal of the provisional abutment, the maturation of the transition zone was noticeable.*

*Fig 23b Occlusal view of tooth 11, highlighting the transition zone.*

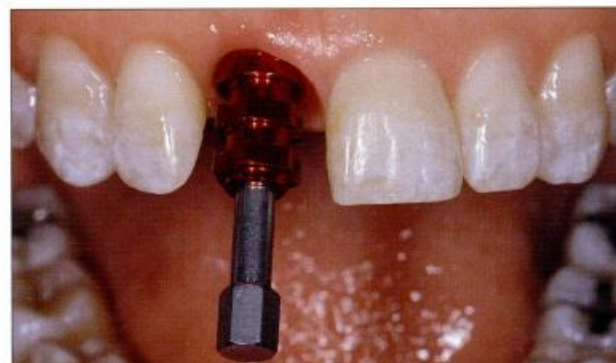
*Fig 25 Facial view of an unmodified synOcta impression cap. Note the lack of interproximal tissue support.*

With a synOcta impression cap in place, the lack of peri-implant tissue support was evident in the interproximal areas (Fig 25). Therefore, the fabrication of a custom impression cap would allow vital information of the transition zone to be transferred to the technician to enhance the final emergence of the definitive abutment and restoration. At chairside, the provisional abutment and crown were utilized to modify the impression cap (Figs 26a-f).

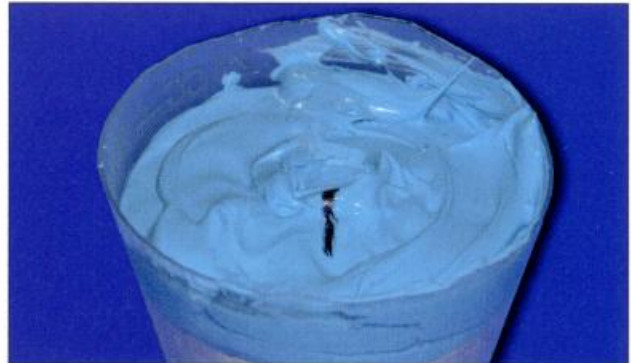
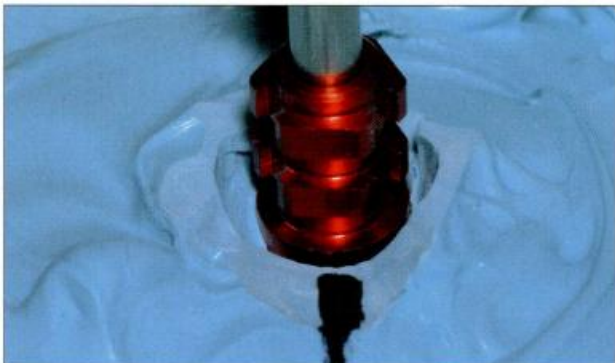
Fig 26d Custom impression cap fabrication. Once set, the provisional and the abutment were removed.

Fig 26e Custom impression cap fabrication. synOcta impression cap (with handle) on the analog.

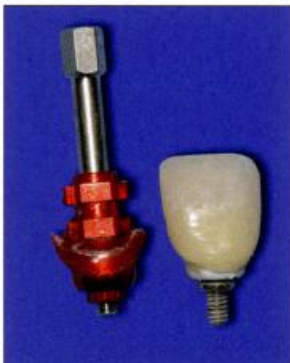
Fig 27 Custom impression cap fabrication. Emergence of the customized impression cap similar to the provisional restoration.

Upon completion of the modification to the impression cap, comparison with the provisional revealed similar emergence profiles of the implant shoulder (Fig 27).

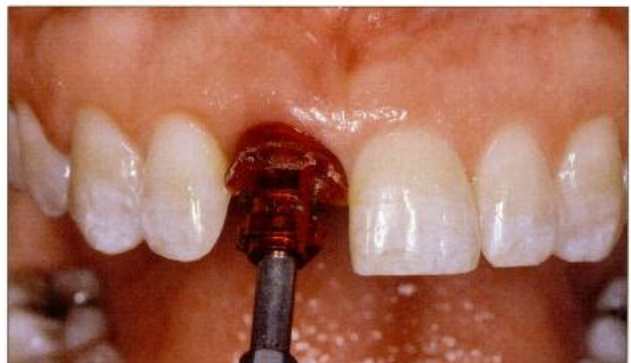
Fig 28 Facial view of a customized synOcta impression cap. Note the added support of interproximal tissue.

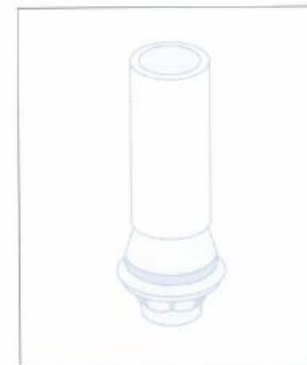
Fig 31  
The synOcta gold abutment.

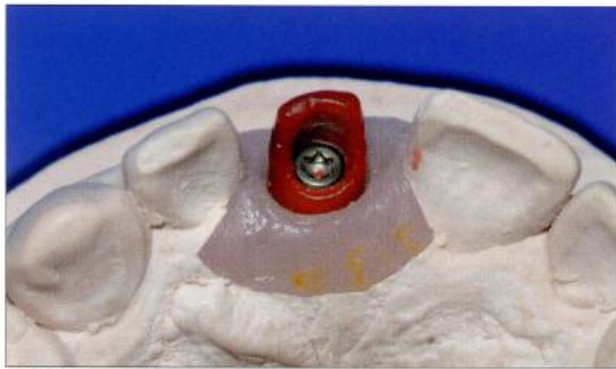
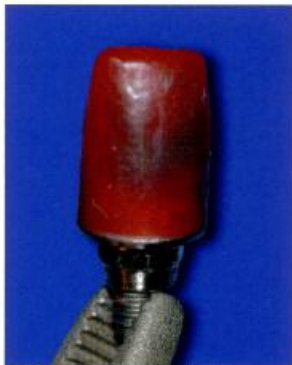
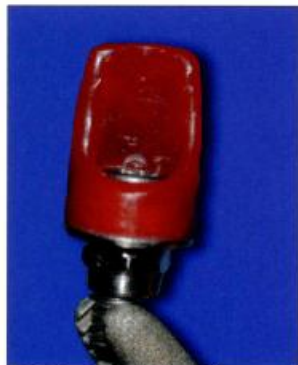
Fig 32b Occlusal view of the wax buildup on the synOcta gold abutment.

Fig 32c Facial view of the waxup.

Fig 32d Palatal view of the waxup.

Due to the thin soft tissues, a ceramic-modified surface was planned for the definitive custom abutment to prevent any submucosal reflection of metal. Once the abutment had been placed onto the master cast, it was modified to provide space for the ceramic material. Wax was then applied to the surface to cast an oxidizable alloy onto the abutment to allow for ceramic application (Figs 32a-d).

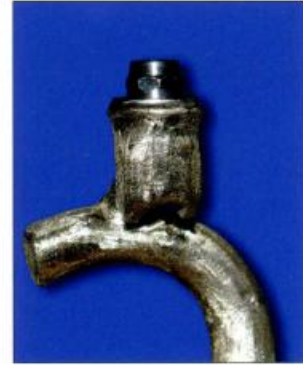
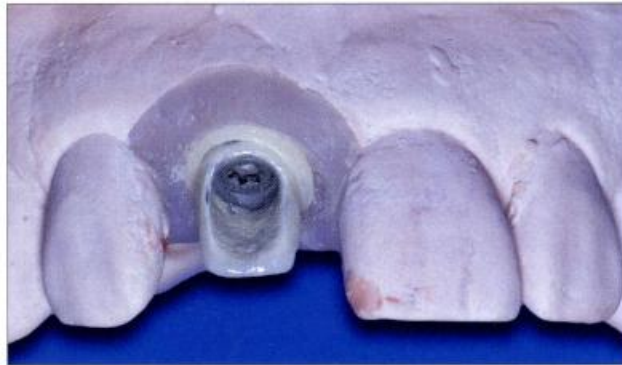
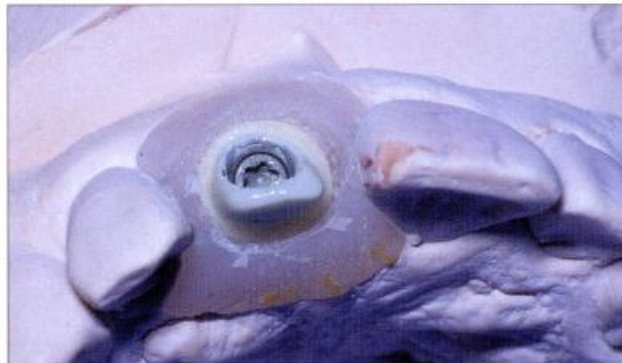
*Fig 33a Casting before removal of the sprue.*

*Fig 33b Frontal view of the synOcta gold abutment customized with ceramics.*

*Fig 33c Palatal view of the synOcta gold abutment customized with ceramics.*

After the abutment was cast, it was then opaqued, followed by a ceramic buildup designed to support the soft-tissue analog and maintain a submucosal margin position (Figs 33a-c).

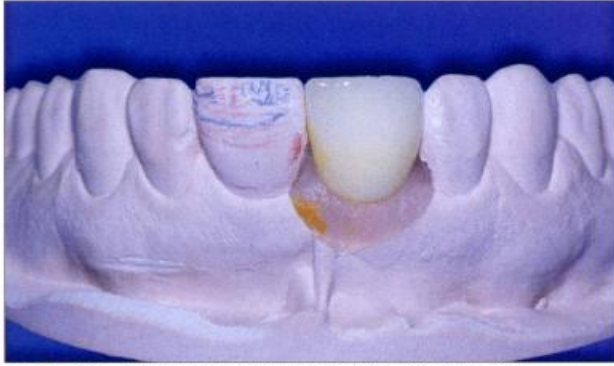
Fig 34 The In-Ceram restoration on the customized abutment.

Upon completion of the customized abutment, an all-ceramic In-Ceram crown was fabricated with a 360° ceramic butt-joint margin (Fig 34).

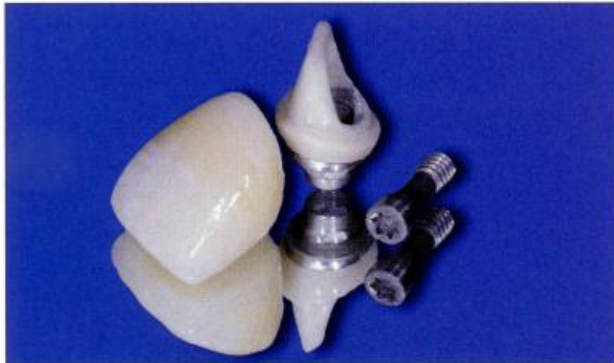
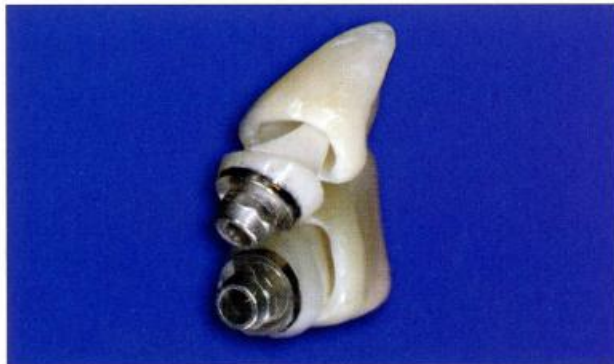
Fig 35a Final restoration and abutment returned from the laboratory.

Fig 35b Exploded view of the relationship between the crown and abutment.

The custom abutment and crown were returned to the clinic for delivery to the patient (Figs 35a-b).

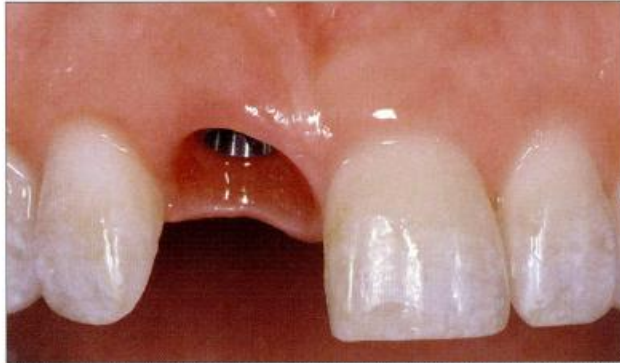
Fig 36 Facial view of 11 before placement of the final custom abutment.

At the delivery visit four weeks after impression-taking, the provisional restoration and abutment were removed (Fig 36). The implant was irrigated with the air-water syringe before placement of the customized abutment. Once the fit and shade of the final restoration had been confirmed, the abutment screw was tightened to 35 Ncm (Figs 37a-c).

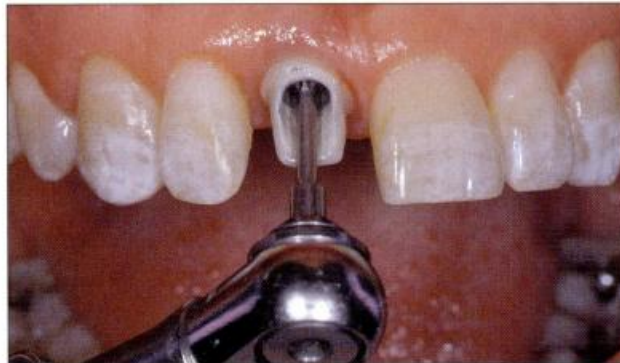
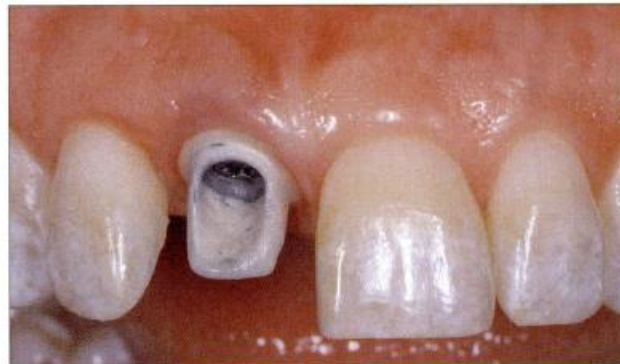
Fig 37a Tightening of the custom abutment to 35 Ncm using the ratchet with torque control device.

Fig 37b Facial view of the custom abutment in place. Note the submucosal margins, accessible for cement cleanup.

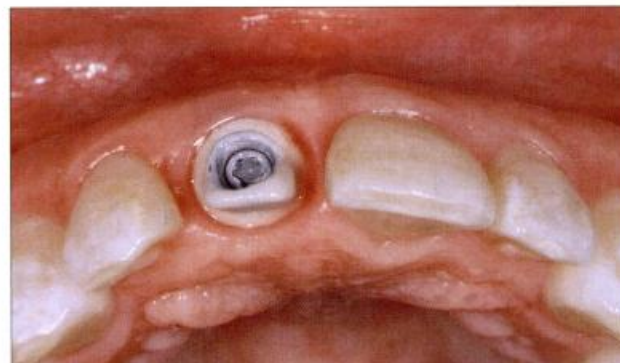
Fig 37c Occlusal view of the custom abutment in place. Note the 360° ceramic butt margin.

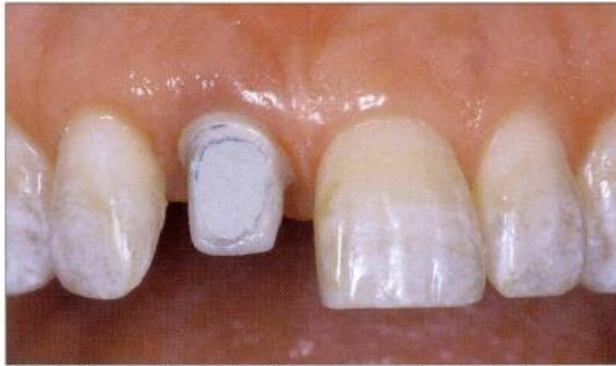
Fig 38 Cotton and Cavit placed to seal access to the abutment screw.

The screw access hole was covered with a cotton pellet and sealed with Cavit (3M Espe) (Fig 38). The final restoration was cemented with permanent cement. Excess cement was removed after setting (Fig 39).

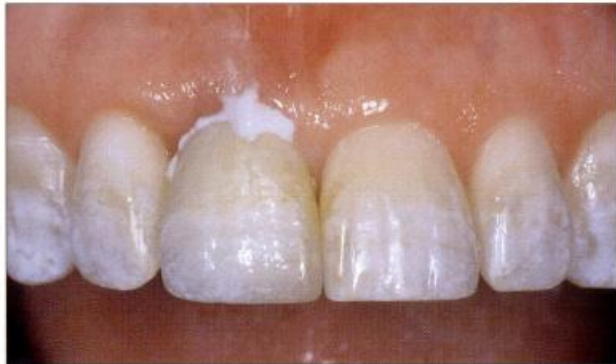
Fig 39 After cementation of the restoration, allowing for accessible cement cleanup.

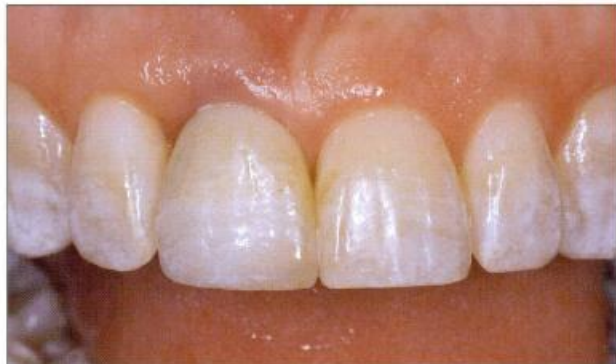
Fig 40a After delivery of the In-Ceram crown for tooth 11.

The occlusion was adjusted to a light shim-stock pull. Adjustments to the ceramic surface were followed by polishing with diamond-impregnated disks that help to create a glaze-like surface on the ceramic. A periapical radiograph was taken and the patient was scheduled for a 3-week follow-up (Figs 40a-b).

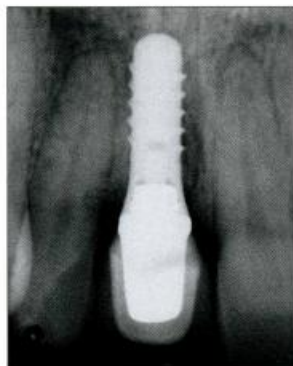
Fig 40b Periapical radiograph after delivery.

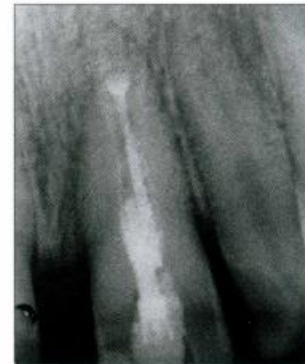
Fig 4 Periapical radiograph showing a mesial radiolucency and the status after apicoectomy.

Radiologically, a radiolucency mesially of tooth 21 could be detected. These findings are symptomatic of a root fracture of the endodontically treated tooth 21, status after apicoectomy (Fig 4).

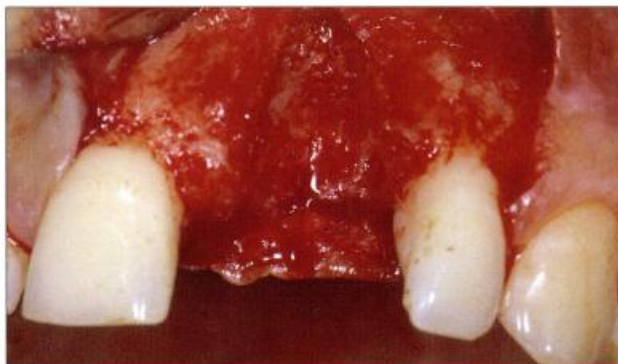
Fig 7 A large buccal dehiscence at reopening, eight weeks after extraction.

The site was reopened eight weeks after extraction. An osseous defect with the expected large buccal dehiscence was present (Fig 7).

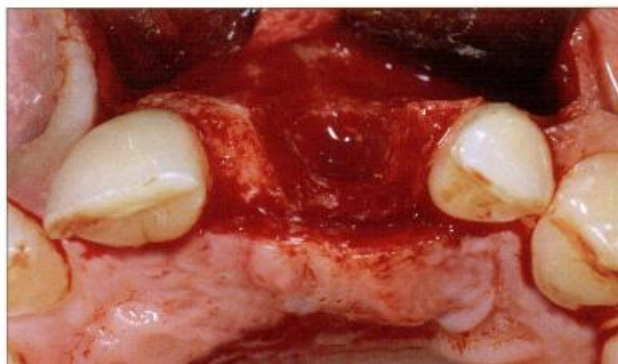
Fig 8 The bone defect at the future implant site had a large horizontal component.

The incisal view shows the full extent of the horizontal bone defect (Fig 8).

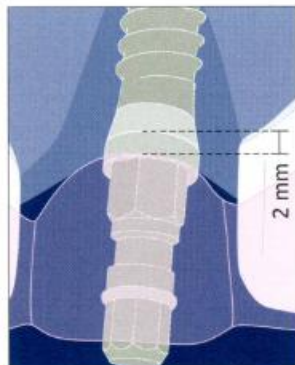
Fig 11 A surgical template helping to visualize the future soft-tissue margin, ideally located about 2 mm coronally of the implant shoulder.

In its ideal coronoapical position, the implant shoulder is located about 2 mm apically of the future soft-tissue margin at the implant-supported crown, imitated by the apical border of the template (Fig 11).

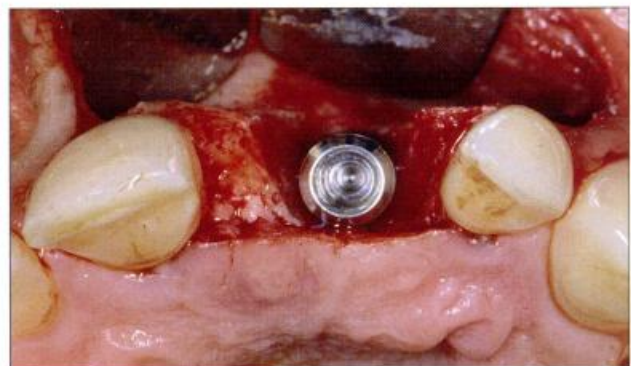
Fig 13 Ideal mesiodistal and orofacial implant positions.

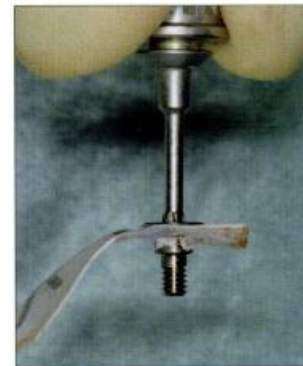
Fig 15 Perforating the membrane for insertion of the closure screw.

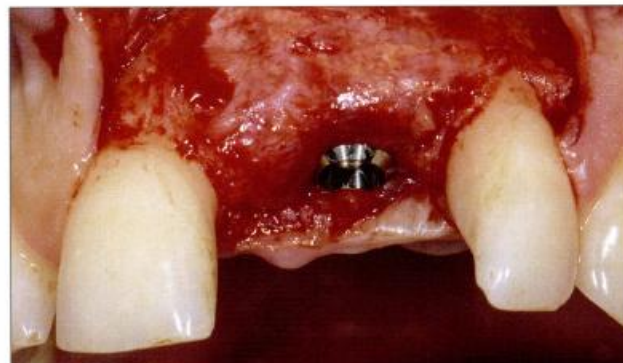
Fig 20b Favorable vertical bone height after membrane removal.

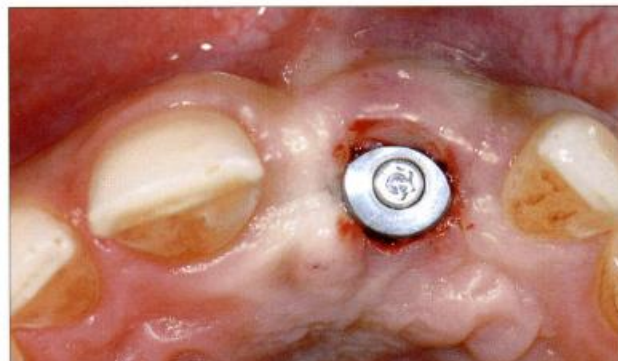
*Fig 28 Healing cap helping stabilize the flap.*

After this procedure, a labially beveled healing cap was inserted onto the implant to ensure access to the implant shoulder and to start the soft-tissue conditioning phase (Fig 28).

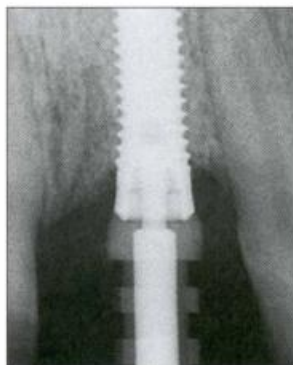
Fig 31 Precise seating of the impression cap on the implant shoulder ensures a precise impression.

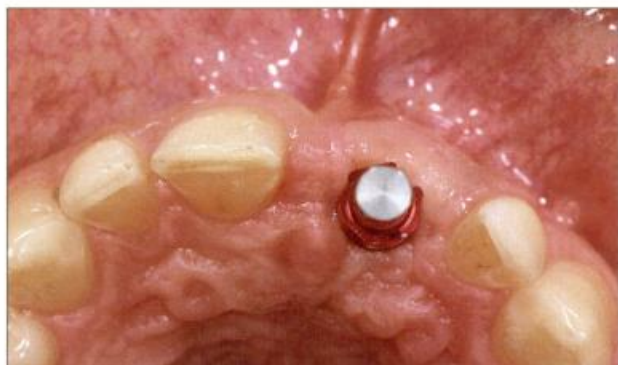
Fig 32 The occlusal view of the impression cap showed a favorable buccal implant position for the screw-retained superstructure.

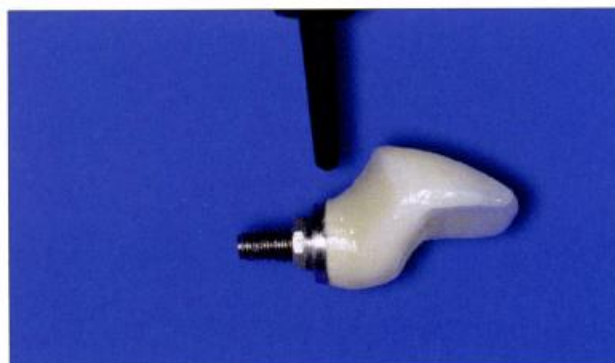
Fig 42 Stepwise adaptation of the cervical portion of the provisional.

To condition the peri-implant mucosa to the desired emergence profile and contour, the cervical portion of the provisional crown was modified accordingly, applying a flowable light-curing composite material in a chairside procedure (Fig 42).

The application of the composite material was driven by the point of emergence of the crown. The goal was to copy and match the line of the marginal gingiva at contralateral tooth 11.

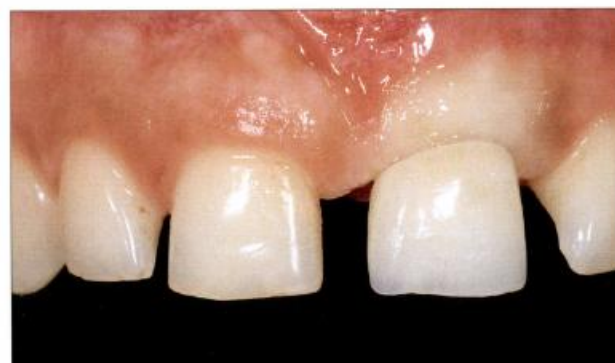
Fig 43 The provisional crown was inserted with slight pressure to the peri-implant mucosa.

At insertion of the provisional crown, notable blanching of the mucosa occurred (Fig 43).

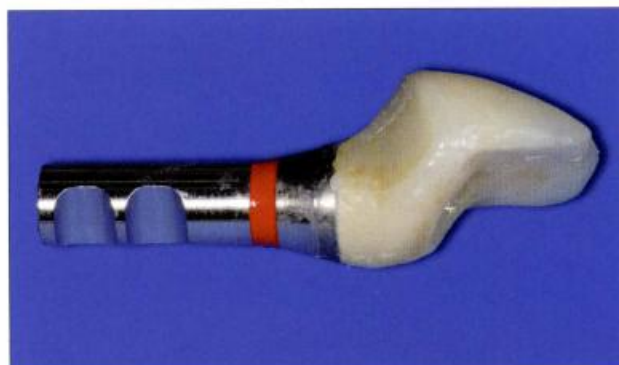
Fig 49 The shape of the provisional crown to be transferred to the impression cap.

To capture this final tissue shape, an individual impression cap was fabricated by placing the provisional on an implant analog (Fig 49) and pressing it into silicone.

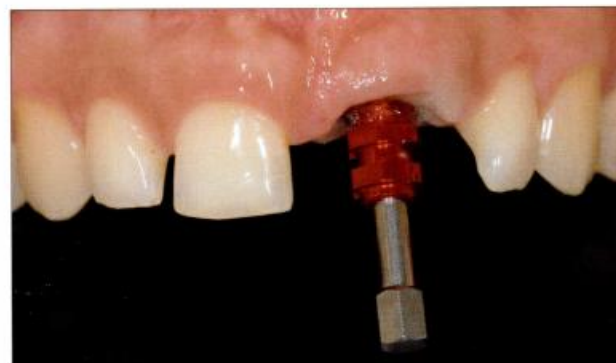
Fig 51 Well-supported labial aspect of the mucosa.

The individualized impression cap prevented the soft tissues from collapsing and ensured precise modeling of the emergence profile for the fabrication of the final crown (Fig 51).

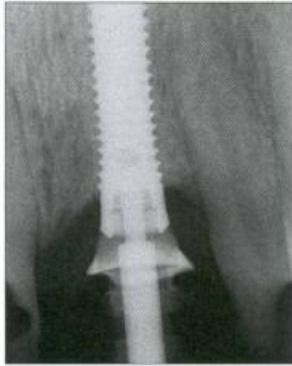
*Fig 52 Individualized impression cap seated on the implant shoulder without marginal gaps.*

The precise seating of the impression cap on the implant shoulder was radiologically checked one more time (Fig 52).

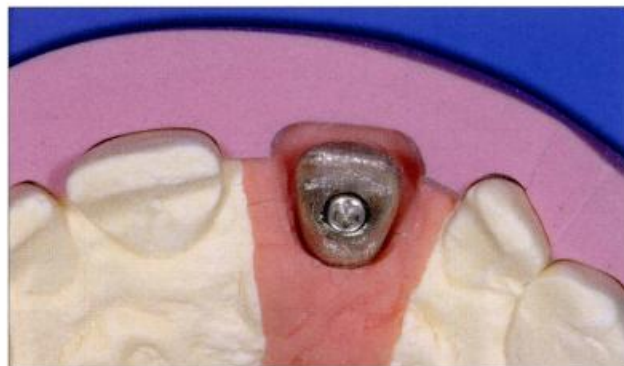
Fig 57b The cast-metal crown framework, incisal view.

Figure 57 shows the crown's cast-metal frame.

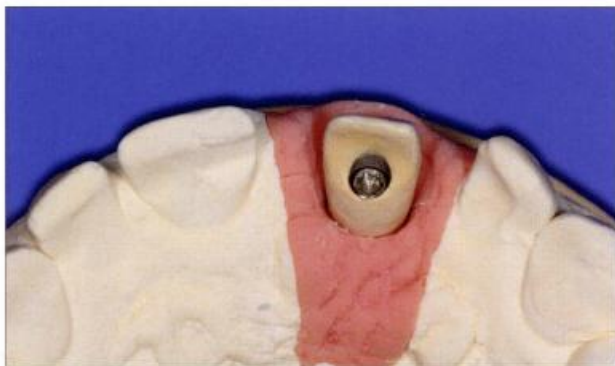
Fig 60 Opaque applied to the cast-metal framework.

Opaque was applied (Fig 60), and the veneering ceramic was built up using the layering technique.

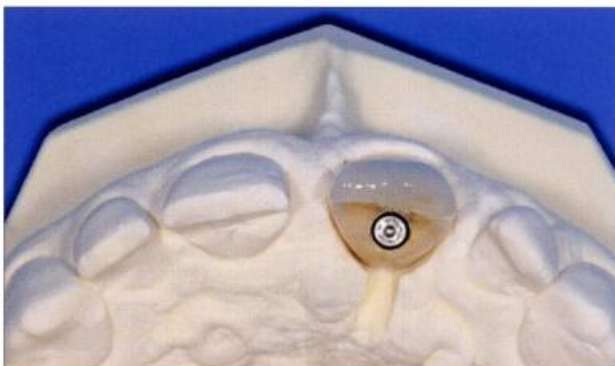
Fig 63 The final crown, incisal view.

Figures 62 and 63 show the crown as it was ready for insertion (Figs 62, 63).

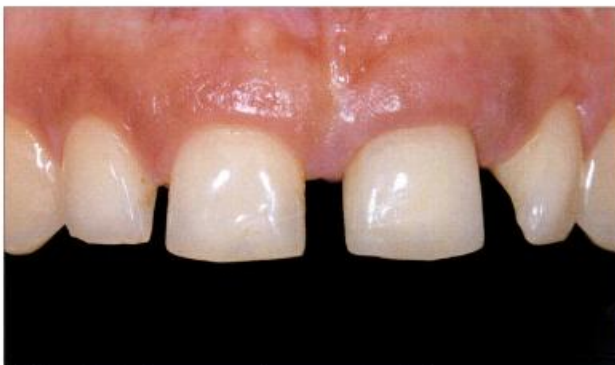
Fig 64 The implant-supported superstructure in situ.

The final crown integrated very well with the natural dentition with regard to tooth shape, size, color, and surface texture. The line of the incisal edges and the line of the gingival and mucosal margins were harmonious and contributed to the esthetically pleasing treatment outcome (Fig 64).

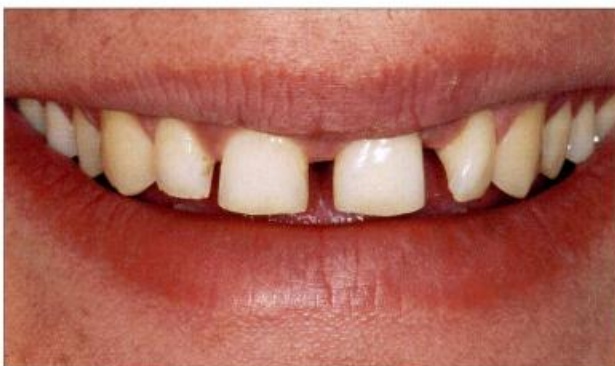
Fig 65 At full natural smile, the implant-supported crown cannot be distinguished from the natural teeth.

The treatment was in line with the patient's wishes and could be considered an esthetic success (Fig 65).

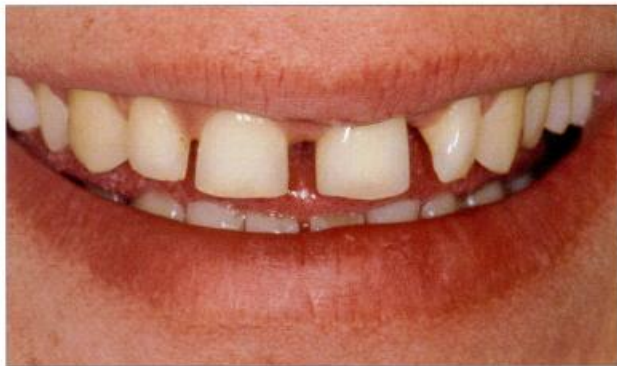
Fig 66 The patient's smile line three years after insertion.

At the patient's follow-up visit three years later, the esthetic treatment outcome was stable (Figs 66 – 68).

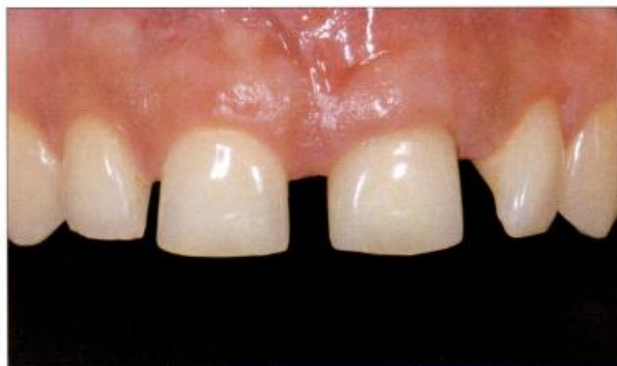
Fig 67 Healthy peri-implant soft tissue and a stable esthetic treatment outcome.

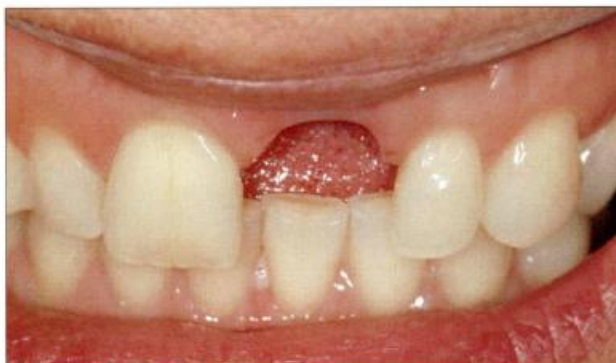
Fig 1 At full smile, the high lip line showed a significant portion of the gingival tissue.

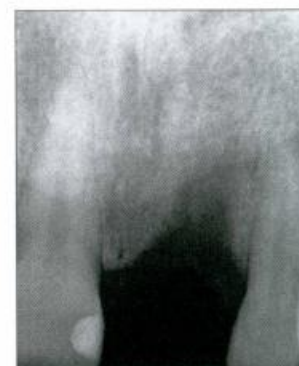
Fig 2 Initial intraoral radiograph showing both the typical situation after a recent tooth extraction (tooth 21) and the presence of intact interproximal bone tissue with sufficient height at the two adjacent roots.

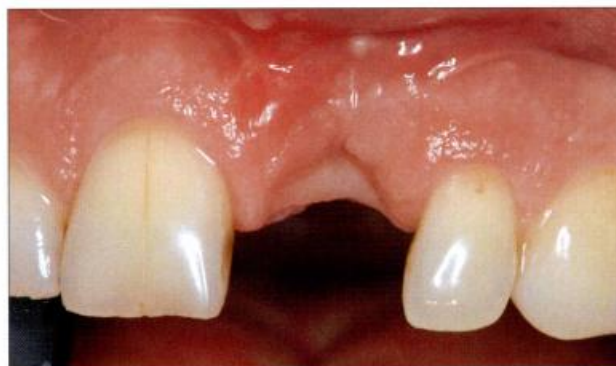
Fig 3 The labial close-up view of the anterior maxilla demonstrated a basically unaltered line of the vestibular soft tissue line with intact interproximal tissue of sufficient height at the two natural teeth adjacent to the extraction site.

Clinical examination of the anterior maxilla revealed the presence of a harmoniously scalloped soft-tissue line and the absence of significant vertical-tissue loss (Fig 3). Together with the relevant radiographic findings, this indicated that the initial clinical situation greatly favored implant therapy for single-tooth replacement.

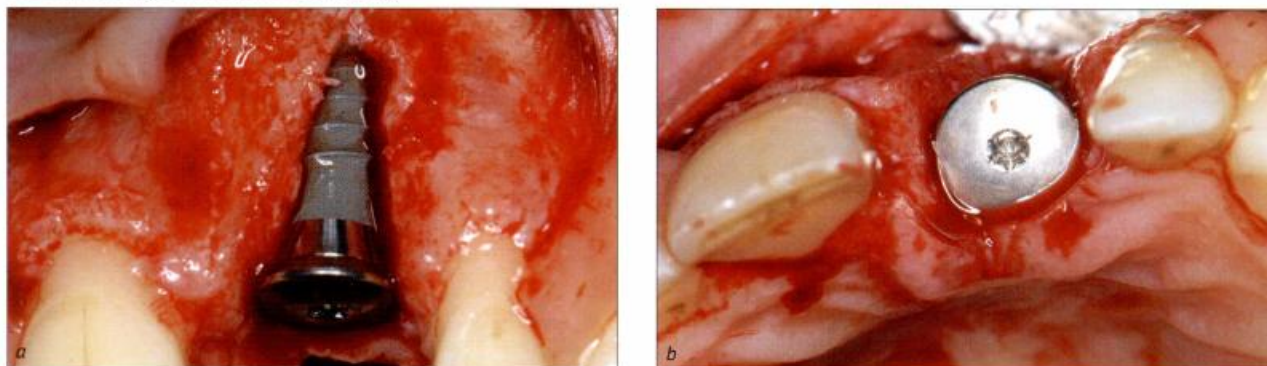
*Figs 5a, b The labial view, immediately after the placement of a standard screw-type implant (a), confirmed the resulting two-wall dehiscence-type defect. The occlusal view clearly documented that the implant had been placed completely inside the alveolar bone crest (b).*
