ITI Treatment Guide  
Volume 1

# Treatment Guide

Volume 1

Implant Therapy in the Esthetic Zone  
Single-Tooth Replacements

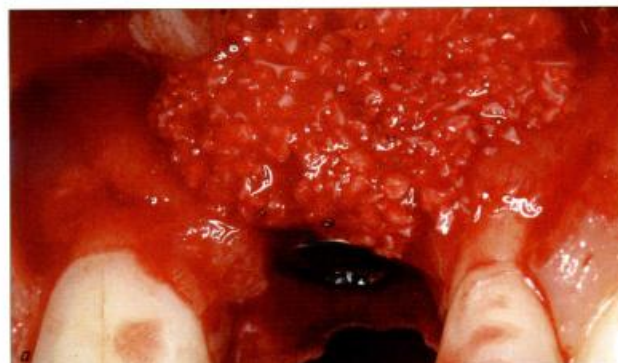
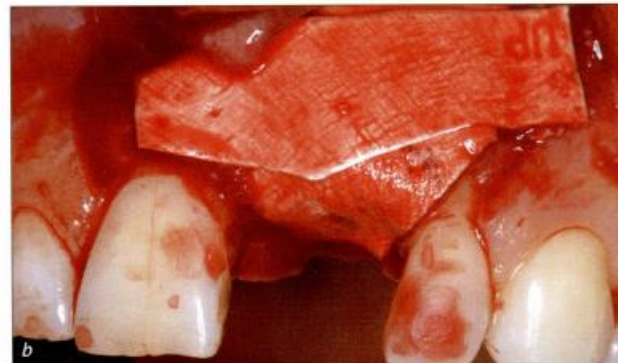
*Figs 7a, b* The second step of the simultaneous GBR procedure was the application of a considerable amount of bone fillers (a) in order to recreate in slight excess the originally convex labial contour of the alveolar ridge. To favor the selective in-growth of bone-forming cells, a bio-absorbable barrier membrane was applied in two layers (b), in what is termed "double layer technique."

The next step was to apply a layer of bone fillers soaked with blood (Fig 7a) to rebuild a slightly excessive convex labial contour of the alveolar bone crest. The bone fillers were covered with two layers of a bioabsorbable barrier membrane (Fig 7b) in order to permit the bone-forming cells to invade the wound selectively and ultimately to cover the bone-filler particles with newly formed bone.

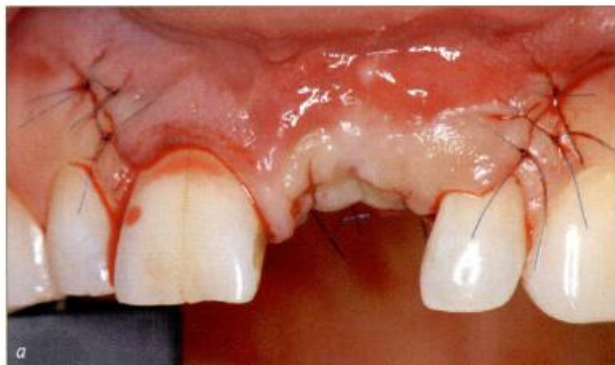
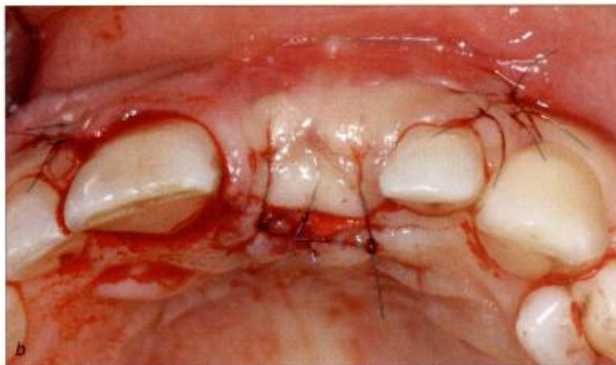
*Figs 8a, b* In order to allow for coronal repositioning and tension-free adaptation of the flap, several horizontal incisions of the periosteum had to be made. The occlusal view (b) confirmed the establishment of a labial convexity of the alveolar ridge at the site of implant placement, similar to that observed at the adjacent natural dentition.

The last step in this combined implant placement/bone augmentation procedure was the precise adaptation of the flap (Figs 8a, b). As a considerable ridge volume had been added in the form of autogenous bone grafts and bone fillers, several horizontal incisions of the periosteum at the base of the flap were required to achieve an accurate and tension-free repositioning of the flap, stabilized by interrupted sutures. The authors consider primary wound closure an integral part of the preferred protocol for the anterior maxilla, in the interest of predictability.

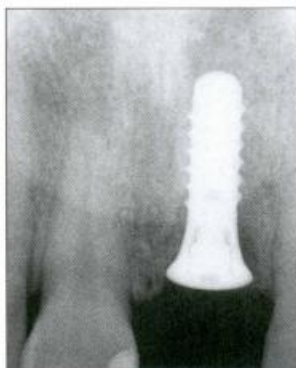
*Fig 9* The intraoral radiograph, taken immediately after the insertion of the 12 mm screw-type implant, confirmed an adequate implant position with respect to depth, axis in the frontal plane, and distance toward the adjacent natural roots.

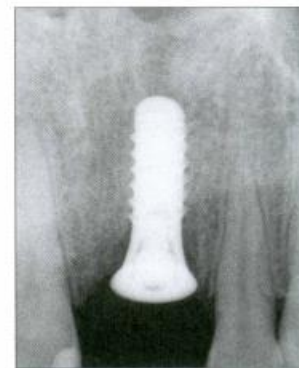
*Fig 10* The control radiograph, taken ten weeks after implant placement, showing the extent of initial interproximal peri-implant bone remodeling and the maintenance of the original vertical bone height at the two adjacent natural roots.

In accordance with the recommended early implant placement/early implant restoration concept, the successful osseointegration was verified ten weeks after implant placement, first radiographically (Fig 10) and then clinically.

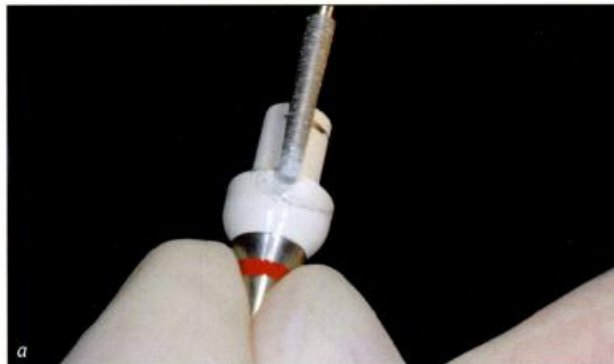
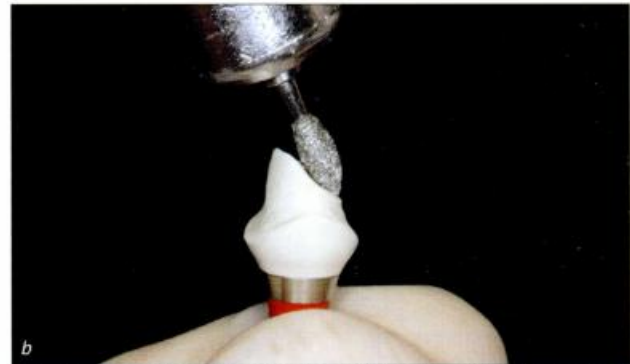
*Figs 13a, b* Necessary individual modifications were performed outside the oral cavity wherever possible, using the appropriate rotary instruments. For that purpose, the mesoabutment was attached to a laboratory analog with its integrated occlusal screw.

The marked mesoabutment was attached to the corresponding RN laboratory analog to facilitate the necessary modifications, which were performed with appropriate diamond burs and abrasive disks (Figs 13a, b). To increase the efficacy (precision and time) of the procedure and to minimize potential sources of tissue irritation, all the corrections that could be carried out outside the oral cavity were made on the implant analog.

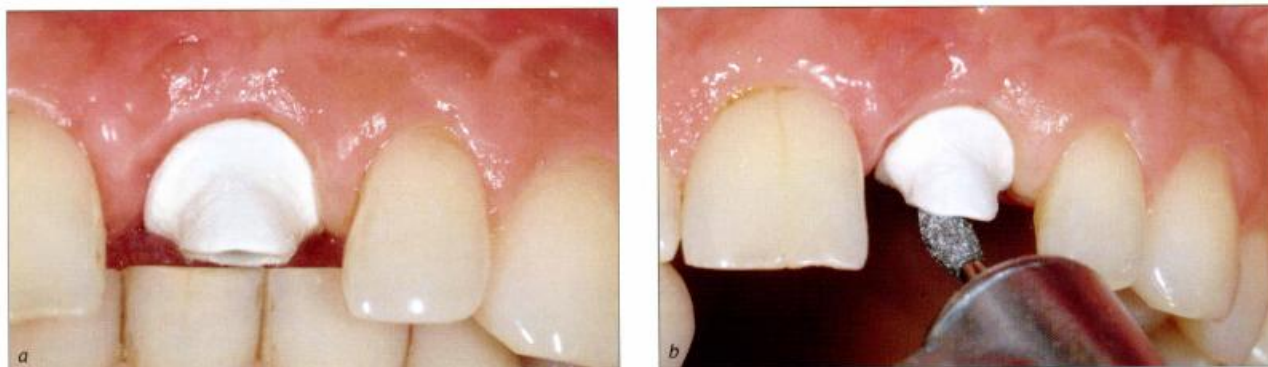
*Figs 14a, b The customized temporary mesoabutment was reattached to the implant, secured with its retention screw, and the occlusal features carefully verified (a) and then corrected intraorally using diamond burs (b).*

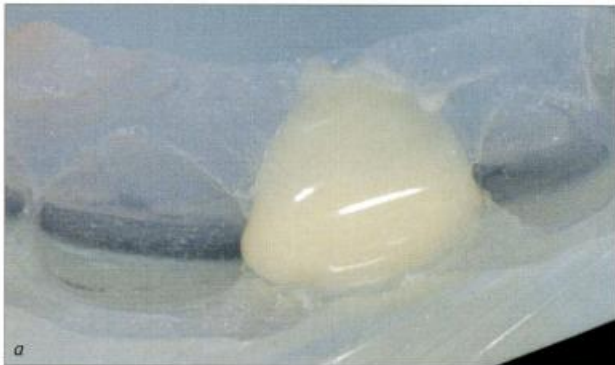
*Figs 17a, b An advantage of using a combination of a transparent silicone material and a light-polymerizing acrylic resin is that the key can be carefully loaded, the absence of air entrapments can be verified, and the subsequent intraoral positioning carried out without time constraints. The light-curing process itself is extremely rapid and has no clinical shortcomings such as tissue irritation caused by free monomers and an increase in temperature.*

Another advantage of using a combination of a transparent silicone key and a light-curing acrylic resin is that they provide abundant time for careful loading of the silicone template at the corresponding location and for verifying the absence of any air entrapments (Figs 17a, b). Once this check had been made and any “bubbles” had been eliminated, the key was precisely repositioned on the dental arch, followed by a short time of exposure to the curing light. The template was removed, the access to the screw-access channel was established, and the restoration was removed from the patient’s mouth, attached to the laboratory analog, and all correction and finishing procedures were performed extraorally.

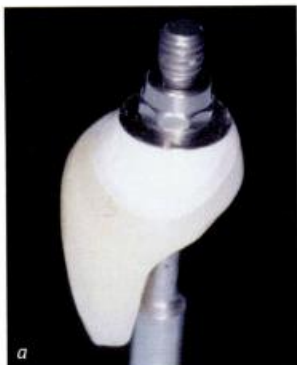
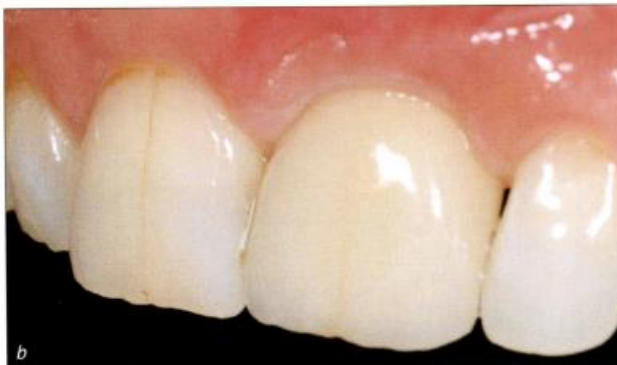
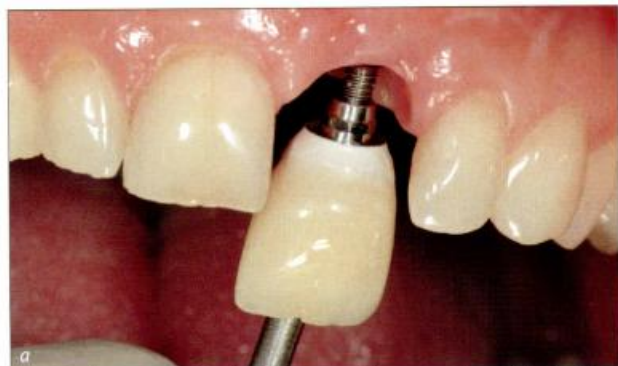
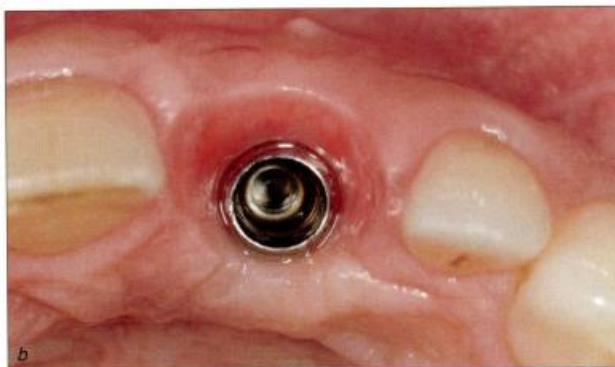
*Figs 19a, b Two months after insertion of the screw-retained implant provisional, the peri-implant soft tissue displayed healthy and stable features. From an esthetic point of view, the soft-tissue appearance and contours were favorable. At this stage, the clinical situation was judged adequate for taking the final impression.*

Approximately two months after the placement of the implant provisional, the peri-implant soft-tissue configuration was considered adequate for undertaking the next treatment step, consisting of final impression taking. A carefully fabricated implant provisional, as previously described, in conjunction with a well-instructed and highly compliant patient as far as plaque control and maintenance were concerned, led to optimal peri-implant soft-tissue conditions, including esthetic mucosal contours (Figs 19a, b).

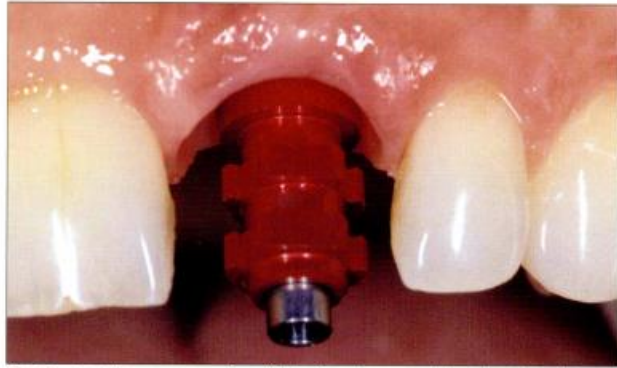
*Fig 20 In the presence of a distinctly submucosal implant shoulder, an open-tray type impression was performed using a screw-retained impression cap. Care was taken to proceed with impression-taking immediately after removing the provisional in order to pick up a maximum amount of the relevant peri-implant soft-tissue contours created by the axial profile of the temporary restoration.*

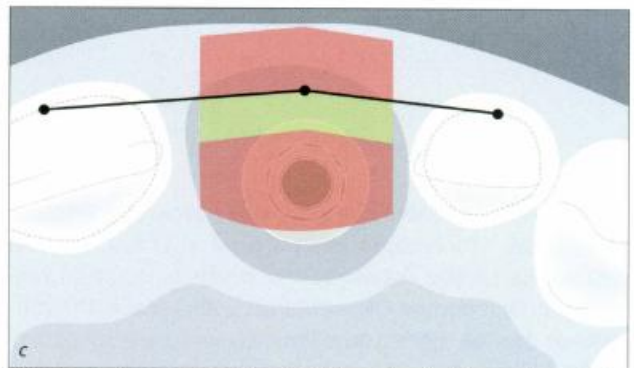
*Figs 21a-c Close-up views (a: palatal; b: occlusal) of the master cast documenting the optimal implant position in an orofacial and a mesiodistal direction. The implant was ideally placed within the orofacial and mesiodistal comfort zones (c).*

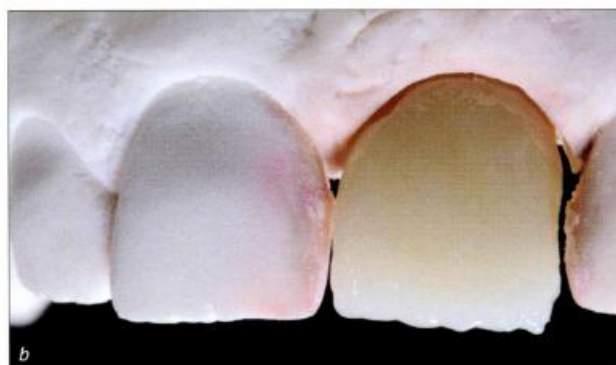
*Figs 22a, b* In the first step, the clinical crown body was established, composed of a complex sequence of layers of different opacities and shades aimed at imitating the basic components – dentin, enamel, and incisal translucency – of a natural central maxillary incisor (a). After the first ceramic sintering step, a significant volume contraction was observed, requiring at least one additional corrective step. The basic optic tooth-like properties, however, were already clearly visible.

Using the silicone key derived from the provisional, the ceramist subsequently proceeded with the mounting of the various layers of different ceramic substrates to achieve an optimal reproduction of shapes and optical properties as present in the natural contralateral tooth. This procedure required an "over-build" of crown volume to anticipate the subsequent sintering contraction (Fig 22a). After the first ceramic firing, the volume contraction was particularly evident at the interproximal surfaces, resulting in an absence of interdental contacts (Fig 22b) and requiring at least one additional correction-sintering step.

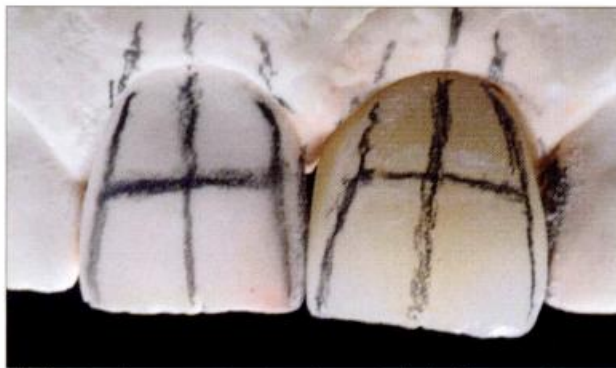
*Fig 23* In order to reproduce the main morphological features of the natural control tooth, these elements, such as mesial and distal transition line angles and the long axis of the clinical crown, were first marked on the contralateral tooth and then highlighted on the ceramic crown.

After the second ceramic firing, the ceramist outlined in pencil the key morphological parameters on both the natural contralateral tooth and on the newly produced ceramo-metal implant-supported crown (Fig 23). This systematic approach ultimately achieved an adequate level of similarity, a determinant for the final esthetic outcome.

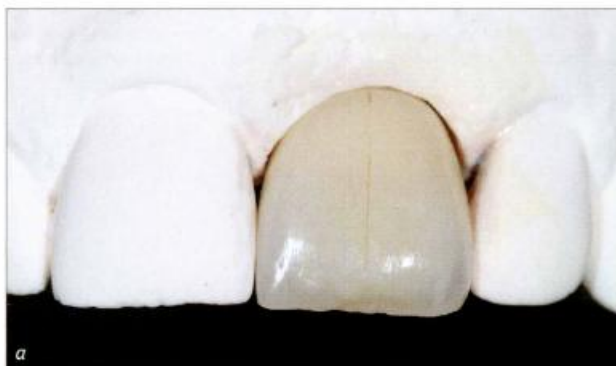
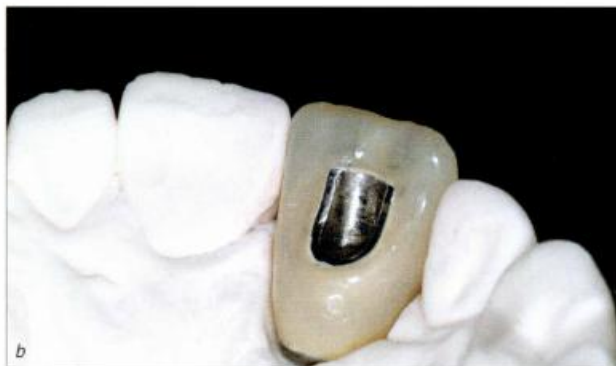
*Figs 24a, b* Vestibular and palatal close-up views of the completed transocclusally screw-retained ceramo-metal implant-supported crown.

After an additional sintering step, the transocclusally screw-retained ceramo-metal implant-supported crown 21 was finalized and mechanically polished to the same characteristic surface texture observed at tooth 11 (Figs 24a, b). For reasons of mechanical strength and to prevent ceramic fractures, the screw-access channel was protected with a metal sleeve.

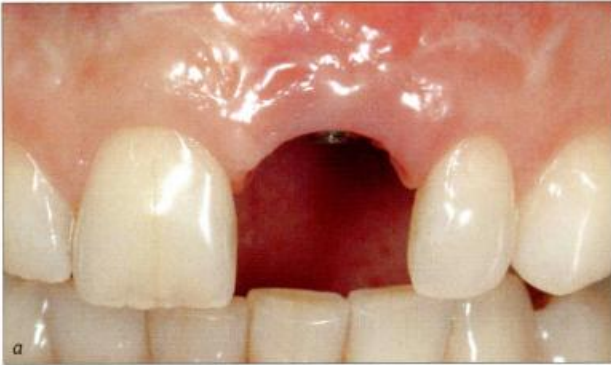
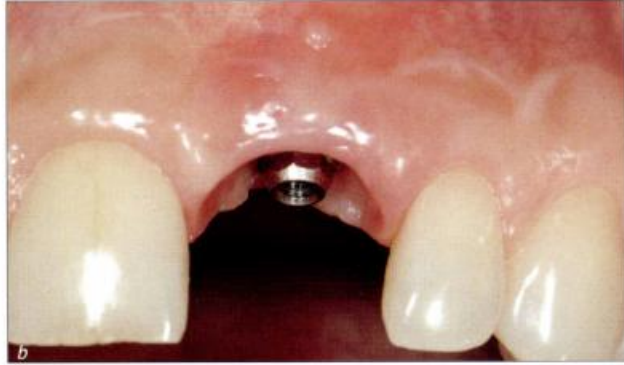
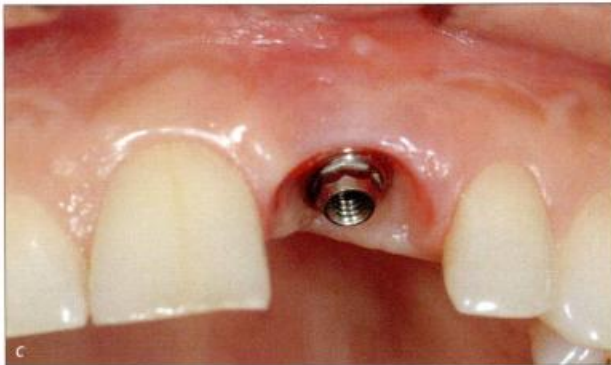
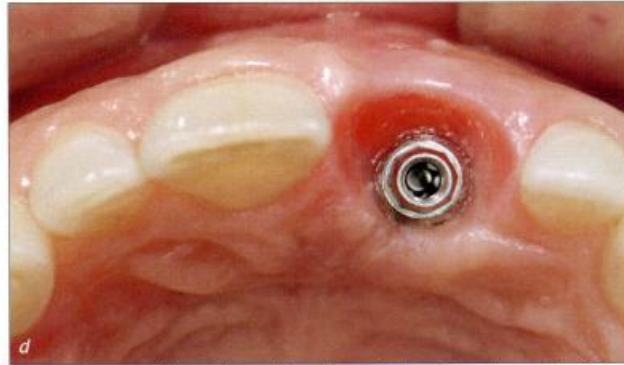
*Figs 25a-d Four different close-up views of implant site 21, documenting the almost perfect condition of the peri-implant soft tissue from the points of view of health and esthetics.*

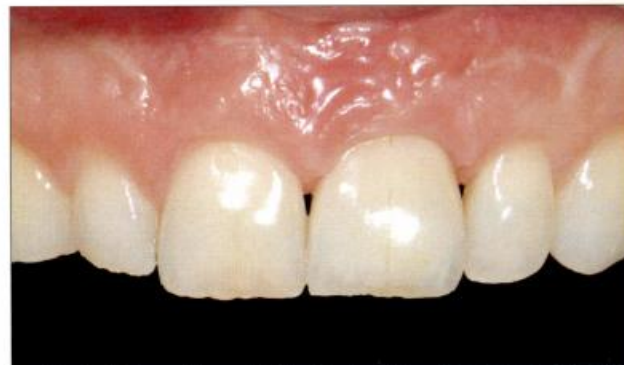
*Fig 26 Labial aspect immediately after insertion of the screw-retained ceramo-metal implant-supported crown 21, confirming esthetic integration in a natural environment.*

As expected under such conditions, the integration of the new implant-supported crown in the adjacent natural dentition reached acceptable standards. A slight vertical soft-tissue loss on both the mesial and distal aspects of the new restoration led to the presence of two small so-called “black triangles.” However, this limited degree of soft-tissue loss is still largely within the limits of what one would consider acceptable from an esthetic point of view.

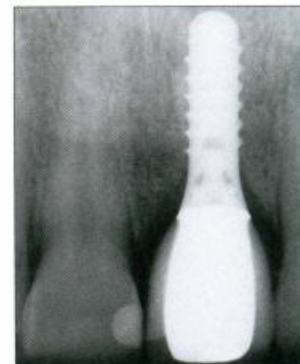
*Fig 27 Final radiograph confirming a stable peri-implant bone situation, excellent radio-opacity of the precious-alloy substructure, and a good marginal fit of the metal-ceramic implant-supported crown.*

From a radiological point of view, the single-tooth replacement 21 was to be considered successful (Fig 27). The peri-implant bone appeared stable, confirming that osseointegration had reached the steady state, and the interproximal bone height at the two adjacent natural teeth was similar to the preoperative situation.

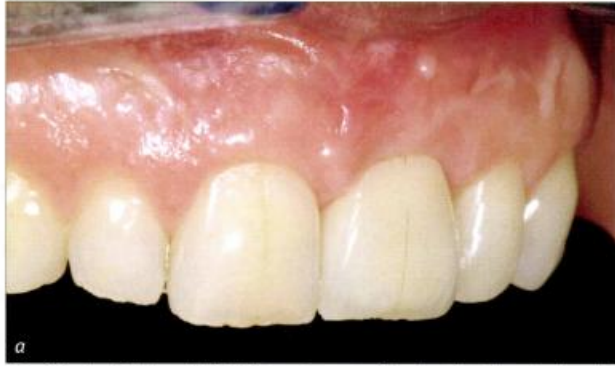
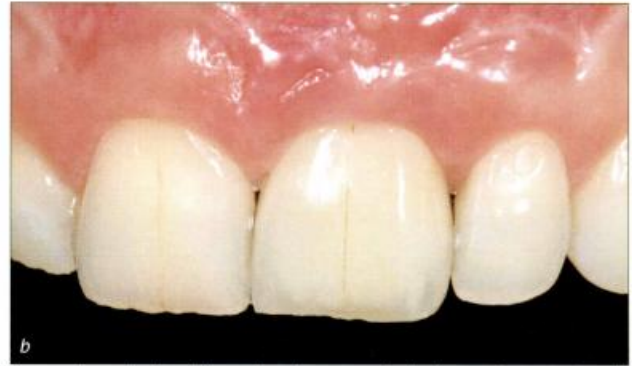
*Figs 28a, b Right and left oblique views, confirming that, despite the slight difference in mesiodistal dimensions between the implant and natural tooth, an esthetically acceptable level of outcome had been reached.*

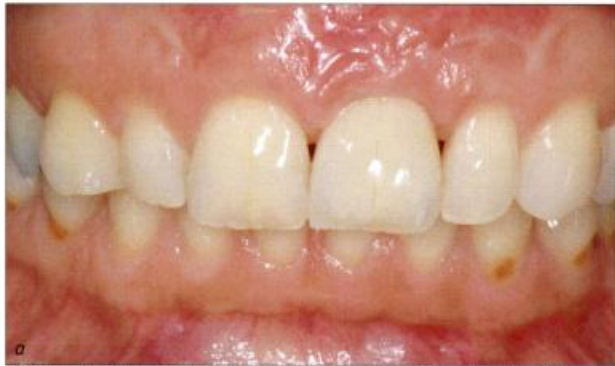
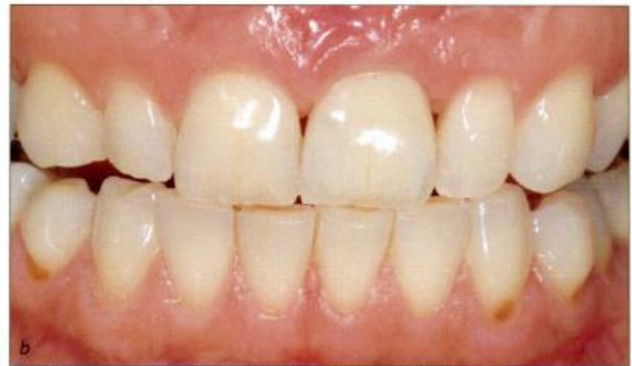
*Figs 29a, b Direct comparison between the centric occlusal position (a) and protrusive excursion of the mandible (b), demonstrating a harmonious occlusal pattern.*

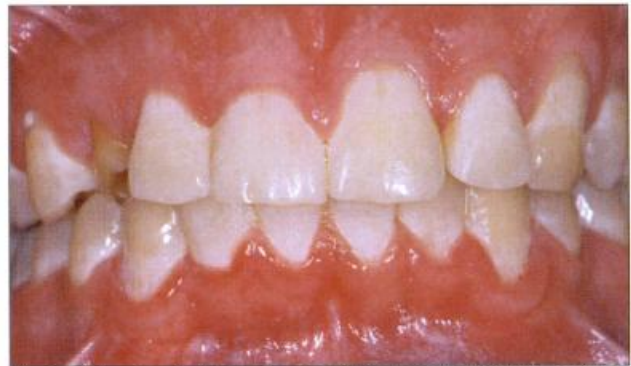
Fig 2a The retracted view showing clinical crowns with thin scalloped papillae and a moderate band of keratinized tissue.

A retracted view of the central incisors showed a discrepancy in the gingival margin positions of teeth 11 and 21 (Figs 2a-c).

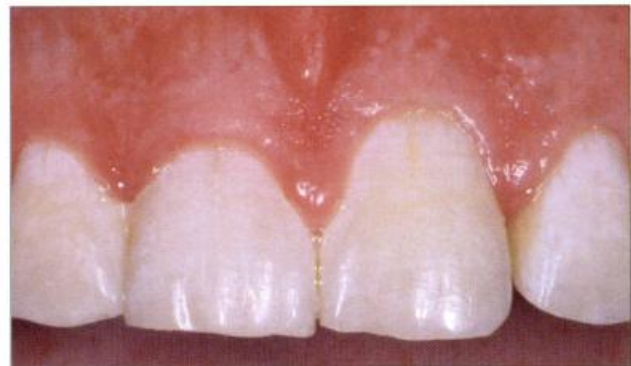
Fig 2b Frontal view highlighting the discrepancy between the gingival margins of teeth 11 and 21. The gingival margin of tooth 21 is the favorable margin position.

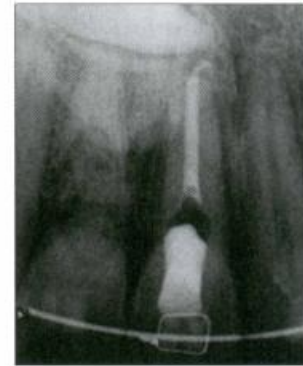
*Fig 4 Periapical radiograph after treatment of tooth 21.*

Endodontic therapy was performed on tooth 21 (Fig 4). A bi-annual follow-up was initiated to track any changes within the tooth.

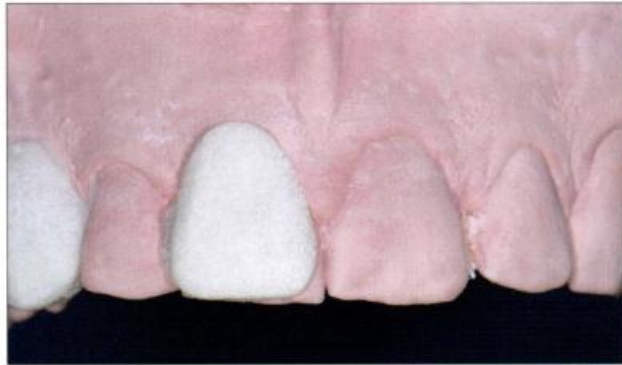
Fig 5 A radiopaque resin tooth highlighting the desired mucosal margin at site 11 was fabricated. This tooth would be incorporated into the CT template.

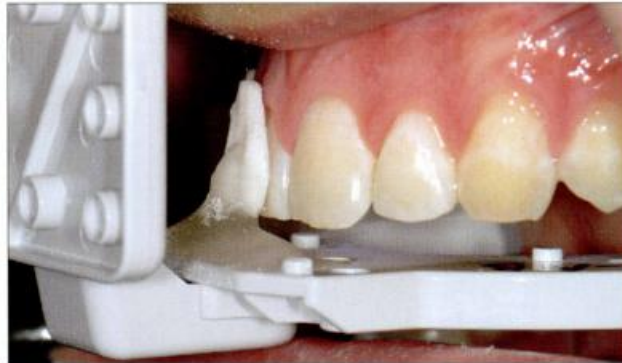
Fig 6 The CT template in place before the radiographic survey.

This template was worn during the CT survey (Fig 6). Information gathered from the survey was analyzed using implant-planning software (DenX Ltd.) In this virtual environment, the dental implant was placed in an ideal position based upon (1) the nature of the planned restoration, (2) available bone, and (3) the position of the impacted canine. At the surgical visit, a periosteum was used to remove tooth 11 while maintaining facial bone support.

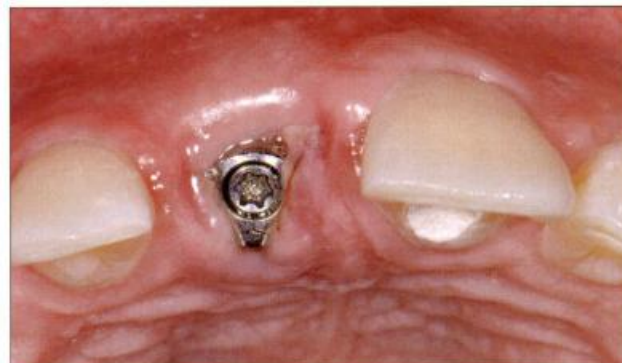
Fig 8 Occlusal view of the healing cap at the one-week follow-up visit.

A healing cap was placed and the extracted central incisor was inserted into a vacuform template to be used as an interim restoration. The patient was scheduled for a follow-up visit one week later (Fig 8).

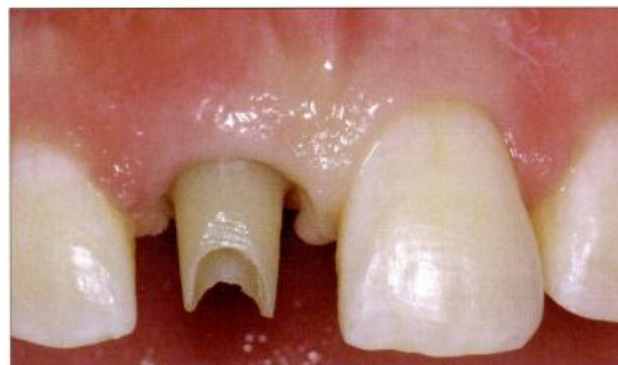
Fig 11a Frontal view after preparation of the mesoabutment.

The abutment was placed on the implant and tightened to 15 Ncm. It was then modified with diamond bur in a high-speed handpiece to create a circumferential submucosal shoulder (Figs 11a, b).

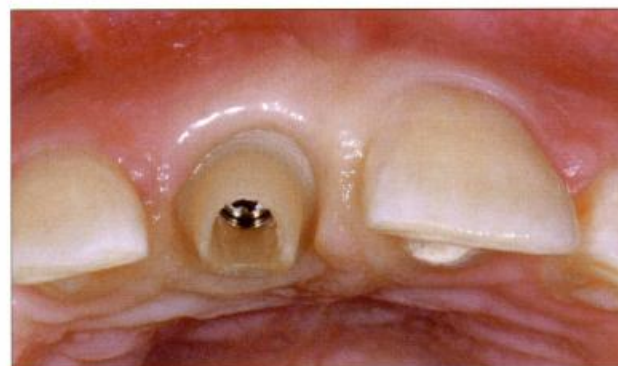
Fig 11b Occlusal view of the mesoabutment, highlighting the axial position of the implant and circumferential margin preparation.

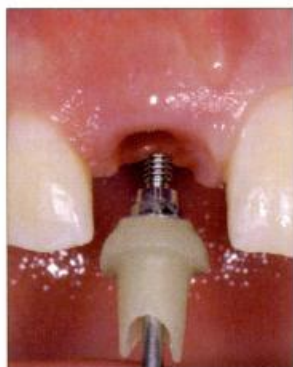
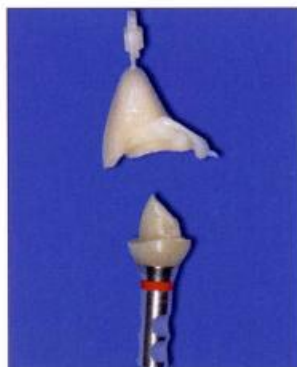
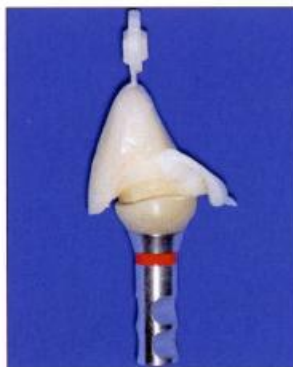
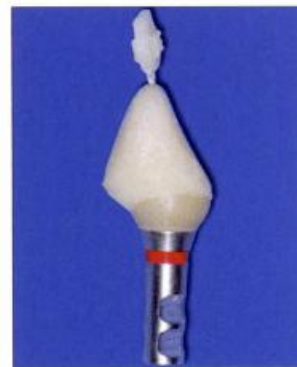
Fig 12a Frontal view of the meso-abutment during removal.

Fig 12b Exploded view of the relined polycarbonate crown and mesoabutment on a synOcta analog.

Fig 12c Once the provisional was placed on the abutment, excess material was removed before building up the ideal emergence profile.

Fig 12d Provisional restoration and abutment, highlighting the facial and palatal contours.

A prefabricated polycarbonate crown was relined with Triad VLC (Dentsply) over the meso-abutment. The margins of the provisional were refined extraorally to create an ideal emergence contour from the shoulder prepared on the meso-abutment (Figs 12a-d).

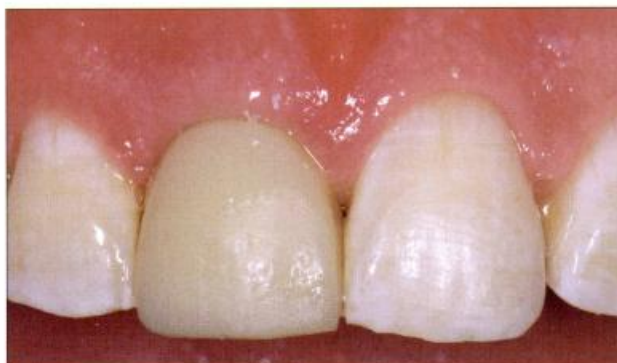
Fig 13 Frontal view after cementation of the provisional restoration.

Upon completion of the extraoral margination process, the mesoabutment was returned to the mouth and tightened to 15 Ncm. The screw access hole was covered with cotton, and the provisional was cemented with temporary cement (Fig 13). The occlusion was adjusted and the patient scheduled for a final impression after four weeks.

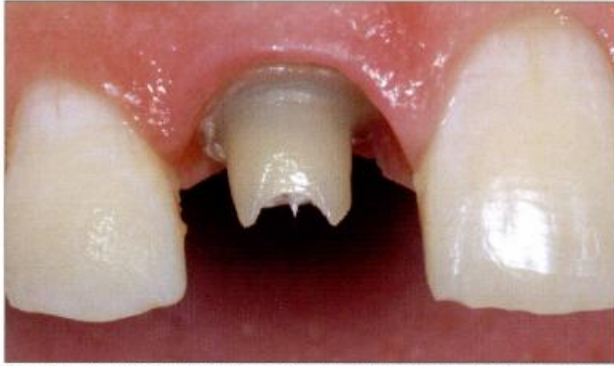
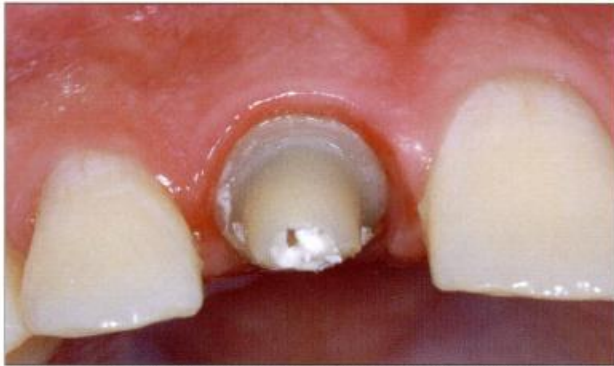
*Fig 15a Facial view of the mesoabutment and surrounding tissue upon removal of the provisional restoration.*

*Fig 15b Occlusal view of the mesoabutment showing minimal inflammation and cement residue.*

Upon removal of the provisional restoration, the tissues showed minimal inflammation and little cement residue (Figs 15a-b).

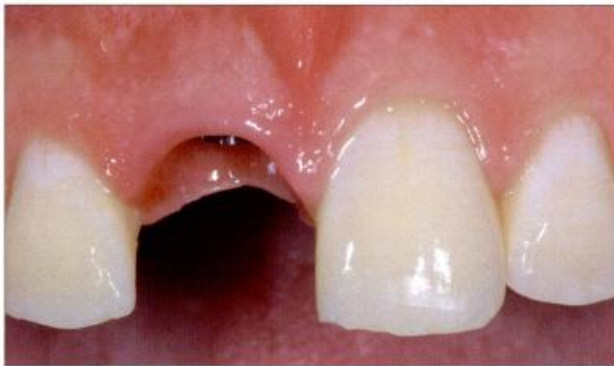
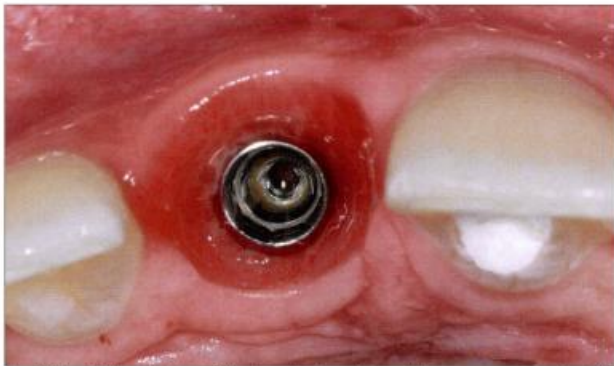
*Fig 16a Facial view of the implant, highlighting the facial and interproximal tissue support.*

*Fig 16b Occlusal view of the implant and transition zone created by the mesoabutment and provisional restoration.*

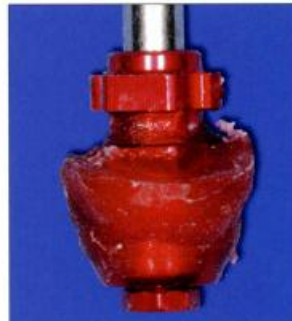
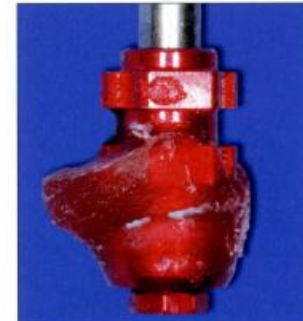
Fig 18a Frontal view of the custom impression cap, showing the emergence of the transition zone captured with the pattern resin.

Fig 18b Lateral view of the custom impression cap. The facial emergence profile can be appreciated.

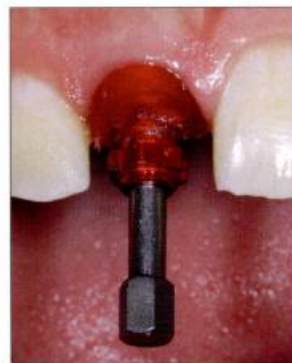
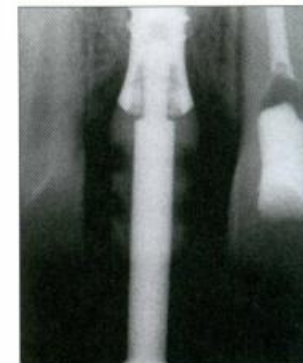
Fig 19a The frontal view of the custom impression cap in place.

Fig 19b Periapical radiograph confirming full seating of the custom impression cap.

Upon placement of the customized impression cap, it became evident that full seating could not be confirmed clinically, so a periapical radiograph was taken (Figs 19a, b).

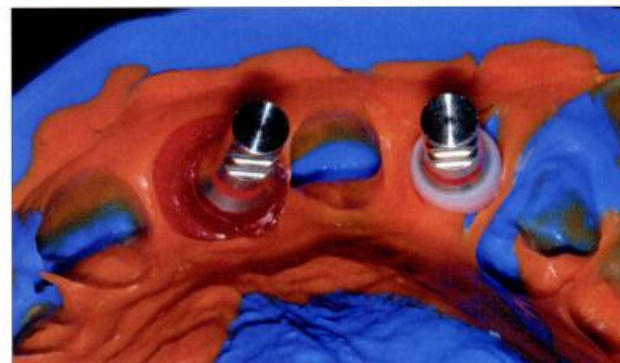
Fig 20 Final impression with the synOcta analogs in place.

Once full seating had been confirmed, a polyvinyl siloxane impression was made (Fig 20).

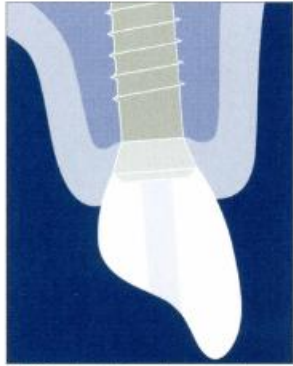
Fig 21 Implant axis passing through the gingulum, allowing for transocclusal screw retention of the crown.

In the laboratory, the position of the implant axis was confirmed as passing through the gingulum of the planned restoration (Fig 21). A screw-retained crown could therefore be selected as the definitive restoration. To accomplish this, a synOcta gold abutment was selected as the definitive abutment (Fig 22). It would allow for the merging of the restoration directly onto the abutment. The result would be a crown that would directly connect into the synOcta connection on the implant, using a single abutment screw to retain the crown on the implant.

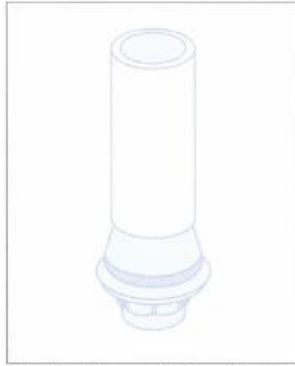
Fig 22 The synOcta gold abutment.

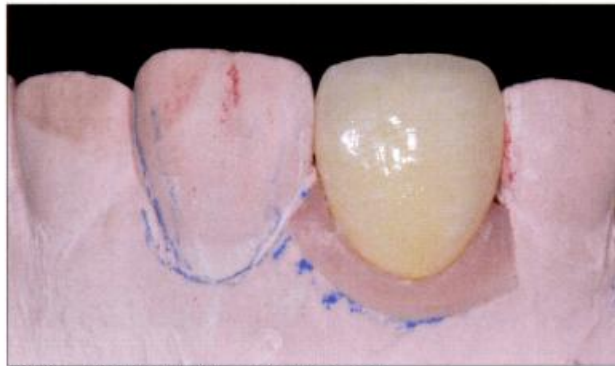
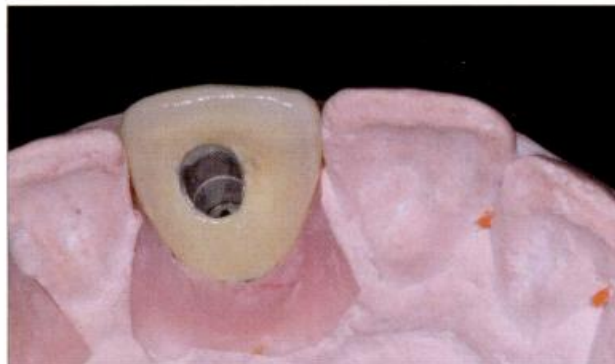
Fig 23a Final restoration on the master cast.

Fig 23b Occlusal view of the final restoration, showing the position of the screw access hole.

The restoration pattern was waxed up to full contour on the master cast, followed by a cut back to allow for the ceramic veneer. After casting, ceramic material was built up and glazed and the fit of the restoration tested on a solid master cast (Figs 23a, b).

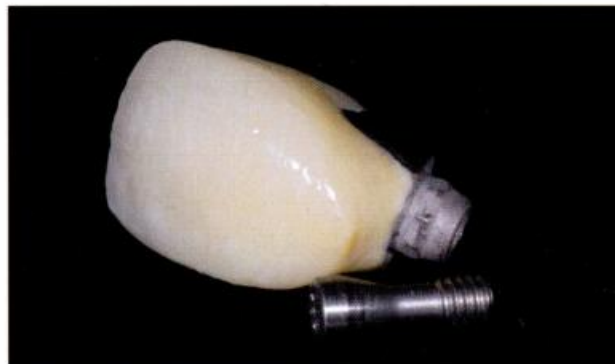
Fig 24 Final crown and abutment screw.

The crown and abutment screw were then returned for insertion (Fig 24).

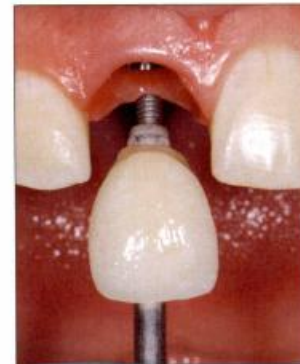
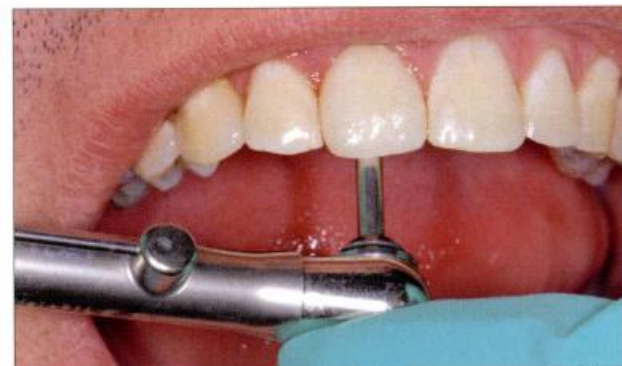
Fig 26a Frontal view showing the seating of the crown onto the implant.

Fig 26b The abutment screw was tightened to 35 Ncm and sealed with cotton and composite.

Once the fit and shade of the final restoration had been confirmed, it was tightened to 35 Ncm (Figs 26a, b). The screw access hole was covered with a cotton pellet and sealed with composite. The occlusion was adjusted to a light shimstock pull. Adjustments to the ceramic surface were followed by a polishing procedure with diamond-impregnated disks that helped create a glaze-like ceramic surface.

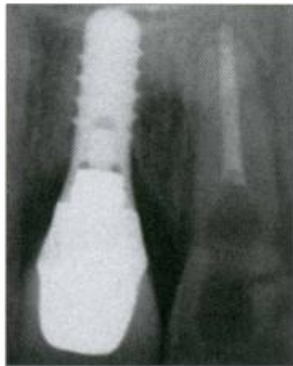
Fig 27 Periapical radiograph taken after insertion of the crown.

A periapical radiograph was taken and the patient was scheduled for a follow-up visit after three weeks (Fig 27).

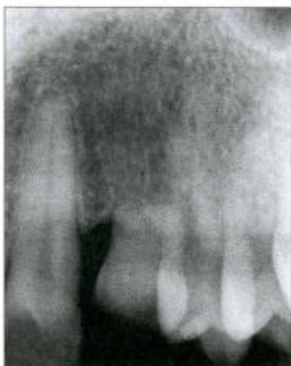
*Fig 6 Pre-treatment periapical radiograph showing the extent of root resorption of tooth 63, vertical bone loss on the distal aspect of tooth 22, and the vertical bone volume available at the prospective implant site.*

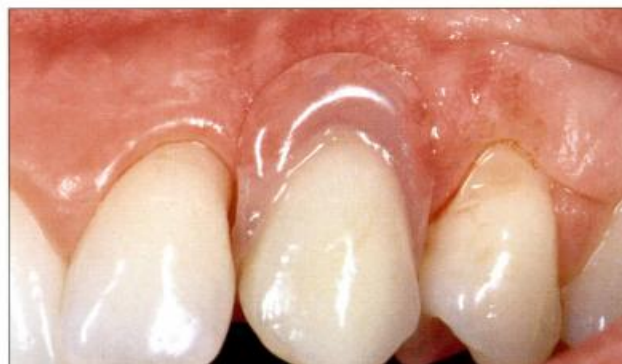
Fig 13 The transient removable partial denture helped maintain esthetics and phonetics.

Immediately after the extraction, a provisional removable partial denture was inserted to maintain the patient's basic esthetic and phonetic functions (Fig 13).

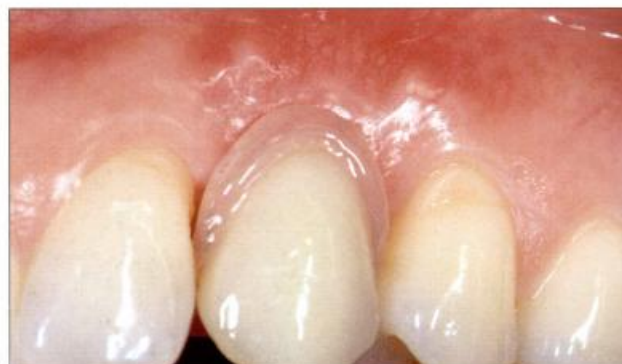
Fig 14 Chairside modification of the provisional improved fit and esthetics.

At this stage, it was important to ensure that no significant tissue compression would occur. "Fit Checker" was used to identify pressure spots, which were subsequently removed. To align the provisional with the line of the neighboring natural teeth and the mucosa line, its pink base was also modified at insertion (Fig 14).

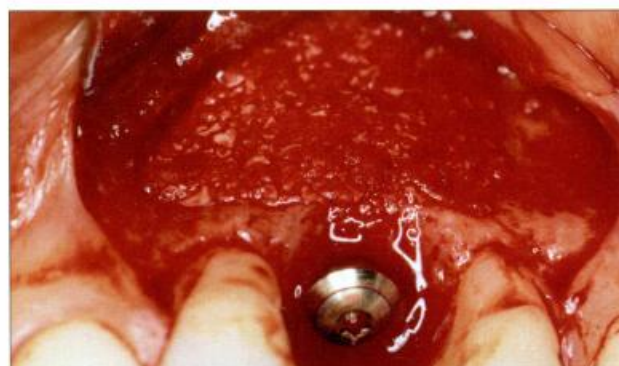
Fig 21 Augmentation of the alveolar bone in order to improve its contour – a prerequisite for optimal esthetics.

The implant was covered with a small closure screw (Fig 21). A free connective-tissue graft was harvested from the palatal premolar region at the time of implant placement. The connective-tissue graft was placed over the augmented implant site in a coronal position. It covered the coronal portion of the implant (Fig 22), improving the volume and position of the marginal tissue.

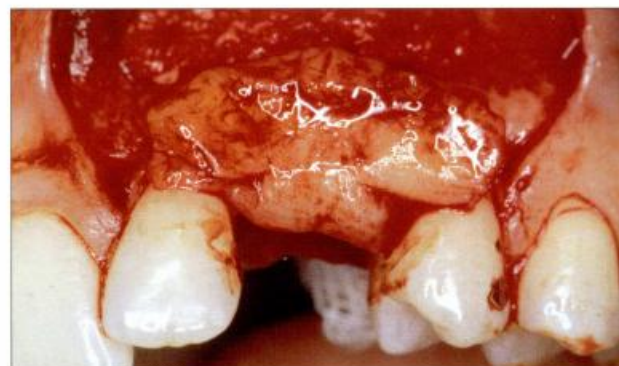
Fig 22 A soft-tissue graft was placed to compensate for the soft-tissue deficiency at site 23.

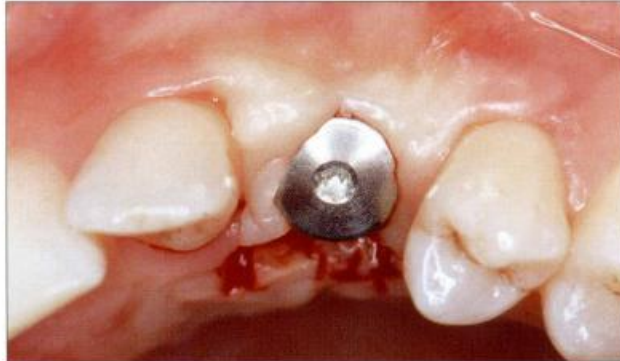
Fig 26 A healing cap was attached to establish and maintain a soft tissue "tunnel" which would provide easy access to the implant shoulder for the prosthetic procedures.

After another six weeks, the site was re-entered to gain access to the coronal implant portion. The small closure screw was removed and replaced by a longer healing cap (Fig 26). This served to establish a soft-tissue "tunnel" from the implant to the oral cavity and initiated the soft-tissue conditioning phase.

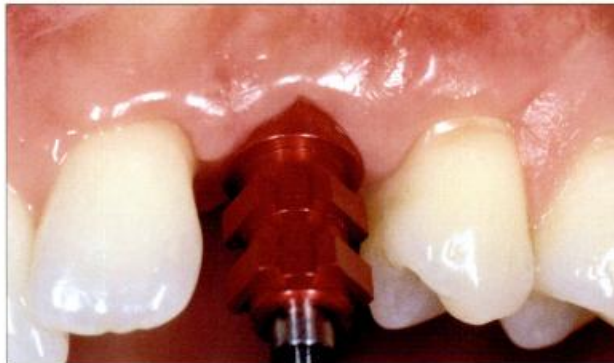
Fig 31 Connecting the impression cap. The soft tissue must not be damaged.

A screw-retained synOcta impression cap was connected to the implant shoulder and tightened with the integral guide screw (Fig 31). The custom impression tray was tried in to ensure a precise fit and easy access to the screw (Figs 32, 33).

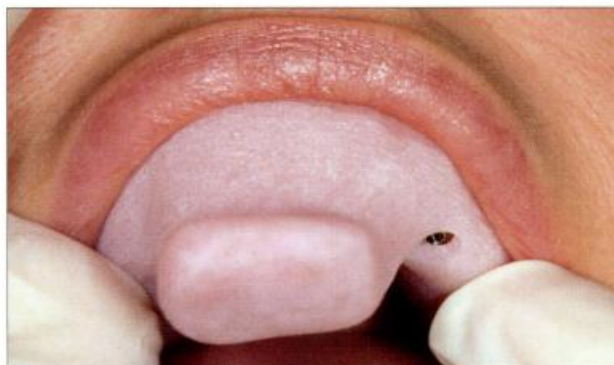
Fig 32 Custom impression tray with the passage hole for the screw of the impression cap.

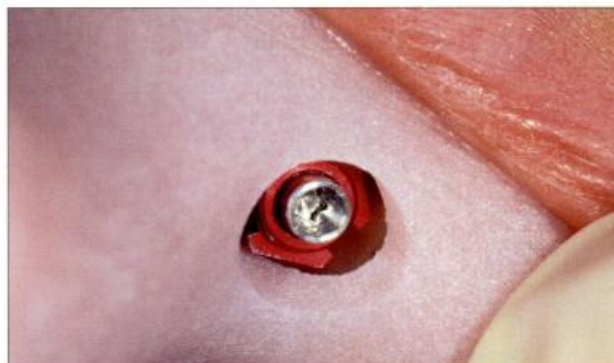
Fig 33 Easy access to the screw of the impression cap.

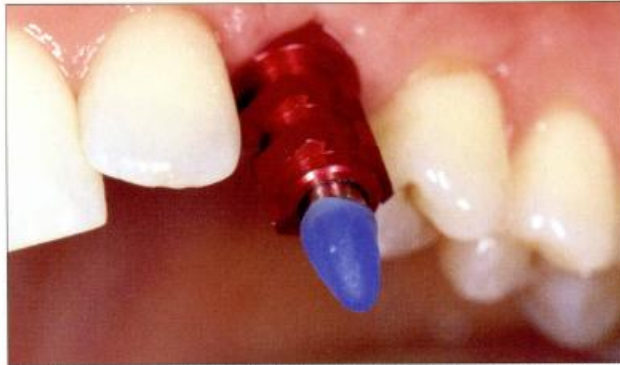
*Fig 34 A wax cover for the screw facilitated easy loosening of the impression cap after the impression was taken.*

The screw access hole of the impression cap was covered with wax to prevent it from being blocked by impression material and to ensure easy access (Fig 34).

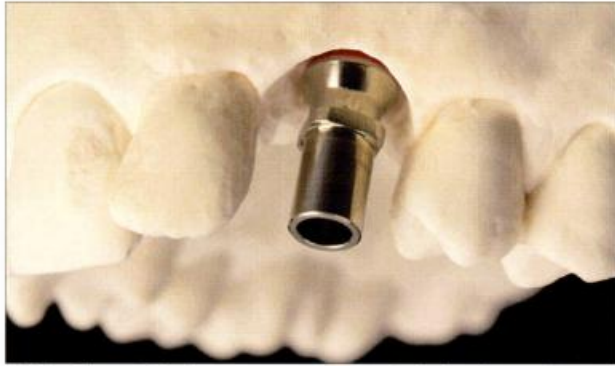
Fig 37 The post for the temporary crown needed to be shortened.

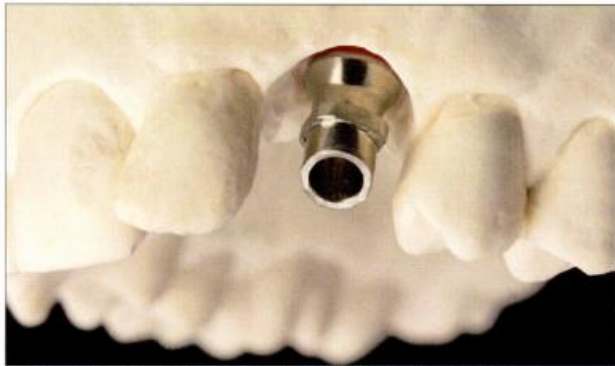
Fig 38 The post was shortened to the desired occlusal height.

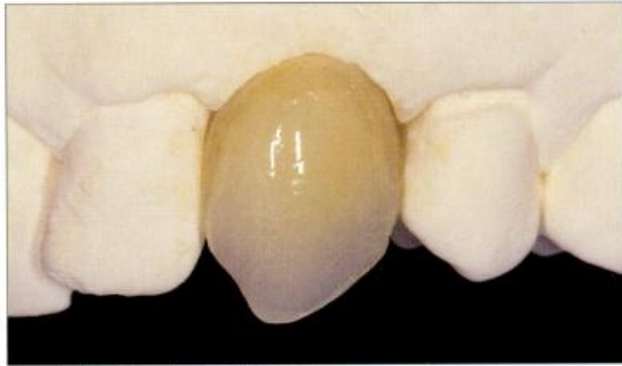
Fig 42 Provisional crown, labial view.

A long interproximal contact line was established to compensate for the vertical soft-tissue deficiency distal of tooth 22 to reduce the size of the interproximal black triangles (Figs 42, 43).

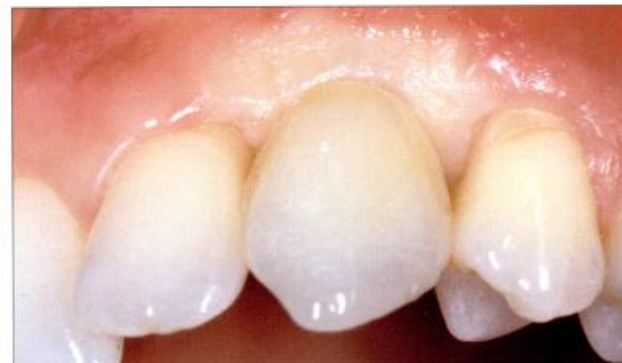
Fig 45 The pressure applied to the soft tissues at the time of integration of the provisional crown initiated the soft-tissue conditioning phase.

At the time of the integration of the provisional crown, the soft-tissue blanching occurring at insertion (Fig 45) indicated that volume had been added at the cervical portion of the restoration. This additional volume was necessary to achieve harmony with the emergence profiles of the natural adjacent teeth.

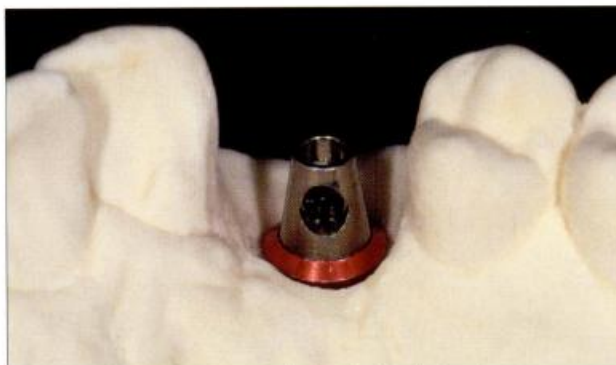
Fig 48 A TS abutment was attached to the implant analog.

In the dental laboratory, a synOcta transversal (TS) abutment for transversally screw-retained crowns was selected and placed on the implant analog (Fig 48).

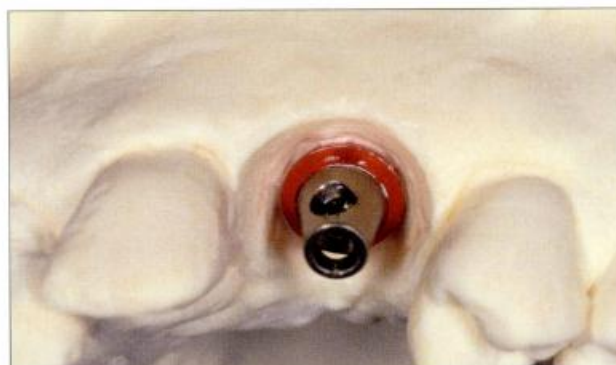
Fig 49 TS abutment on the analog, incisal view

In order to permit perfect positioning of the respective metal component, the peri-implant soft tissue had to be modified at its palatal aspect: The model was relieved to generate space for positioning the cervical portion of the crown carrying the screw-retention part (Fig 49).

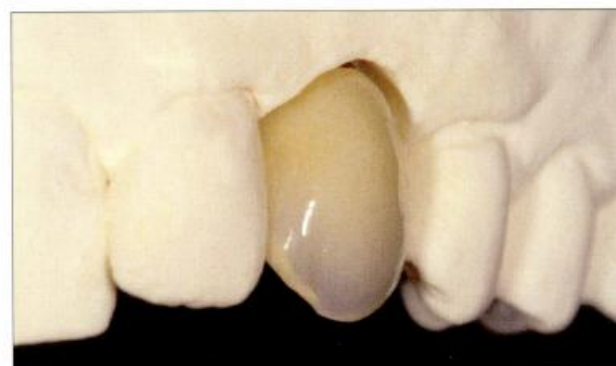
Fig 50 The final crown, labial view.

The ceramo-metal crown was fabricated according to a standard protocol: A metal framework based on a prefabricated cast-on component was created and veneered with compatible ceramics, applying a complex layering technique to achieve the required optical properties (Figs 50–52).

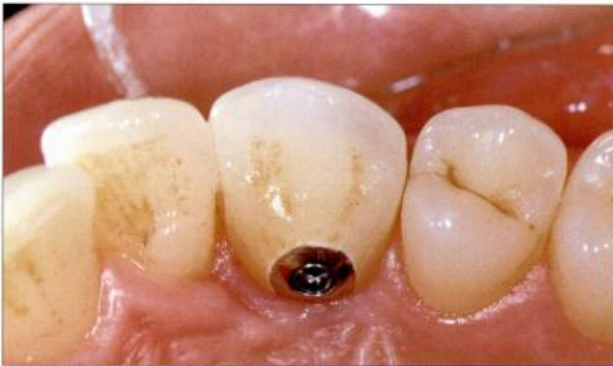
*Fig 54 Palatal view of the final implant restoration showing easy access for manipulating the transversal screw. The screw-access channel was protected by a minimal perimeter of metal.*

The crown was attached to the abutment and the transversal screw tightened to 15 Ncm (Fig 54).

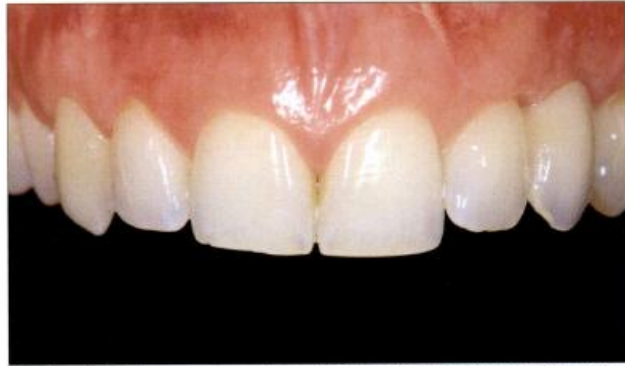
*Fig 55 Clinical appearance immediately after installation of the final crown.*

The implant-supported crown blended in well with the natural dentition in an esthetically pleasing way, matching the natural teeth in shape, texture, and color. The course of the marginal gingiva and the lines of the incisal edges were harmonious and esthetically appealing (Figs 55–57).

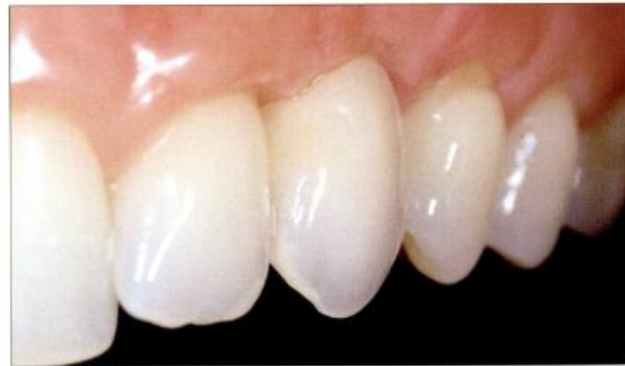
*Fig 56 A more tangential view. Straight vestibular emergence profile of the implant-supported restoration, establishing harmony with the buccal contour of the adjacent natural dentition.*

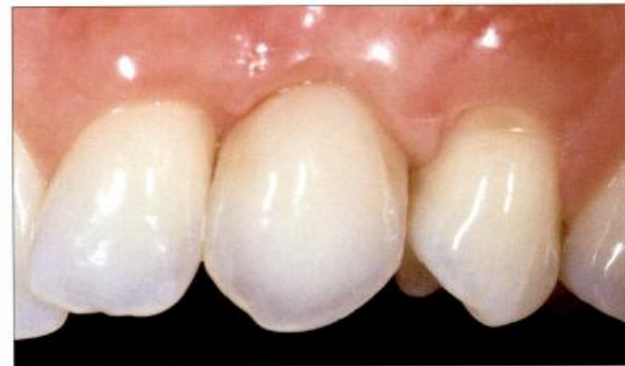
*Fig 57 The implant-supported superstructure blended in nicely with the natural dentition.*

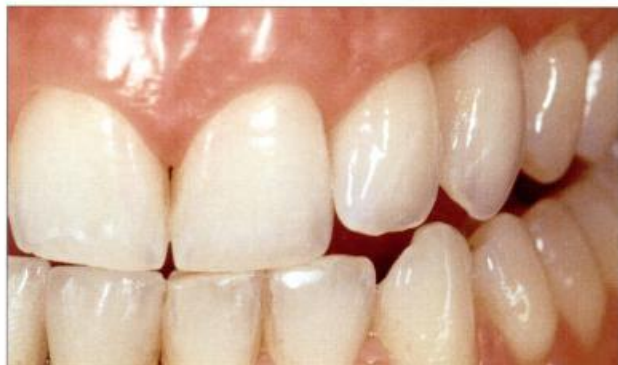
*Fig 58 The occlusal guidance during lateral excursion of the mandible was meticulously checked, and any interference was carefully removed.*

The occlusion was carefully checked. Minor discrepancies were adjusted (Figs 58, 59).
