ITI Treatment Guide  
Volume 1

# Treatment Guide

Volume 1

Implant Therapy in the Esthetic Zone  
Single-Tooth Replacements

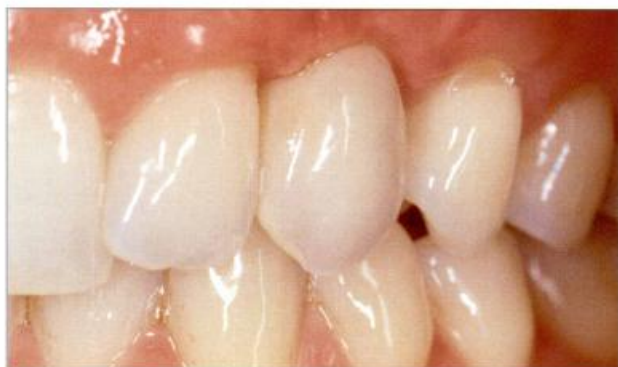
*Fig 59 The cervical position of the screw access channel helped create a disturbance-free occlusion.*

The occlusion was carefully checked. Minor discrepancies were adjusted (Figs 58, 59).

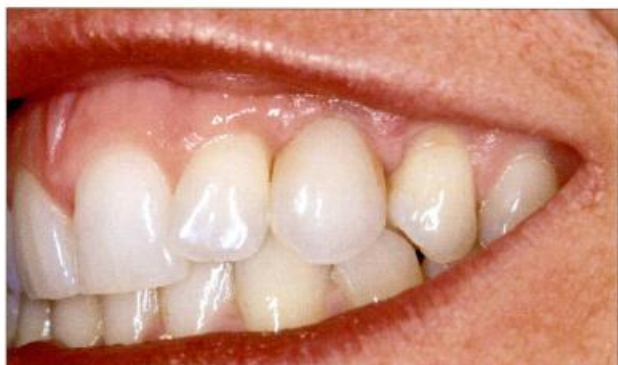
*Fig 61 Stable soft tissue conditions twelve months after final crown installation.*

The situation twelve months after integration of the final restoration is seen in Figure 61.

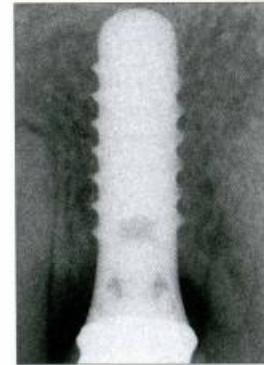
Fig 62 Stable bone contours twelve months after final crown installation.

The periapical radiograph twelve months after implant placement shows a stable bone level (Fig 62).

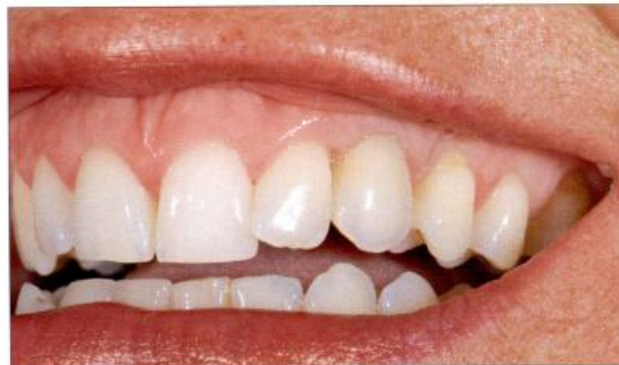
Fig 63 Five years after insertion of the crown, the peri-implant soft tissues continued to be stable.

At the five-year clinical follow-up in March 2005, the soft-tissue contours as well as the bone contours were stable (Figs 63 – 65).

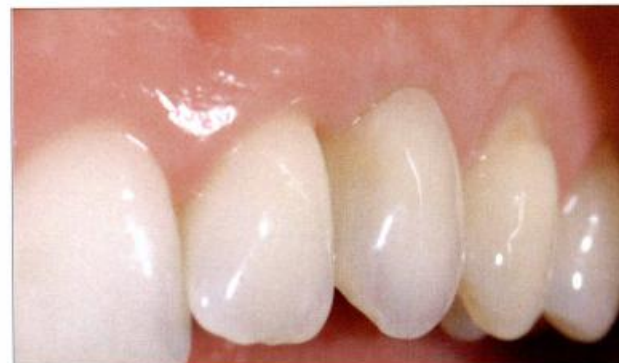
Fig 64 Close-up view of the implant site at the five-year follow-up visit.

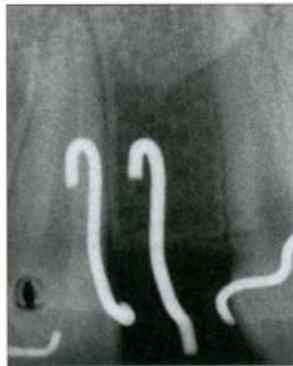
*Fig 8* Periapical radiograph of the future implant site after orthodontic treatment. The wires of the retainers and the wires of the removable partial denture to close the gap at site 22 were visible.

The periapical radiograph taken after orthodontic treatment demonstrated the straightened tooth axes of teeth 21 and 23 and the widened gap, which now had a mesiodistal width of approximately 6 mm (Fig 8).

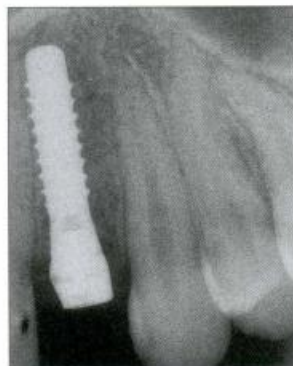
*Fig 9* Situation after implant placement.

Due to an apical fenestration defect at the time of implant placement caused by the horizontal bone deficiency, a simultaneous augmentation procedure was performed. This also allowed for the optimization of the horizontal bone volume and contour. Good primary stability and an ideal three-dimensional implant position were achieved (Figs 9, 10).

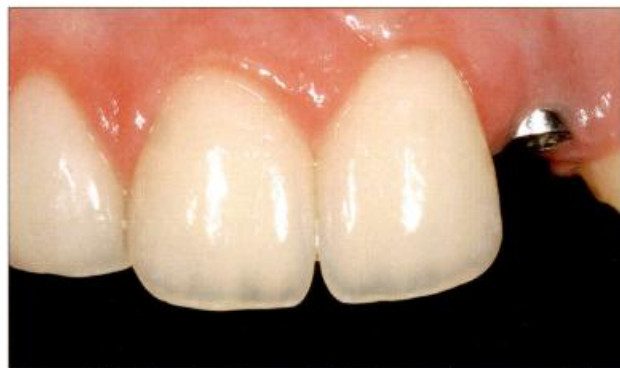
Fig 11 Clinical situation eight weeks after implant placement. A gingivectomy was performed and a longer healing cap was placed to keep the space open after the impression was taken.

Eight weeks after implant placement, the soft tissues were healthy and had healed well (Fig 11). It was therefore decided to take an impression to enable fabrication of a provisional restoration.

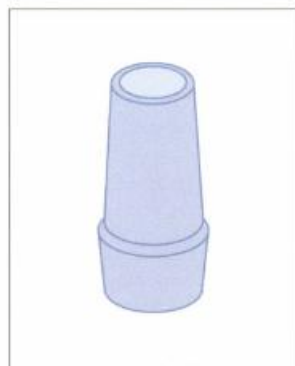
Fig 13 NN titanium coping.

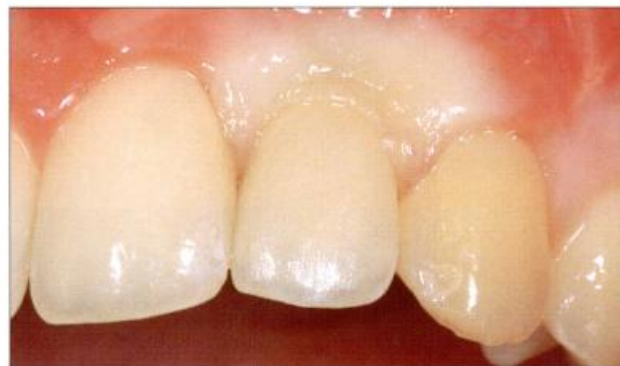
Fig 14 Pressure needs to be applied to the peri-implant mucosa to start the soft-tissue conditioning process.

The provisional was given its ideal shape at the time of integration, and adaptations of the provisional crown during the course of the mucosa-conditioning process were set aside. This explains the extent of blanching. Due to this initial compression of the soft tissue, some patients request an anesthesia for this step of the treatment. The blanching of the mucosa should disappear within 10 to 15 minutes.

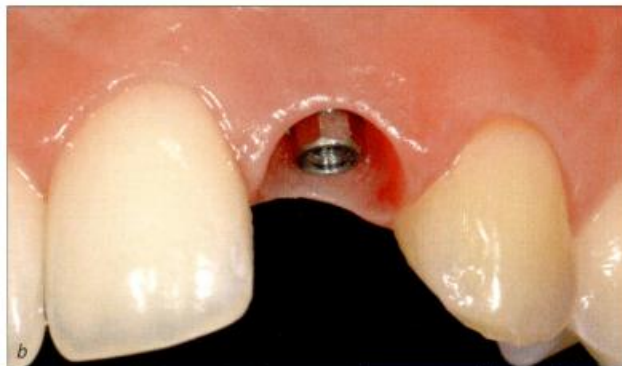
*Figs 15a, b The mucosal arch was naturally curved, and the papillae were well shaped.*

Nine months after loading with the provisional crown, the desired emergence profile was well developed (Fig 15) so that it was decided to take the impression for the final crown (Fig 16).

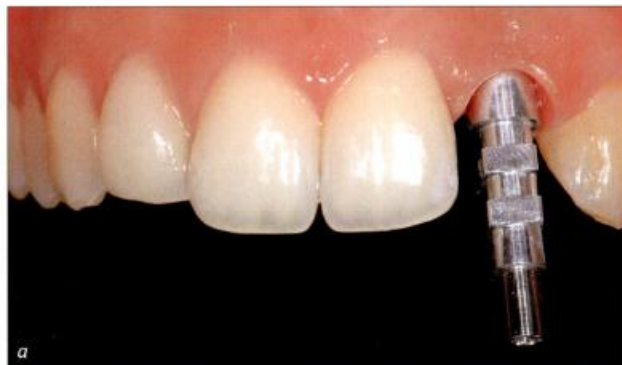
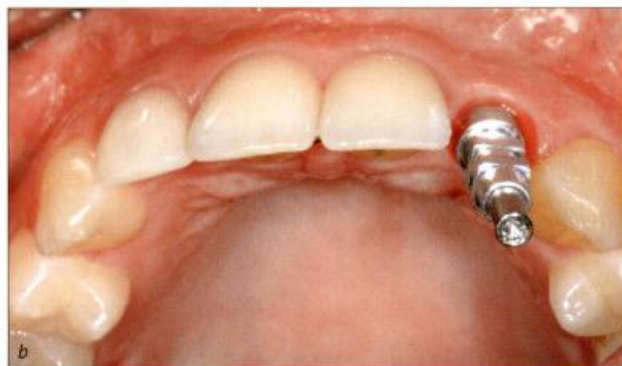
*Figs 16a, b A NN impression cap was screw-tightened on the implant shoulder.*

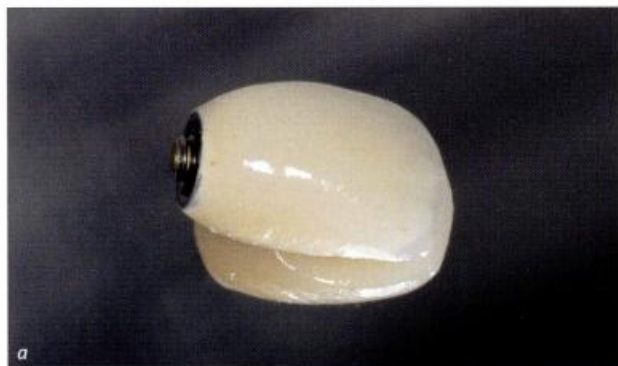
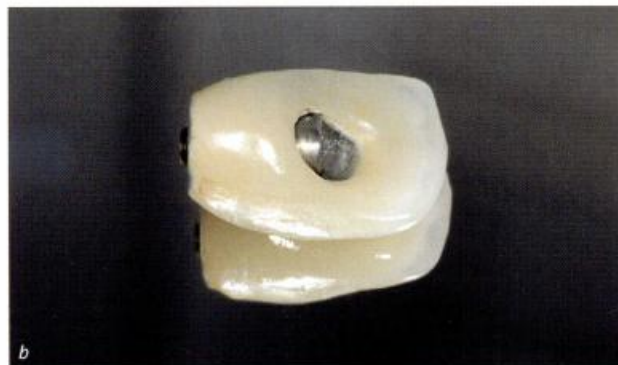
*Figs 17a, b The final transocclusally screw-retained ceramo-metal crown ready for insertion.*

The implant axis had been planned to “exit” through the dental cingulum of the planned restoration, which made transocclusally screw-retained attachment mode possible (Fig 17a). The crown was fabricated using an NN framework blank made from an oxidizable alloy not suitable for casting-to, which was directly veneered with veneering ceramics (Fig 17b).

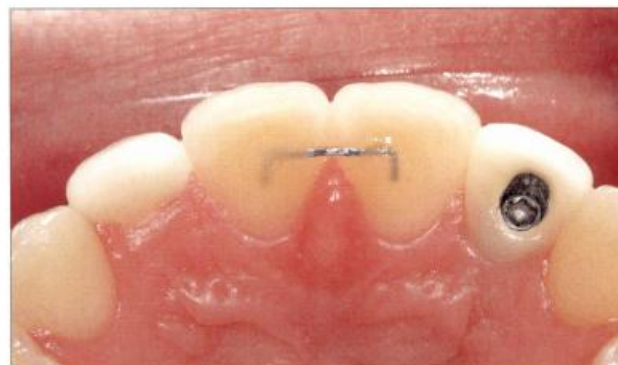
*Fig 18 Situation after tightening of the occlusal screw at 35 Ncm, ready for sealing the screw access hole.*

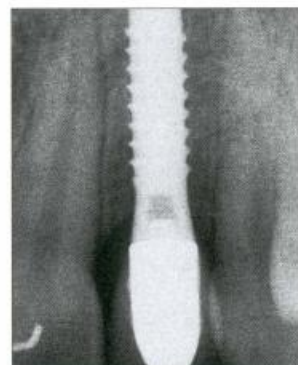
*Fig 19 The crown was precisely seated on the implant shoulder.*

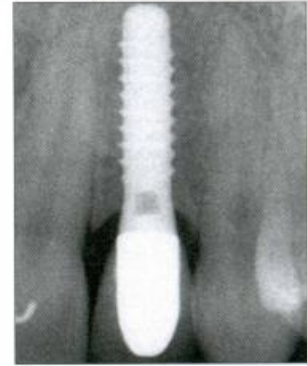
Fig 20 Two-year follow-up radiograph.

In 2004, two years after crown insertion, the follow-up periapical radiograph confirmed stable peri-implant bone-crest levels (Fig 20).

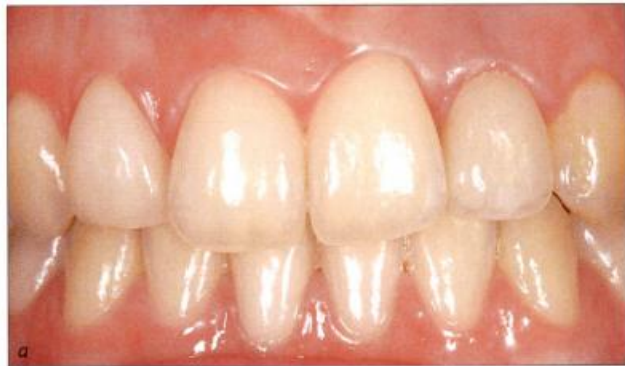
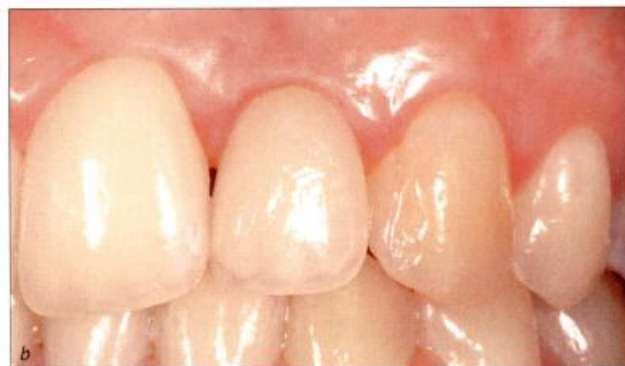
Figs 21a, b The two year follow-up showed stable and esthetically pleasing soft-tissue contours.

At the same visit, the peri-implant tissues were inspected. Facial and interproximal tissue support was ideal, with excellent soft-tissue stabilization (Fig 21).

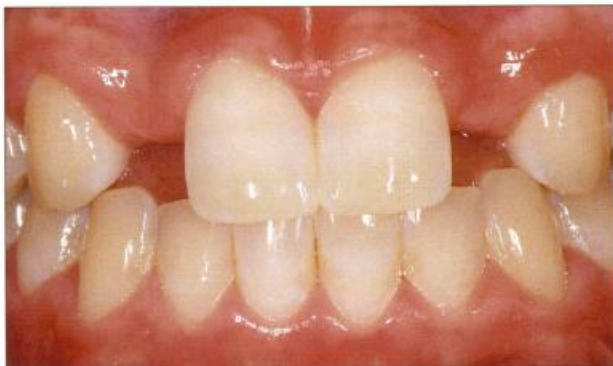
*Fig 2a Retracted anterior view showing virgin teeth adjacent to the edentulous spaces and a medium gingival biotype with moderate scalloped papillae and medium-thick tissue. A thin band of keratinized tissue spanned the area from canine to canine.*

After a consultation on treatment options, the patient requested an implant-retained fixed restorative solution. A detailed examination of the teeth and periodontium adjacent to the edentulous spaces was performed to assess the potential for an esthetic result (Figs 2a-d).

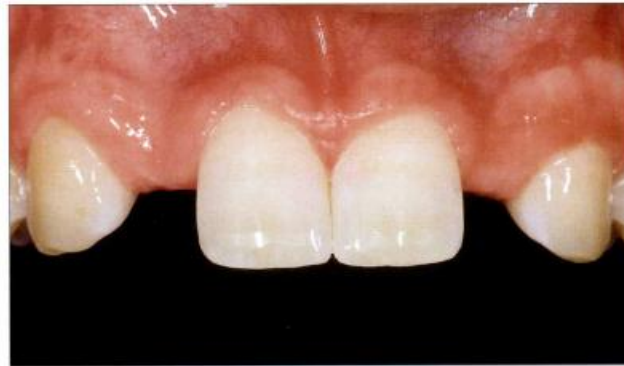
*Fig 2b Open-retracted view showing square-shaped teeth and irregular gingival margins between the canines and central incisors. Inadequate clinical crown exposure on tooth 23. The excess tissue height was favorable, as it allowed for modifications during the surgical procedures.*

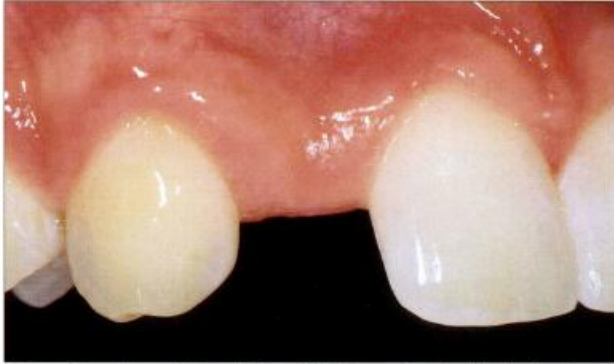
*Fig 2c* Open-lateral of teeth 13 and 11. Excess tissue height in the edentulous space, indicating a potential need for hard-tissue scalloping during implant placement to allow for proper vertical positioning of the implant shoulder. Probing depths were 2 mm around teeth 13 and 11.

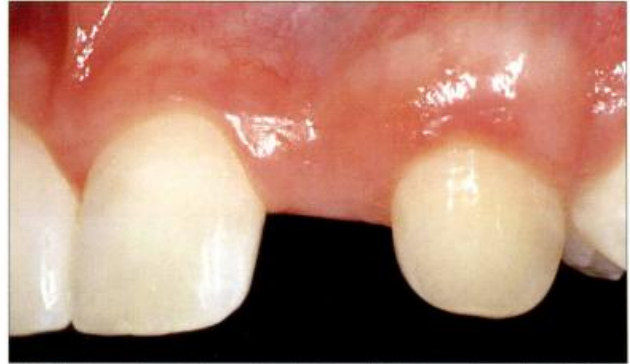
*Fig 2d* Open-lateral view of teeth 21 and 23. Excess tissue height in the edentulous space as well as on the facial side of tooth 23. The surgical procedures planned would address excess tissue problem. Probing depths were 2 mm around teeth 21 and 23.

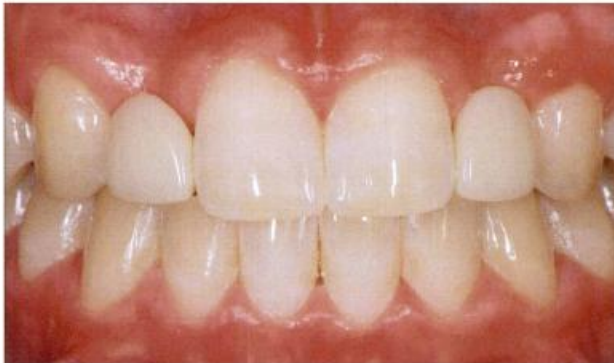
*Fig 3* The retracted anterior view with the removable interim prosthesis in place. Confirmation of the edentulous span (7 mm) was possible as the denture teeth were acceptable in size and shape.

The patient reported that orthodontic therapy had recently been completed and that the edentulous spaces were maintained with an interim removable prosthesis (Fig 3).

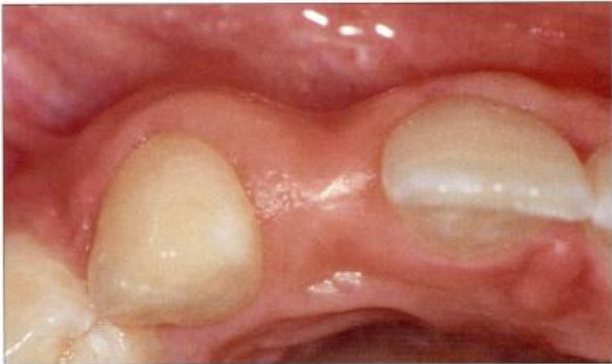
Fig 4a Occlusal view of the edentulous space at site 12, revealing a horizontal hard-tissue deficiency.

Close inspection of the denture teeth on the interim restoration indicated that adequate facial and interproximal tissue height existed to allow for tooth replacement with soft-tissue margins symmetrical to those of adjacent teeth. It was also apparent that the horizontal tissue thickness was inadequate to allow for a pleasant-looking "root-form" emergence of the definitive restorations. The occlusal view without the prosthesis in place confirmed these horizontal deficiencies (Figs 4a-c).

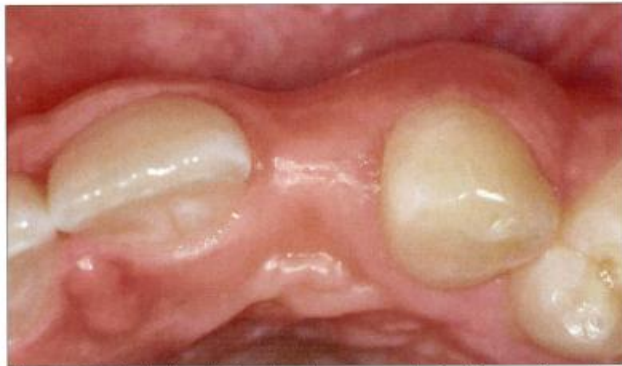
Fig 4b Occlusal view of the edentulous space at site 22, revealing a horizontal hard-tissue deficiency.

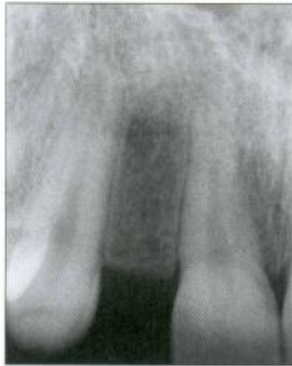
*Fig 5a* Periapical radiograph of site 12. Interproximal root space less than 7 mm, alveolar crest less than 5 mm from the desired contact point.

Examination of the periapical radiographs revealed ideal space between the roots of the adjacent teeth as well as an ideal height of the interproximal crests for papilla support (Figs 5a-b).

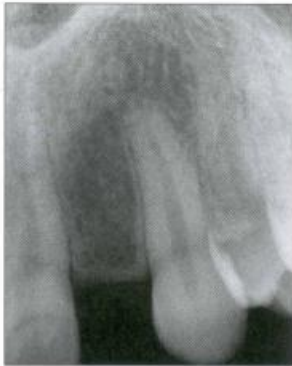
*Fig 5b* Periapical radiograph of site 22. Interproximal root space less than 7 mm, alveolar crest height less than 5 mm from desired contact point.

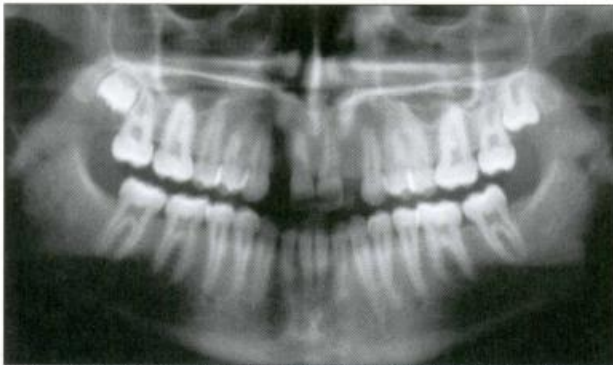
*Fig 6* The panoramic radiograph revealed potential donor sites in the ramus and chin areas.

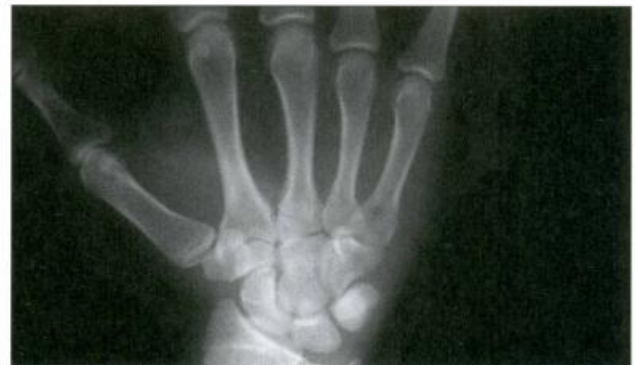
*Fig 7* A view of the hand-wrist film depicting fusion of the epiphysis and diaphysis of the middle phalanx and the degree of calcification of the ulnar sesamoid bone.

Consideration was given to the patient's age and predicted completion of growth. Unable to obtain serial lateral cephalographs, the best determinant of growth completion, a hand-wrist film was used to examine the fusion of the epiphysis and diaphysis of the middle phalanx and the degree of calcification of the ulnar sesamoid bone (Profit and coworkers, 1992) (Fig 7). In general, male patients above the age of 19 are good candidates for implant therapy. Risks associated with premature implant placement include delayed passive eruption of the anterior dentoalveolar segments and orthodontic relapse of the adjacent teeth with subsequent "intrusion" of the implant restorations. A correction will most often require replacement of the restoration or orthodontic retreatment.

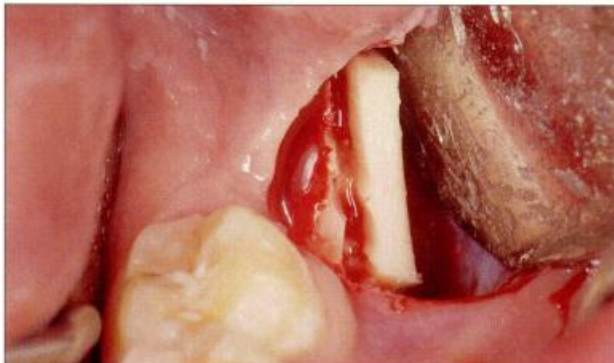
Fig 8b A straight fissure carbide bur was used to create a vertical section in the lateral portion of the ascending ramus.

Autographs and allografts were considered. Due to the patient's limited available treatment time, bilateral autogenous ramus grafts were indicated. A 1.5 x 1.5 cm donor block graft was harvested from the left ramus and sectioned into two 7 x 7 mm blocks (Figs 8a-d).

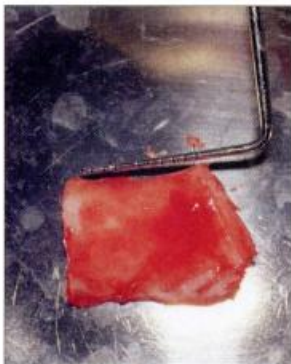
Fig 8c A 1.5 x 1.5 cm harvested donor block.

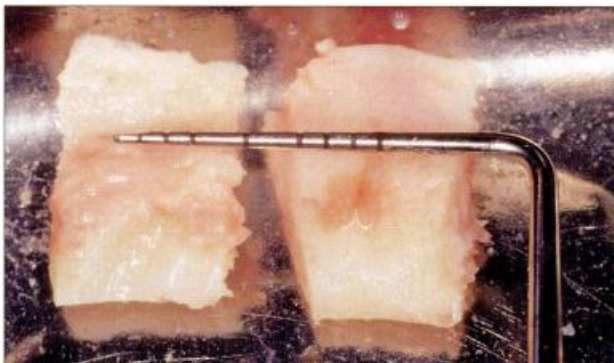
Fig 8d Two 7 x 7 mm blocks created from the donor block to be used for onlay grafting at sites 12 and 22.

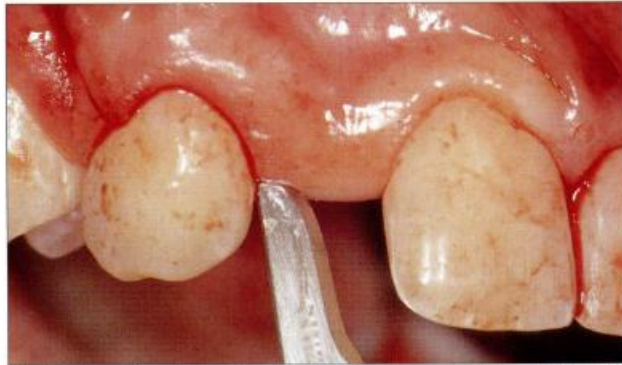
*Fig 9a* A mid-crestal incision at site 12 performed with a straight #12 blade.

A mid-crestal and a distal vertical releasing incision were executed, followed by a periosteal releasing incision. The periosteal releasing incision allowed for placement of the donor block and membrane, followed by tension-free closure (Figs 9a-p).

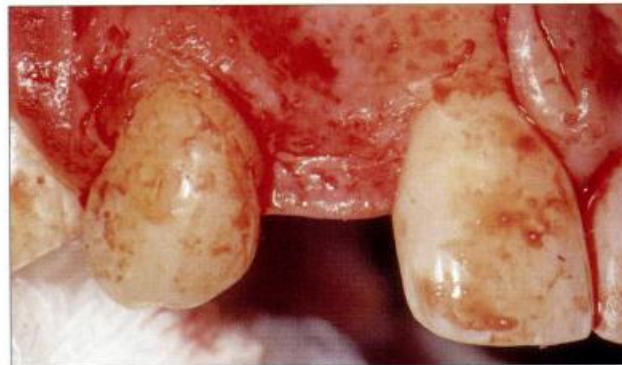
*Fig 9b* Elevation of the tissue and removal of any soft-tissue residue on the surface of the bone.

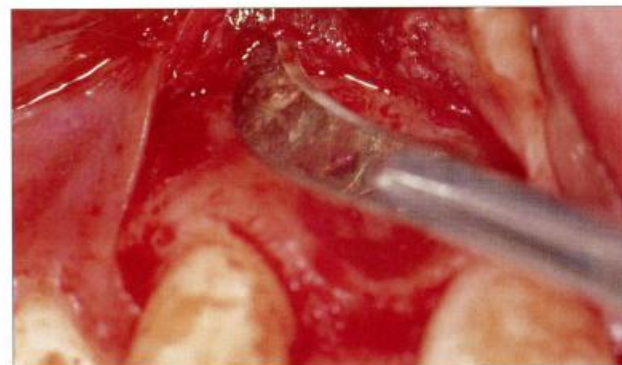
*Fig 9c* Periosteal releasing incision performed with a curved #15c blade.

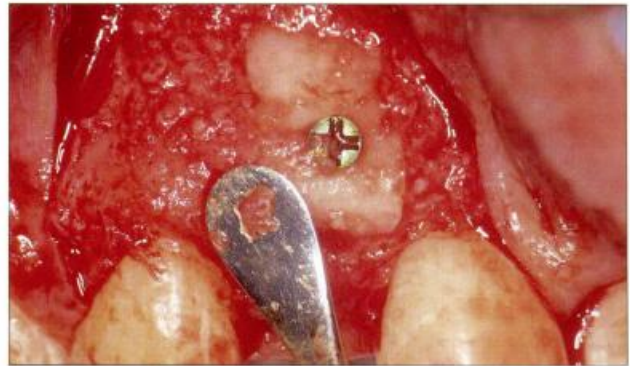
Fig 9f Cancellous bone collected during the preparation procedures was packed around the block before covering it with the membrane.

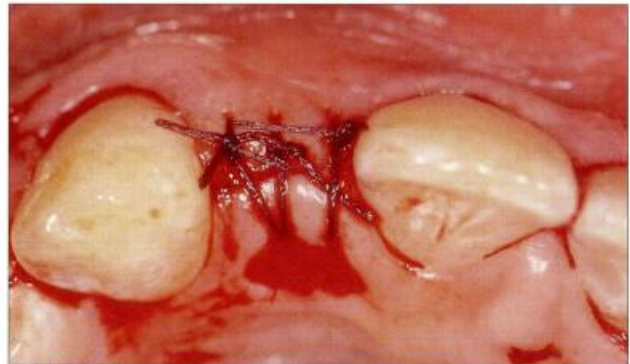
Fig 9h Occlusal view after suturing.

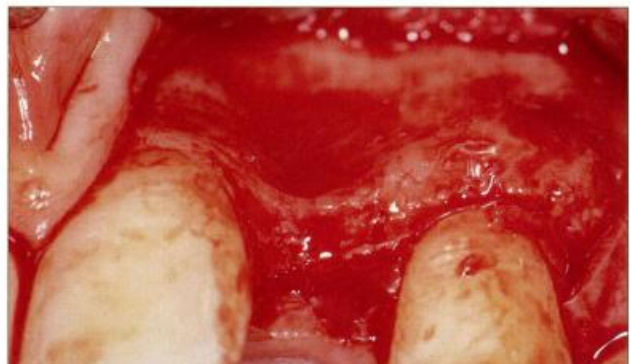
Fig 9j Elevation of the tissue and removal of any soft-tissue residue on the surface of the bone.

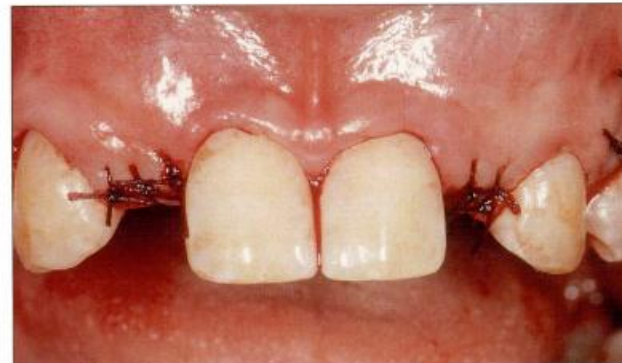
Fig 9p Frontal postoperative view.

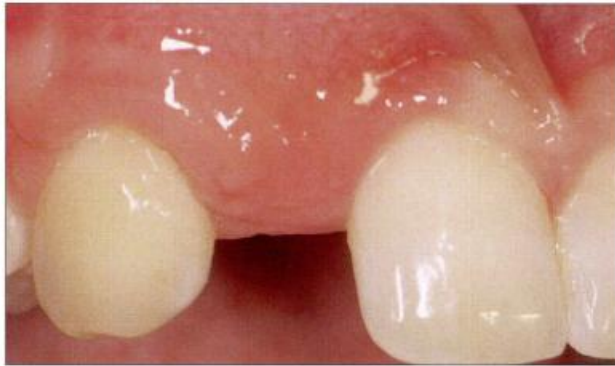
Fig 10a Lateral view of edentulous site 12, three months after grafting.

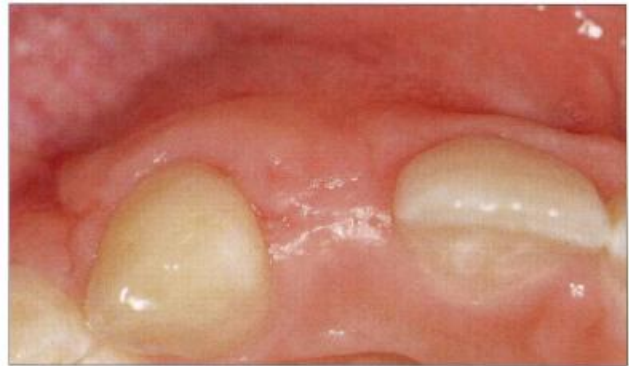
Fig 10b Occlusal view highlighting width gained.

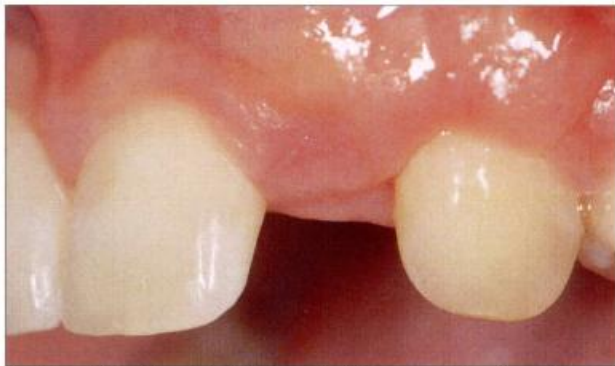
Fig 10c Lateral view of edentulous site 22, three months after grafting.

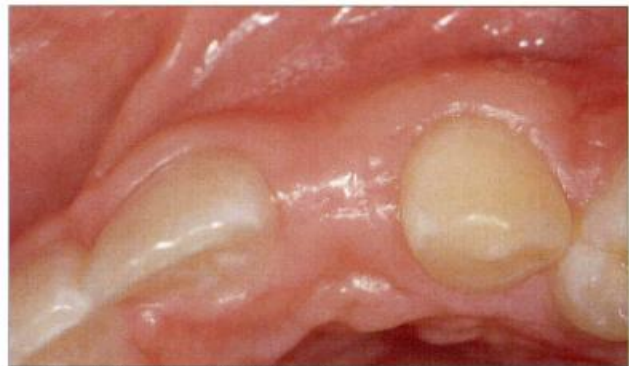
Fig 10d Occlusal view highlighting width gained.

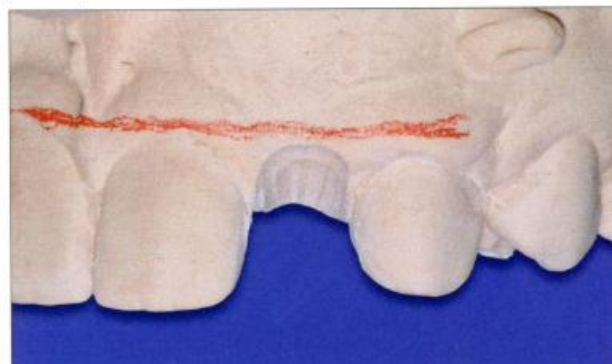
Fig 11e Lateral view of site 22 highlighting the scalloping performed to place the soft-tissue margin slightly superior to the red line connecting the gingival margins of teeth 21 and 23.

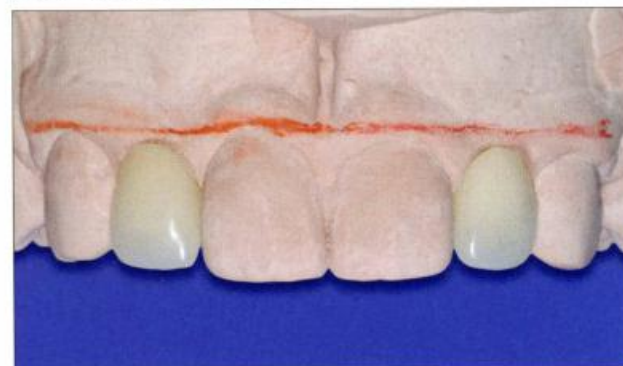
Fig 11f Frontal view of the diagnostic waxup.

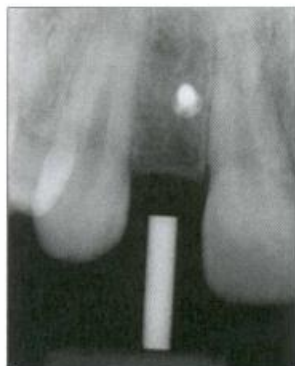
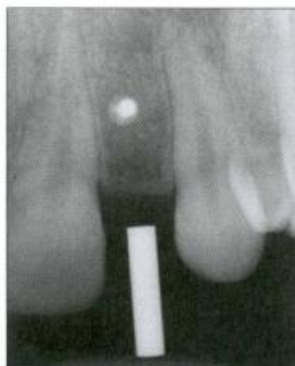
Fig 12a Periapical radiograph with the radiographic template in place.

Fig 12b Periapical radiograph with the radiographic template in place.

Once the planned restorations were determined, a radiographic template was fabricated for surveying before the fabrication of the surgical template (Figs 12a, b). The template utilized a rod 10mm in length and 2.2mm in diameter and indicated the proposed implant position. Coronal tissue thickness and radiographic distortion could be accounted for based on the known dimensions of the rod. This assisted the surgeon in selecting the ideal implant length for the site.

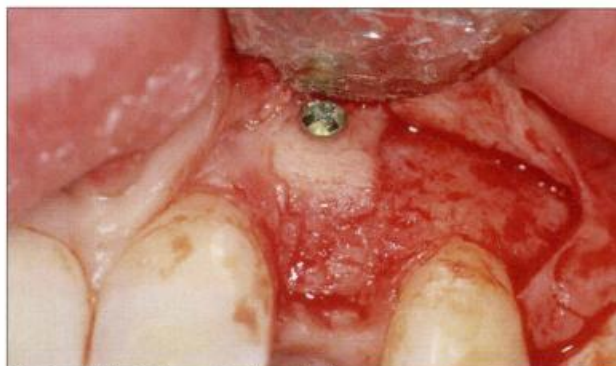
Fig 13 Minimal tissue reflection allowing access to the titanium retaining screw at site 22.

Upon confirmation of the radiographic survey, the surgical template was fabricated. At the time of surgery, a minimal tissue reflection was performed to obtain access to the retaining screw (Fig 13). A 0.5mm template (vertical template) highlighting the proposed mucosal margin of the implant restoration was placed. Scalloping of the osseous crest was performed to allow for the placement of the implant shoulder approximately 2mm apical of the zenith of the vertical template (Figs 14a, b).

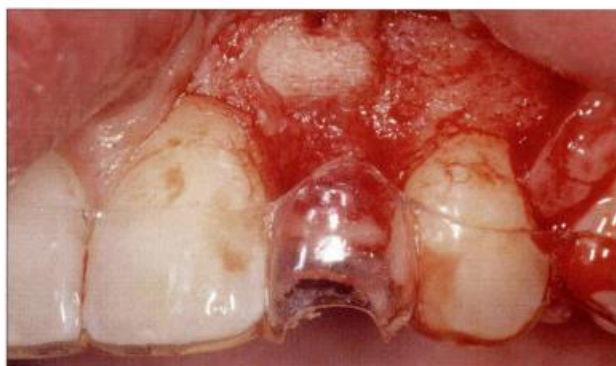
Fig 14a Upon placement of the vertical template, the excess height of hard tissue can be appreciated.

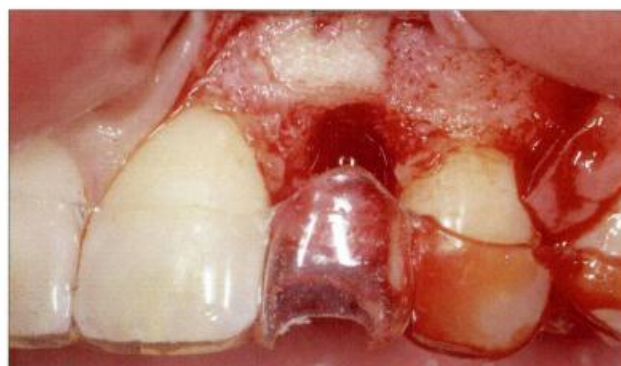
Fig 14b After scalloping. Osseous crest located at a position that allows for the vertical placement of the dental implant shoulder, 2mm apically of the proposed mucosal restorative margin.

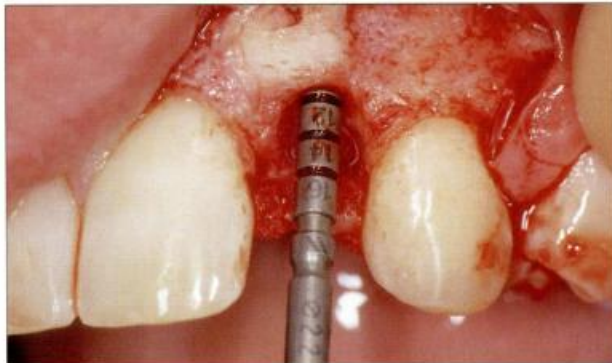
Fig 15c Confirmation of the initial depth of the osteotomy with the 2.2-mm alignment pin.

Once the hard tissue scalloping was completed, a 1.0 mm template with drill sleeve was placed that allowed for the preparation of the osteotomy site while directing orofacial and mesiodistal angulations (Figs 15a-e). The site was prepared for a Narrow Neck implant 12 mm in length. Upon completion of the osteotomy, the implant was placed with close regard to the vertical position of the shoulder.

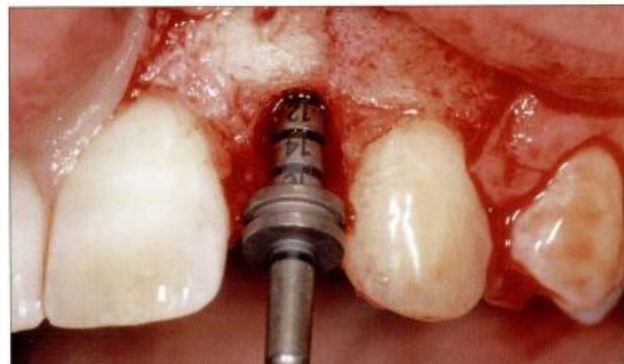
Fig 15e Confirmation of osteotomy depth and angulations with the 2.8-mm depth gauge.

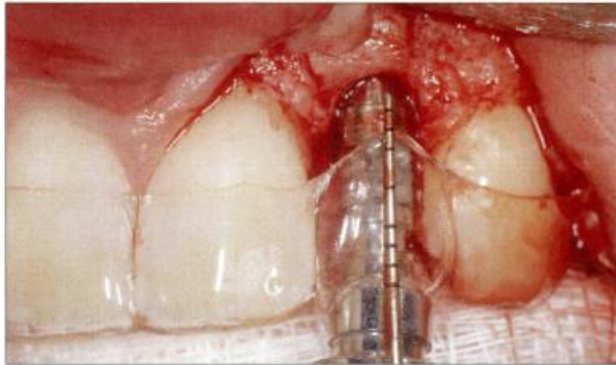
*Fig 16a* Before the removal of the transfer post, the vertical depth of the implant was confirmed using the vertical template.

Before the removal of the transfer post, the vertical template was used to help confirm the proper implant depth (Figs 16a-c).

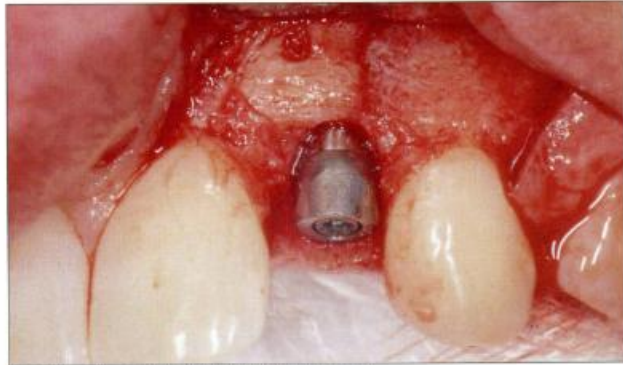
Fig 17a Placement of the NN healing cap.

After removal of the transfer post, the healing cap was placed and the tissue closed with a 4-0 vicryl suture (Figs 17a, b). The patient was sent for a postoperative radiograph while the interim restoration was adjusted to prevent contact with the healing cap under function (Fig 18). The patient was scheduled for a follow-up appointment after one week.

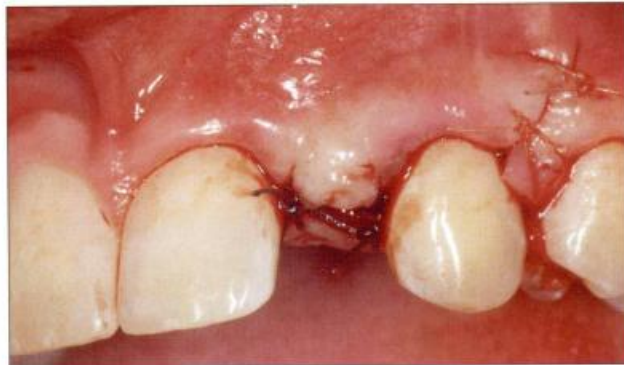
Fig 17b After surgical suturing.

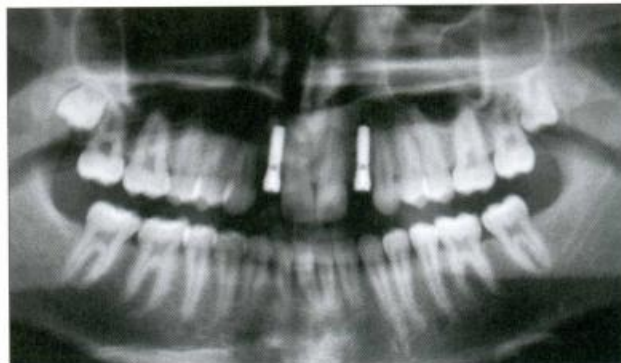
Fig 18 Postoperative panoramic radiograph confirming final implant angulations.

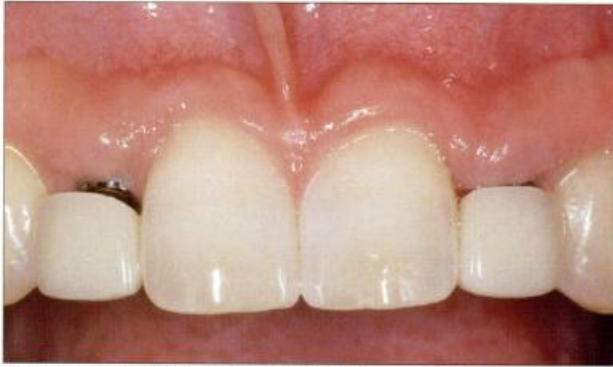
Fig 19a Six weeks after implant placement.

Six weeks after implant placement, the patient was scheduled for a loading visit (Figs 19a-e). At that appointment, provisional restorations were fabricated that would initiate maturation of the transition zone. As mentioned in Chapter 1.2, the transition zone is the emergence created from the shoulder of the implant to the soft-tissue margin.

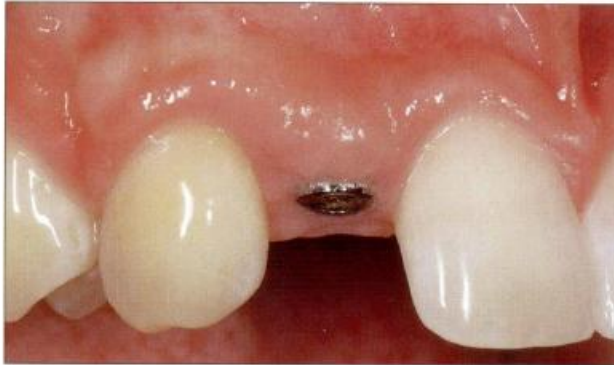
Fig 19b Lateral view of implant 12 implant six weeks after implant placement.

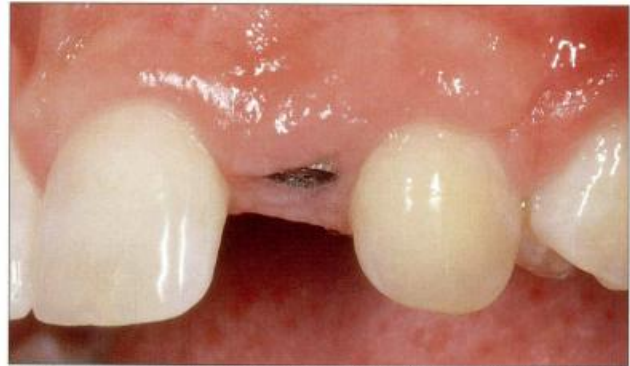
Fig 19d Lateral view of implant 22 six weeks after implant placement.

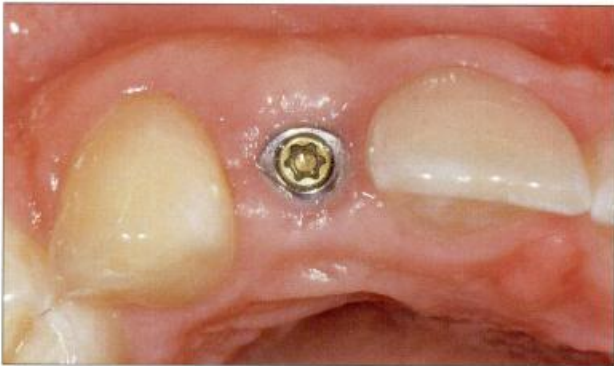
Fig 19c Occlusal view of implant 12 six weeks after implant placement.

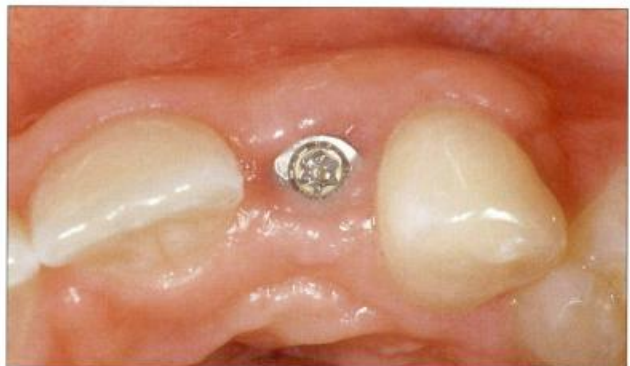
Fig 19e Occlusal view of implant 22 six weeks after implant placement.

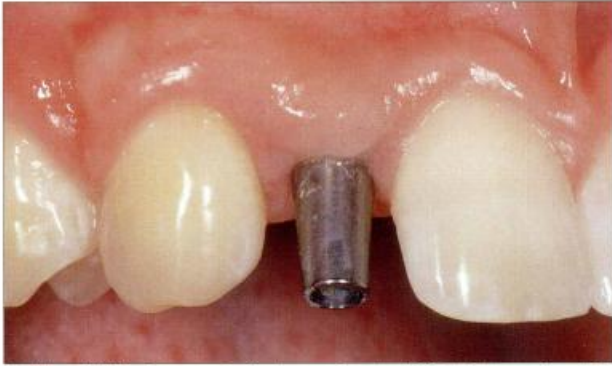
Fig 20a NN titanium coping in place on implant 12. A high-speed carbide bur was used to mark indicator grooves (mid-facial, interproximal, palatal, and gingival) to assist with extraoral preparation.

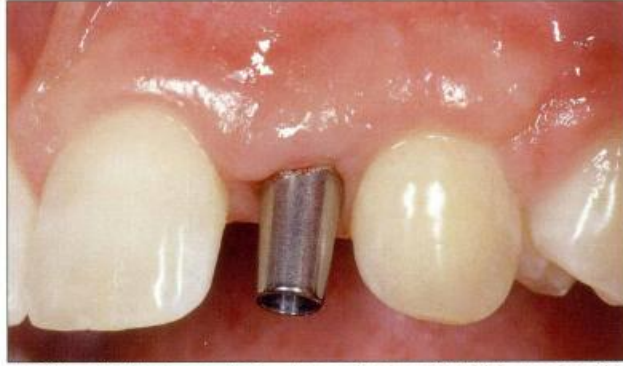
Fig 20b NN titanium coping in place on implant 22. A high-speed carbide bur was used to mark indicator grooves (mid-facial, interproximal, palatal, and gingival) to assist with extraoral preparation.

After placement of the NN titanium copings on the implants and tightening to 15 Ncm, indicator grooves were prepared on the surface with a high-speed carbide bur to help obtain the correct reduction and angulations while the definitive finishing was performed extraorally (Figs 20a-d). In general, titanium should not be prepared intraorally in order to avoid impregnating the tissue with titanium particles.

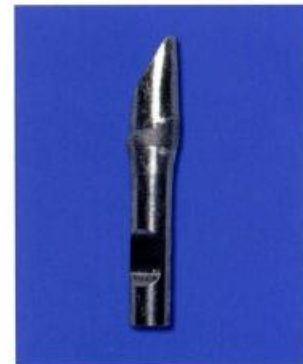
Fig 20d Final preparation design of the titanium coping.

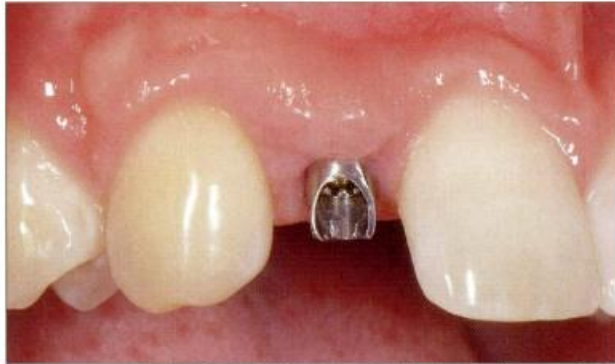
Fig 21a Lateral view of the NN implant 12 with the titanium coping in place. The access hole was covered with cotton, and a polycarbonate crown was relined over it.

Once the custom preparation was complete, the copings were placed on the implants and the access holes blocked with cotton before the prefabricated polycarbonate crowns were relined (Figs 21a, b).

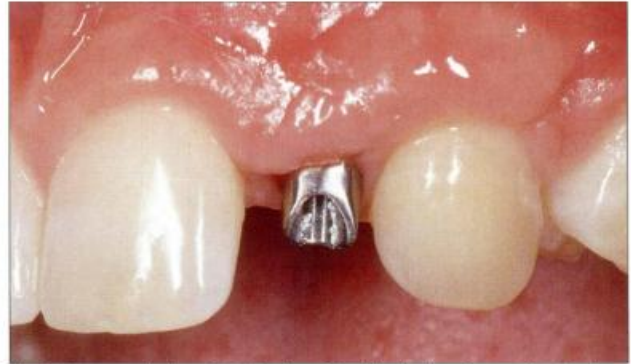
Fig 21b Lateral view of NN implant 22 with the titanium coping in place. The access hole is covered with cotton, and a polycarbonate crown was relined over it.

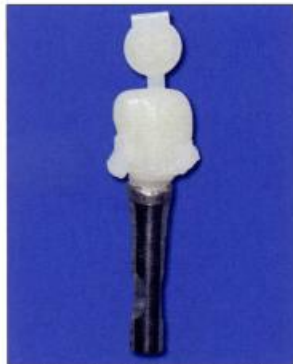
Fig 22a Facial view of provisional crown 12 on the titanium coping and laboratory analog after the relining procedure.

Once the provisionals had set intraorally, they were removed along with the copings and placed onto laboratory analogs (Figs 22a, b). Composite resin was added to create an emergence profile from the coping margin to the contact point, establishing the transition zone. Creating interproximal emergence requires straight or slightly convex support from the coping margin through the tissue to the contact point (Fig 23). The facial emergence contour was straight or concave from the coping margin to the proposed position of the mucosal margin, at which point it becomes convex (Fig 24). This convexity will help establish the final position of the mucosal margin of the implant restoration.

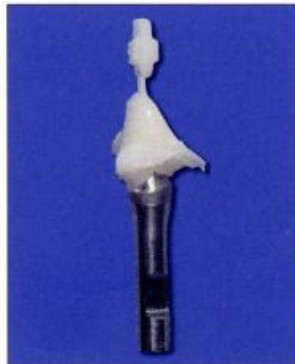
Fig 22b Lateral view of provisional crown 12 on the titanium coping and laboratory analog after the relining procedure.

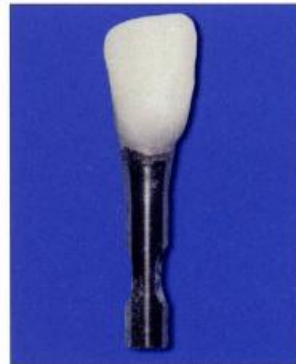
Fig 23 Composite resin was added to the interproximal surfaces to create support for the peri-implant tissue, supporting the papillae.

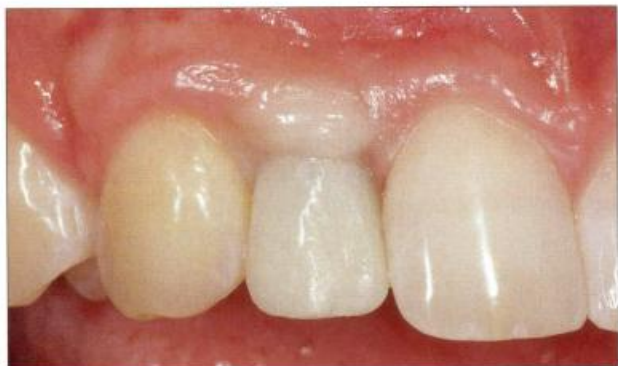
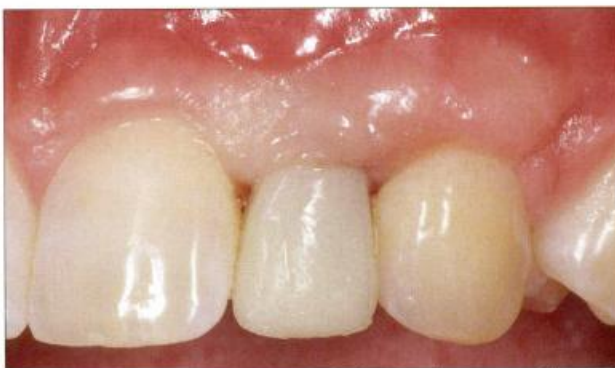
*Fig 25a Tissue blanching immediately after the placement of the provisional on implant 12.*

*Fig 25b Tissue blanching immediately after the placement of the provisional on implant 22.*

Once the emergence modifications of the provisionals were completed, the copings were placed back on the implants, tightened to 15 Ncm, covered with cotton, and the provisionals were seated. Blanching of the tissue is often evident (Figs 25a, b). In general, if the blanching subsides within 10 minutes, no reduction in the emergence profile or removal of tissue is necessary (Figs 26a, b).

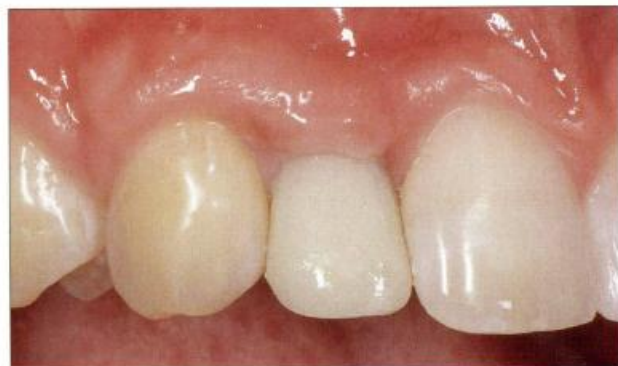
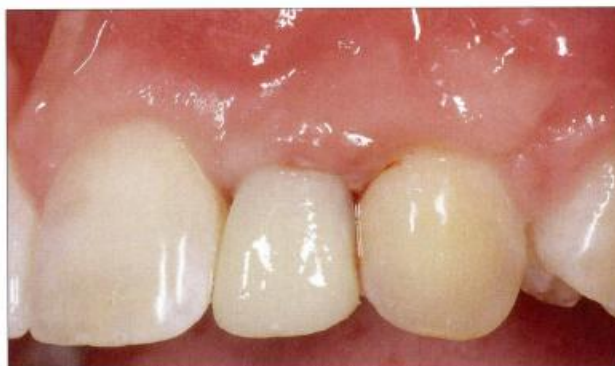
*Fig 26a Reduction in blanching noticed after 10 minutes.*

*Fig 26b Reduction in blanching noticed after 10 minutes.*

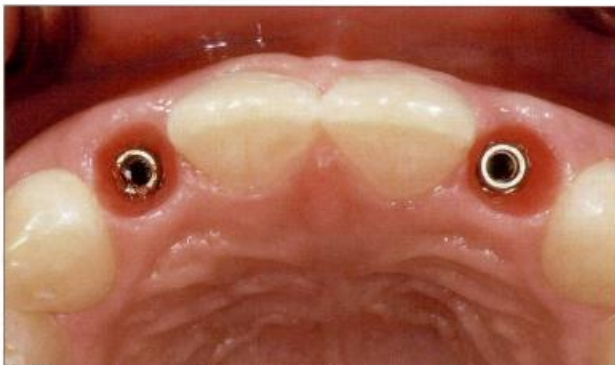
*Fig 28* Occlusal view of implants highlighting the transition zone created by the provisionals.

In general, if dental bleaching is planned, it is performed during the 4-week tissue-maturation phase. After removal of the provisionals and copings, the tissue maturation in the transition zone can be appreciated (Fig 28).

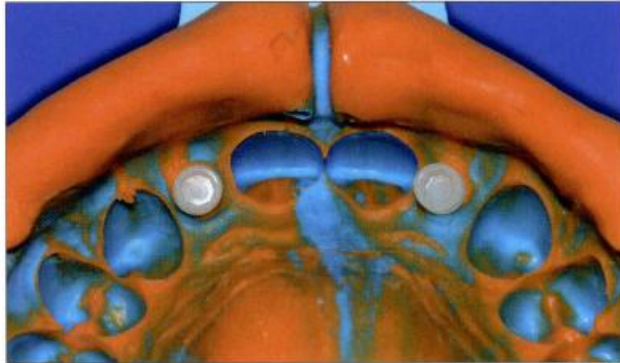
Fig 29 The polyvinyl siloxane impression with NN snap-on impression caps.

Before the final impression, the shade was taken using photographs and communicated to the laboratory. NN snap-on impression caps were placed on the implants and a polyvinyl siloxane impression was made (Fig 29).

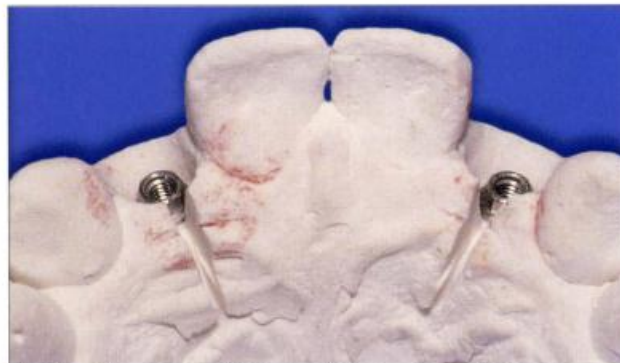
Fig 30b Master cast for fabrication of final copings and restorations.

In the laboratory, NN laboratory analogs were inserted into the final impression, into which a low-expansion die stone was then poured (Figs 30a, b).

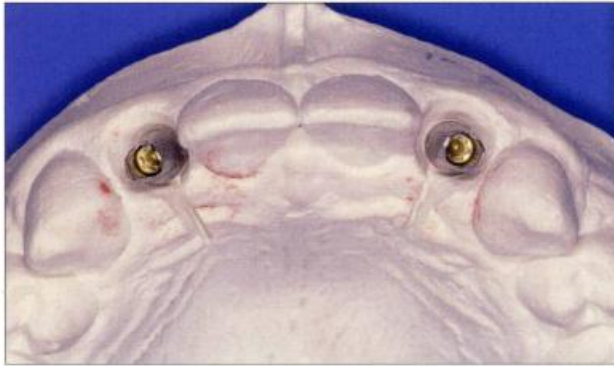
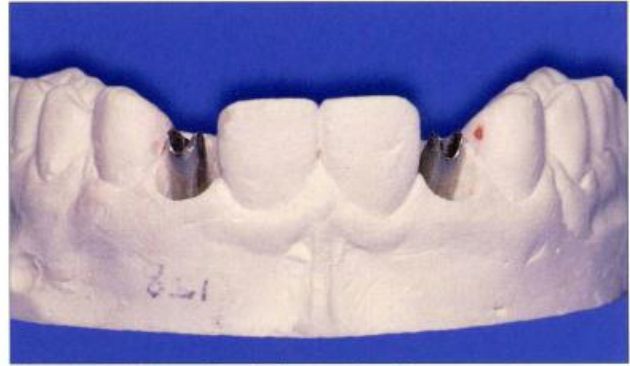
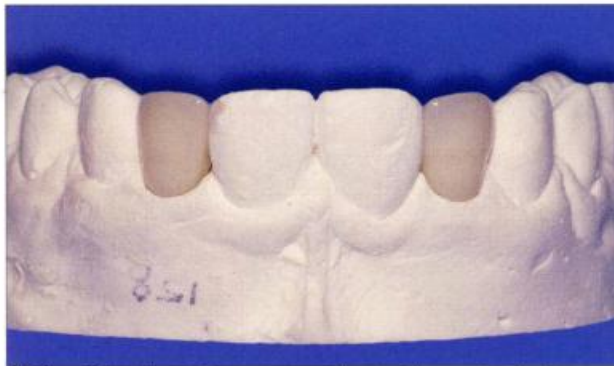
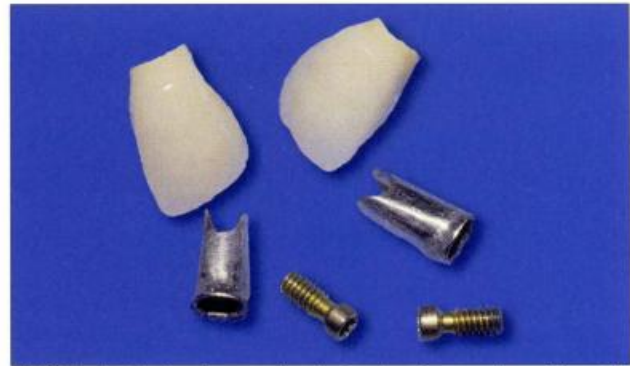
Fig 31a Occlusal view of the titanium copings after preparation.

Fig 31b Facial view of the titanium copings after preparation.

Fig 31c Facial view of the ceramo-metal restorations on the titanium copings.

Fig 31d Final restorations and customized copings as returned from the laboratory.

Two new NN titanium copings were used to fabricate the final custom copings and ceramo-metal restorations (Figs 31a-d).

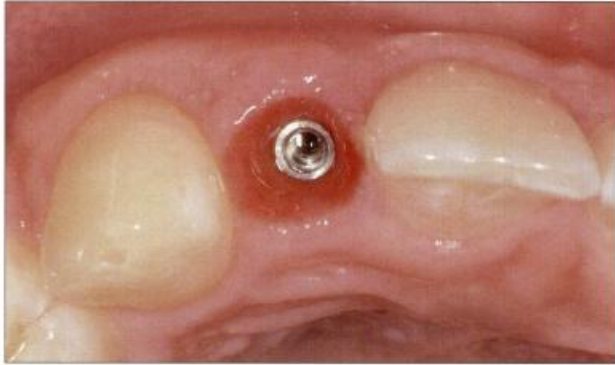
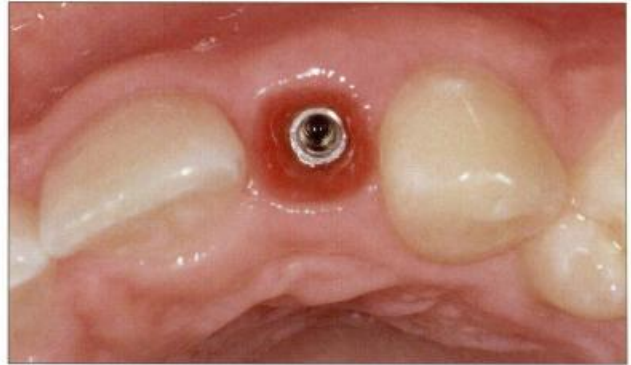
*Fig 33a Occlusal view of implant 12 after irrigation and before the insertion of the definitive coping. The transition zone was mature.*

*Fig 33b Occlusal view of implant 22 after irrigation and before the insertion of the definitive coping. The transition zone was mature.*

The implants were irrigated with an air-water syringe before inserting the definitive copings (Figs 33a, b).
