ITI Treatment Guide  
Volume 1

# Treatment Guide

Volume 1

Implant Therapy in the Esthetic Zone  
Single-Tooth Replacements

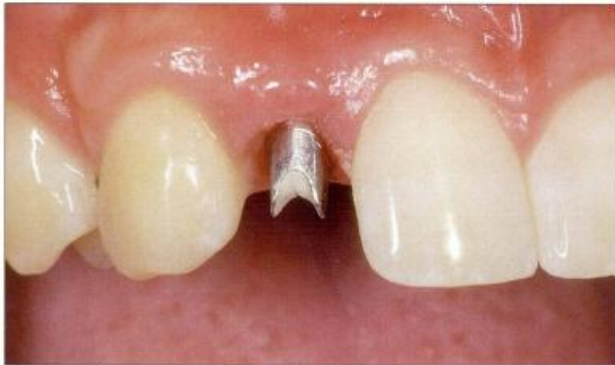
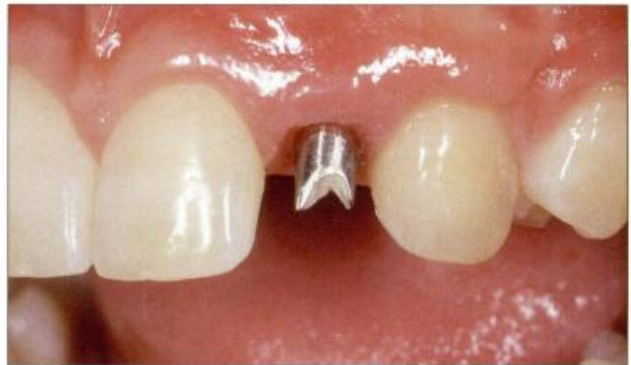
*Fig 34a After insertion of the definitive customized titanium coping for tooth 12, torqued to 35 Ncm, and sealed with cotton and Cavit.*

*Fig 34b After insertion of the definitive customized titanium coping for tooth 22, torqued to 35 Ncm, and sealed with cotton and Cavit.*

Once the fit and shade of the final restorations were confirmed, the coping screws were tightened to 35 Ncm. The screw access hole was covered with a cotton pellet and sealed with Cavit (3M Espe) (Figs 34a, b).

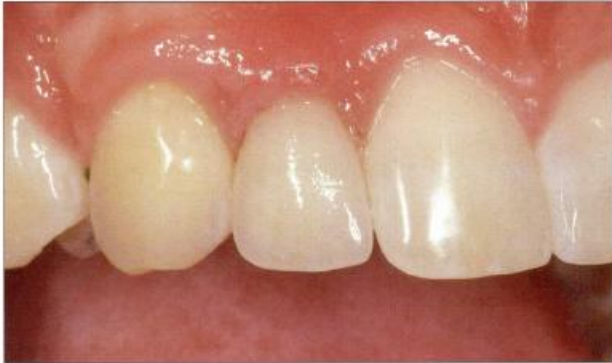
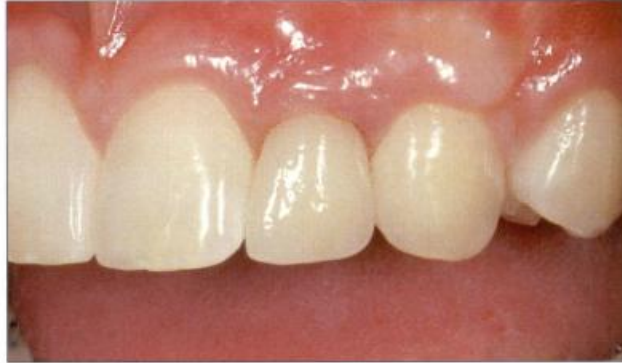
Fig 35a Final restoration after delivery.

Fig 35b Final restoration after delivery.

The final restorations were cemented with a permanent cement and the occlusion was adjusted to a light shim-stock pull (Figs 35a, b). Adjustments to the ceramic surface were followed by a polishing procedure with diamond-impregnated discs that help to create a glaze-like surface on the ceramic.

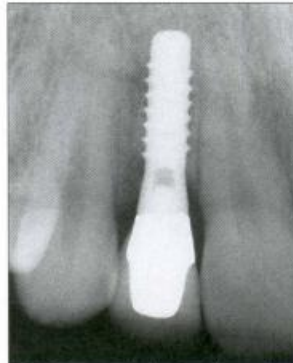
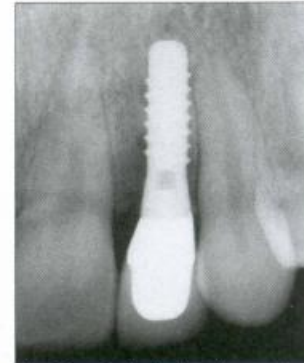
Fig 36a Periapical radiograph of implant 21 after insertion of the final restoration.

Fig 36b Periapical radiograph of implant 22 after insertion of the final restoration.

Periapical radiographs were taken and the patient was scheduled for a three-week follow-up (Figs 36a, b).

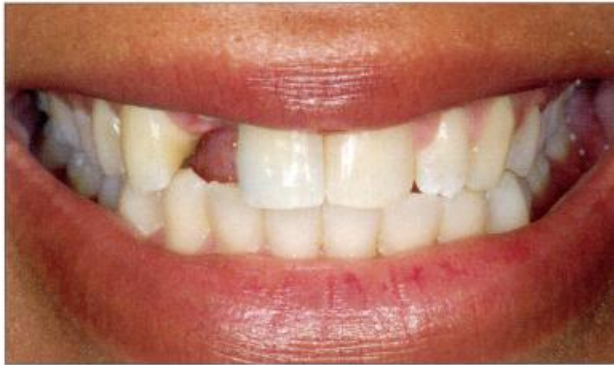
*Fig 1 At full smile, the patient presented with a medium lip line, displaying the incisal and middle thirds of the clinical crowns and the tips of the papillae.*

A healthy 32-year-old female patient presented at the clinic for recementation of a resin-retained fixed partial denture (RRFPD) and for a consultation on treatment options to replace the congenitally missing tooth 12 (Fig 1). She desired a more esthetic and functional treatment option than her current one.

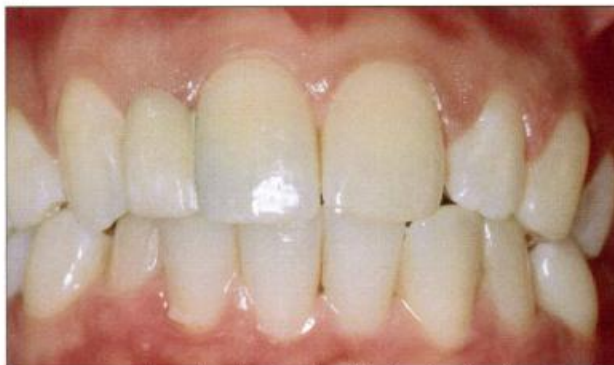
*Fig 2 Retracted anterior view showing discolored teeth adjacent to the edentulous space, a medium gingival biotype with moderately scalloped papillae and medium-thick tissue. A moderate band of keratinized tissue spanned from canine to canine.*

A detailed examination of the teeth and periodontium adjacent to the edentulous space was performed to assess the esthetic risk for implant therapy. The intraoral exam revealed a pre-existing metal-reinforced RRFPD replacing tooth 12. Discoloration of teeth 13 and 11 due to the large metal retainers on the prosthesis was evident. The patient reported several occasions on which the prosthesis had debonded and had to be reinserted. It had become a nuisance for her, and she wanted a more permanent solution. Upon comparison of the adjacent lateral incisors, the mesiodistal width of 12 was slightly smaller and 22 was slightly undercontoured in its incisal embrasure (Fig 2).

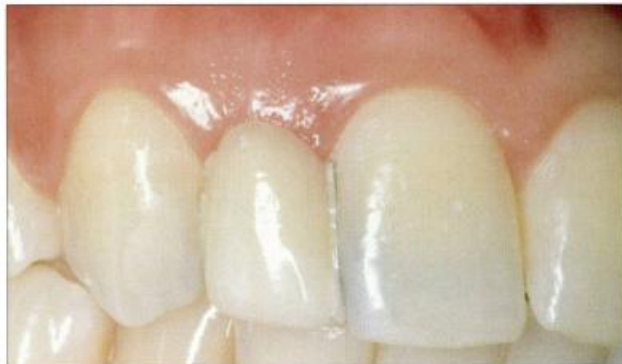
*Fig 3 Lateral view revealing square-shaped teeth and harmonious gingival margins between the canine and central incisor. Broad contact points were evident at the retainers for tooth 12, which explained the esthetic problem.*

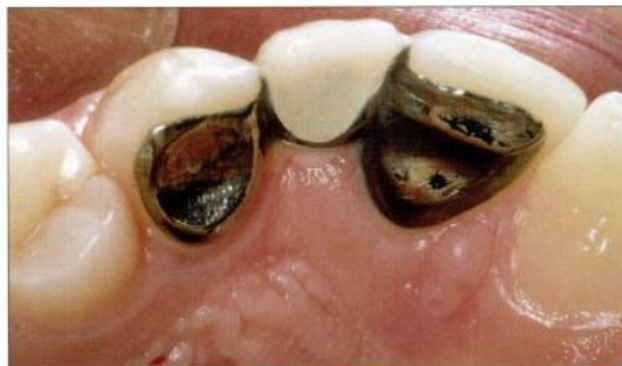
*Fig 4 An occlusal view from tooth 13 to tooth 11 showing the large metal retainers used in the resin-retained restoration.*

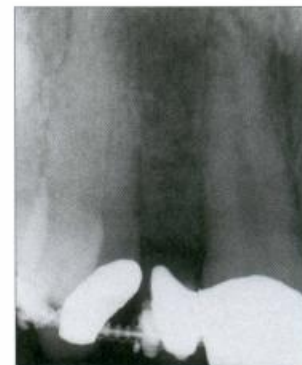
*Fig 5 Periapical radiograph of site 12. Interproximal root space less than 7 mm, alveolar crest height less than 5 mm from the desired contact point.*

Examination of the periapical radiograph revealed limited space between the roots of the adjacent teeth as well as adequate height of the interproximal crests for papilla support (Fig 5).

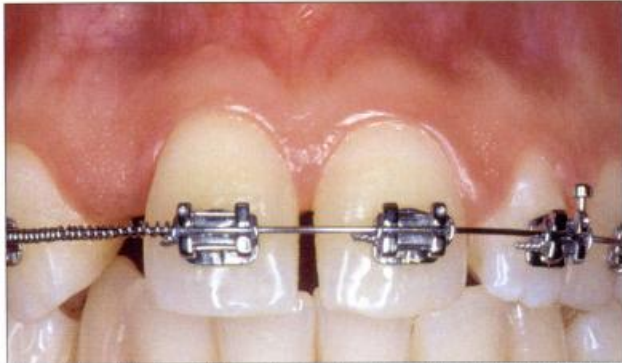
*Fig 6a Frontal view of the spring used on the orthodontic wire to create mesiodistal space.*

The mesiodistal space at site 12 was enlarged orthodontically by approximately 1 mm (Figs 6a, b).

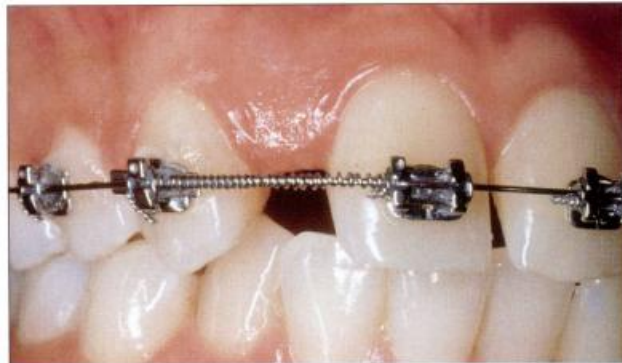
*Fig 6b Lateral view of site 12 during the orthodontic procedures.*

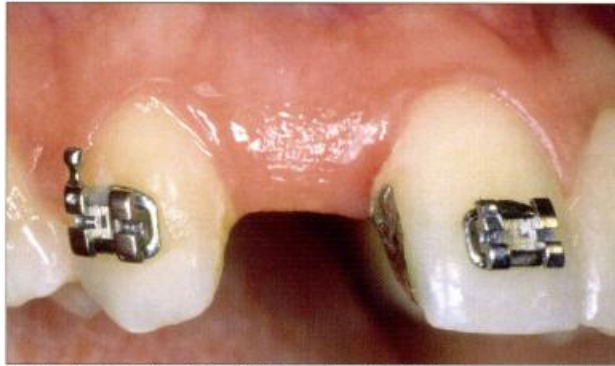
Fig 7a Lateral view of site 12. 7 mm of mesiodistal space was created.

The pre-treatment dimension of site 12 was 6 mm, and of tooth 22, 7 mm. If desired, a denture tooth could be bonded to a bracket and incorporated into the orthodontic archwire, providing esthetics while tooth movement occurs. Upon completion of the orthodontic treatment, the patient was seen before the removal of the brackets to confirm that ideal restorative space was generated (Figs 7a-c).

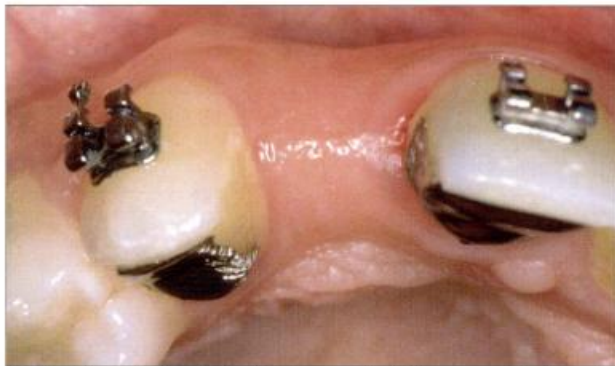
Fig 7b Occlusal view of site 12 shows good width compared to the adjacent teeth.

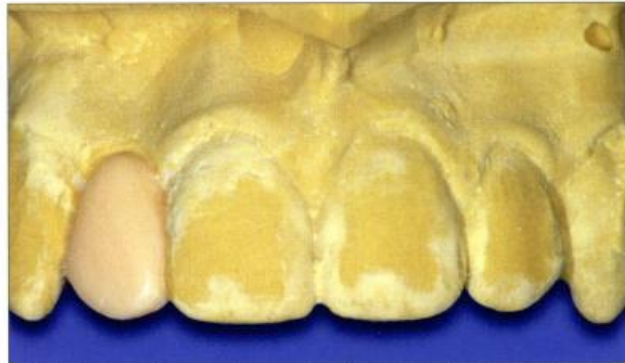
Fig 8a Diagnostic waxup for a restoration-driven plan for implant placement.

Before the removal of the braces, the patient returned for a data-collection visit, during which diagnostic casts were fabricated. A diagnostic waxup was completed in the laboratory and a radiographic template fabricated (Figs 8a-d).

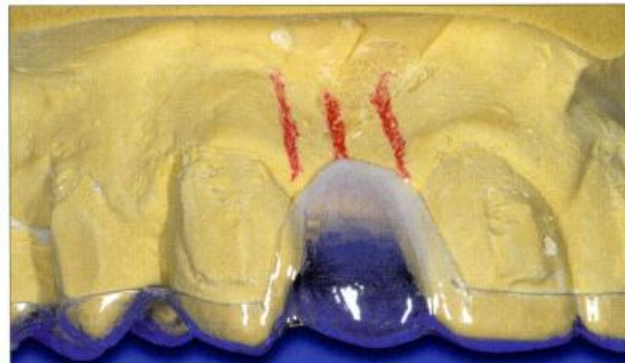
Fig 8b A Vacuform template of the diagnostic waxup.

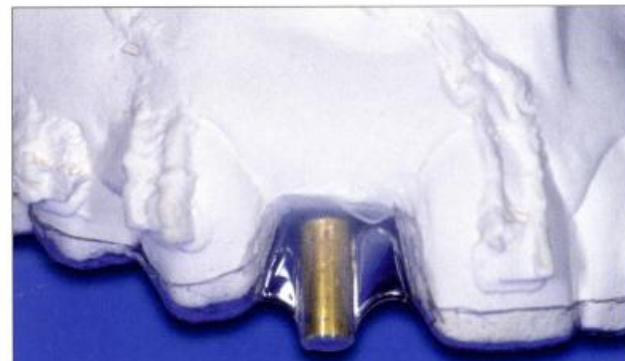
Fig 8d Radiographic template on the duplicated diagnostic cast.

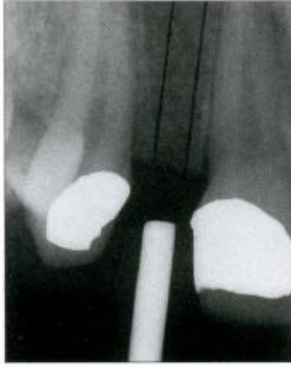
*Fig 9* Periapical radiograph showing the radiographic rod, highlighting the proposed implant mesiodistal angulation.

A periapical radiograph was taken with the template in place to confirm the planned implant position, avoiding the adjacent tooth roots (Fig 9). The surgical template was then fabricated based upon the confirmed radiographic pin position (Fig 10).

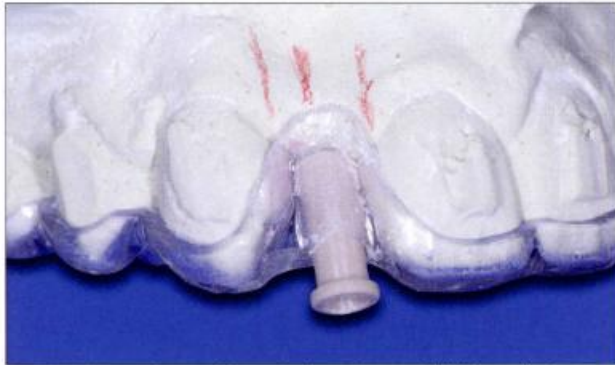
*Fig 10* Diagnostic cast with surgical template and drill sleeve in place.

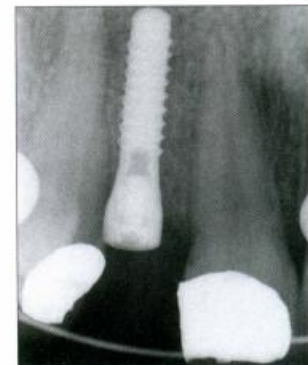
Fig 12c Postoperative radiograph.

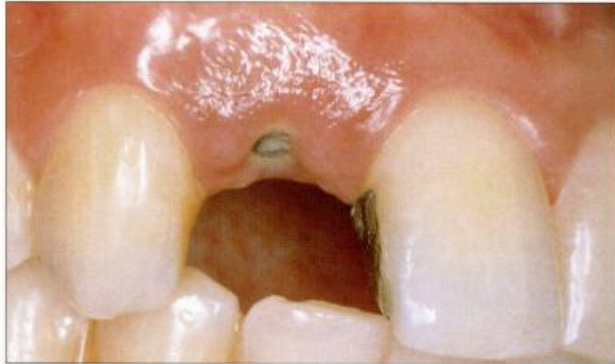
*Fig 13* Twelve weeks after implant placement. The healing cap was slightly exposed, allowing access to the implant shoulder without the need for tissue removal.

Twelve weeks after implant placement, the patient was scheduled for a loading visit (Fig 13). Loading of the NN implant occurred at twelve weeks because it had a titanium-plasma sprayed surface (TPS); all NN implants today have a sandblasted large-grit acid-etched (SLA) surface that allows loading after six weeks of healing.

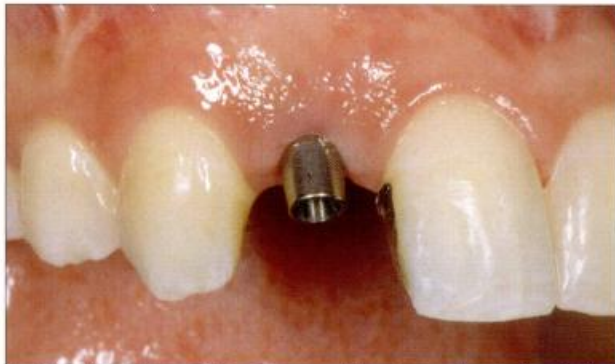
*Fig 14a* Lateral view with an unprepared titanium coping in place. Indicator grooves were made mid-facially and in any areas requiring reduction for interocclusal and interarch space.

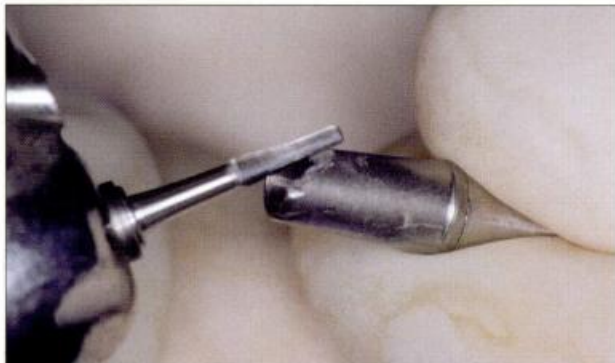
*Fig 14b* Extraoral preparation of the titanium coping with a high-speed carbide bur.

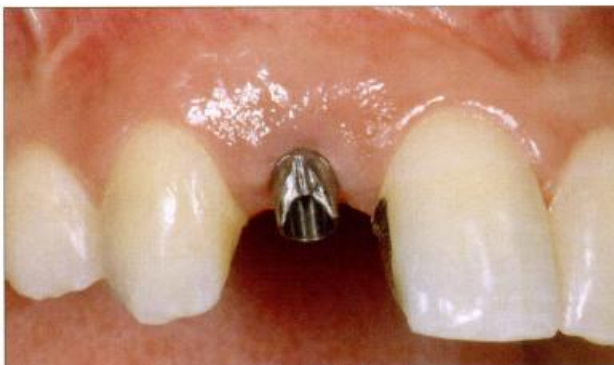
Fig 15 Lateral view with prepared coping in place.

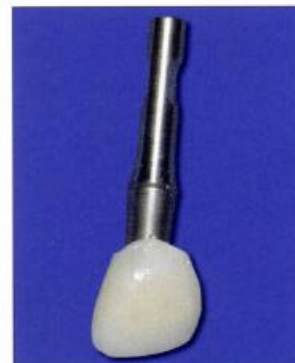
Fig 16 The provisional restoration on the coping and laboratory analog. Peri-implant tissue prevented the acrylic resin from extending submucosally, creating an overhang between the acrylic resin and the coping.

A vacuum retainer of the waxup was used with methyl-methacrylate resin to fabricate the provisional restoration. Once the provisional material had set intraorally, it was removed along with the coping and placed back onto a laboratory analog (Fig 16). Methyl methacrylate powder and monomer was mixed in a dappen dish and added to the provisional with a brush to create an emergence profile from the coping margin to the contact point, establishing support for the transition zone (Fig 17).

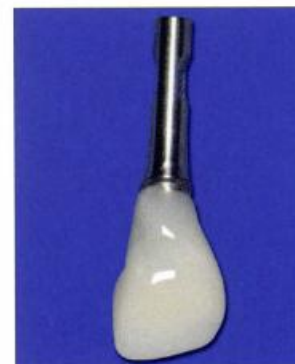
Fig 17 Acrylic resin was added to create an emergence profile to support the interproximal tissue and create a facial soft-tissue margin.

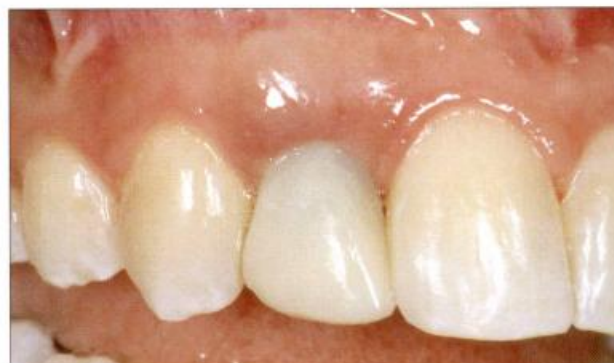
Fig 18 Lateral view after cementation of the provisional. The blanching of the tissue had subsided.

After the emergence modifications of the provisional were complete, the coping was returned to the implant and tightened to 15 Ncm and covered with cotton pellets, and the provisional was seated. Blanching of the tissue subsided within 10 minutes, so that the provisional was cemented with a temporary cement (Fig 18). The occlusion was adjusted and the patient was scheduled to return to the clinic for a final impression after four weeks.

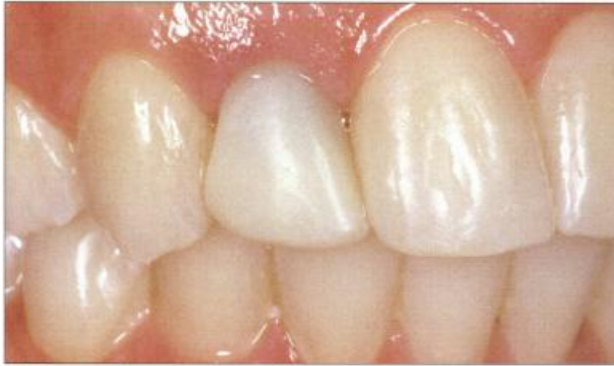
Fig 19 Lateral view four weeks after insertion of the provisional restoration.

The patient returned after four weeks for a final impression. The tissue had begun the maturation process, and the mucosal margin looked more refined (Fig 19).

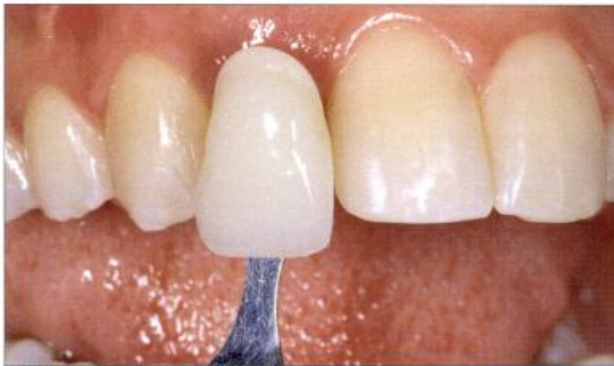
Fig 20a The selected shade tab in place.

Before the final impression, a periapical radiograph was taken and the correct shade determined (Figs 20a, b).

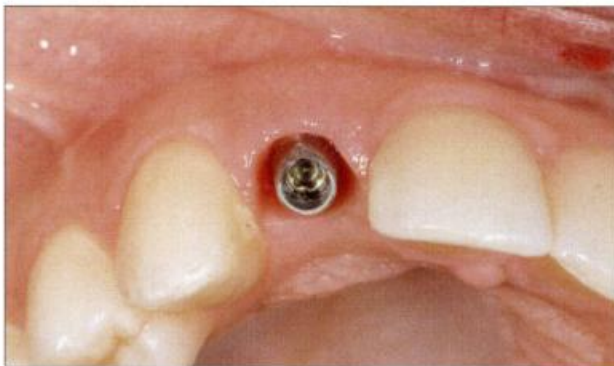
Fig 21 Occlusal view of the coping and transition zone after removal of the provisional restoration.

Upon removal of the provisional restoration, the matured transition zone was exposed (Fig 21).

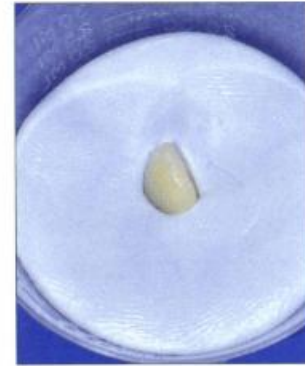
*Fig 22a* Fabricating a custom impression cap. The provisional on the titanium coping and analog are embedded in silicone putty.

The tissue scallop created by the provisional was larger than the diameter of the impression cap. To prevent the collapse of this tissue as the impression was taken, a custom impression cap was fabricated extraorally from the provisional restoration (Figs 22a-c).

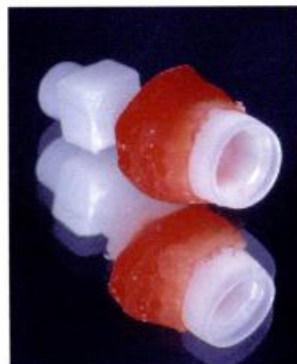
*Fig 22c* Fabricating a custom impression cap. The modified impression cap upon removal from the putty matrix. The pattern resin has captured the transition zone.

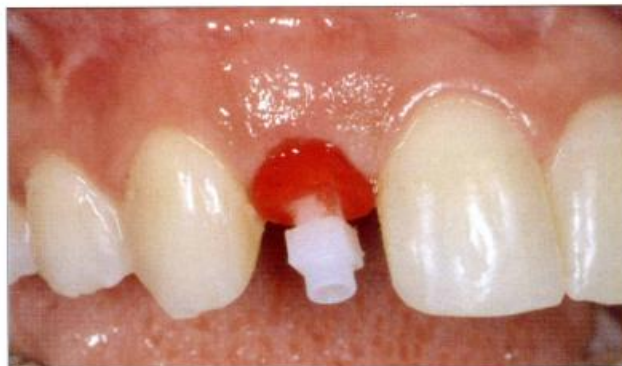
*Fig 23* Customized NN snap-on impression cap in place before taking the final impression.

Once modified, the impression cap was placed on the implant shoulder, and a polyvinyl siloxane impression was made (Fig 23).

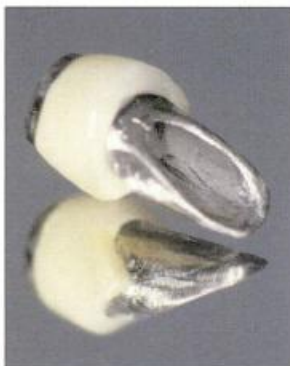
Fig 27 Customized framework blank. Emergence profile in ceramic instead of the traditional gold alloy.

An opaque was then applied, followed by a buildup designed to support the soft-tissue analog and maintain a submucosal margin position (Fig 27).

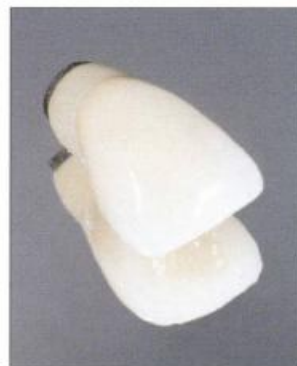
Fig 28 The customized framework blank and ceramo-metal crown ready for insertion.

Upon completion of the customized abutment, a ceramo-metal crown was fabricated with a 360° ceramic butt-joint margin (Fig 28).

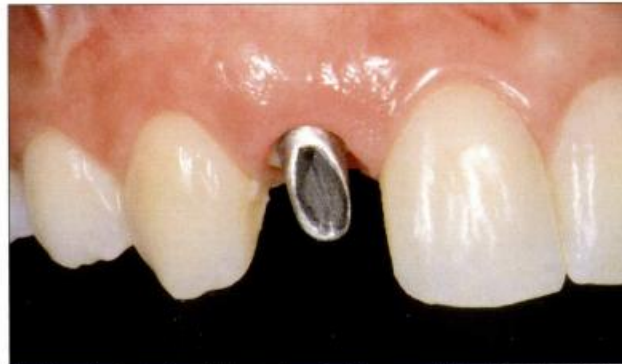
*Fig 30a Lateral view of the customized framework blank in place before crown cementation.*

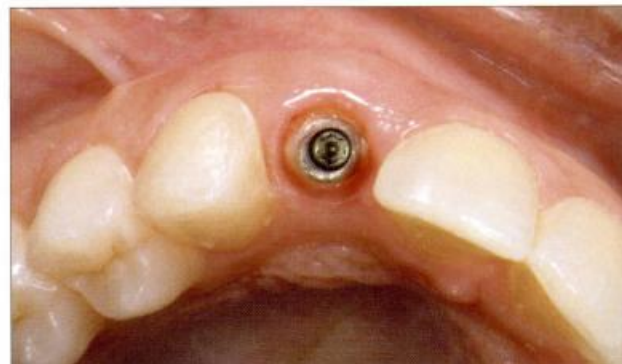
*Fig 30b Occlusal view of the customized framework blank in place before crown cementation. The ceramic margin is located slightly below the mucosa, thus allowing for easy post-cementation access.*

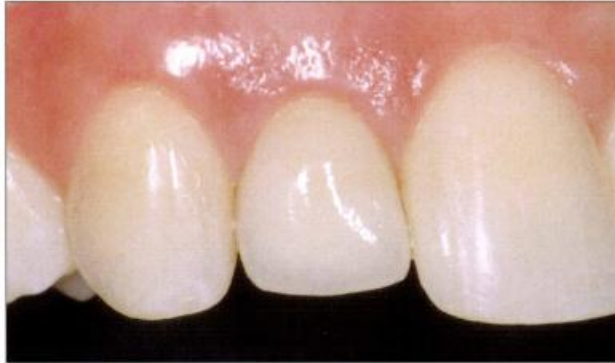
*Fig 31a Lateral view of the inserted implant-supported crown on tooth 12.*

The screw access hole was covered with a cotton pellet and sealed with Cavit (3M Espe). The final restoration was cemented with permanent cement, and the occlusion was adjusted to a light shim-stock pull (Figs 31a-c). Adjustments to the ceramic surface were followed by a polishing procedure with diamond-impregnated disks that helped create a glaze-like ceramic surface.

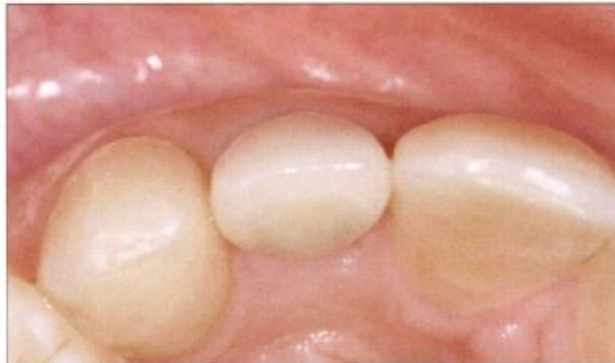
*Fig 31b Occlusal view of the inserted implant-supported crown on tooth 12.*

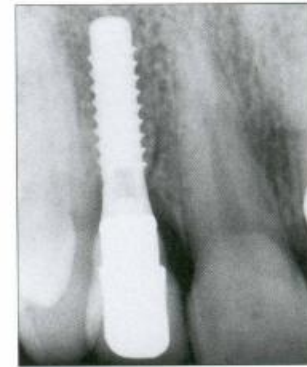
*Fig 32 Periapical radiograph of the implant-supported crown on tooth 12.*

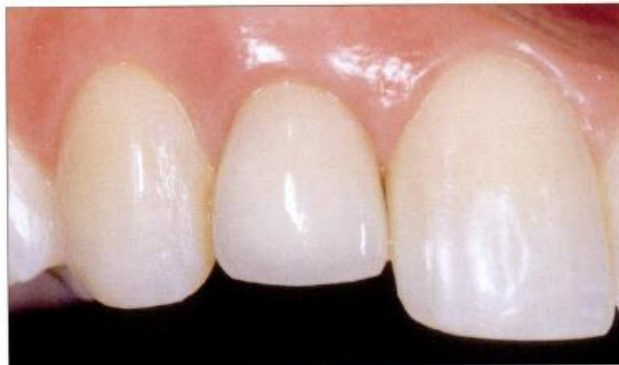
*Fig 33a Lateral view of the implant-supported crown on tooth 12, four years after insertion.*

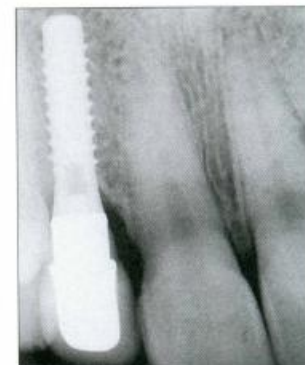
*Fig 33b Periapical radiograph of the implant-supported crown on tooth 12, four years after insertion.*

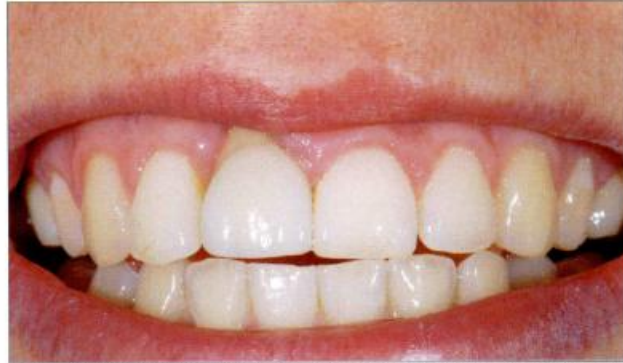
Fig 1 The high lip-line situation clearly reveals the interruption of the harmonious gingival line.

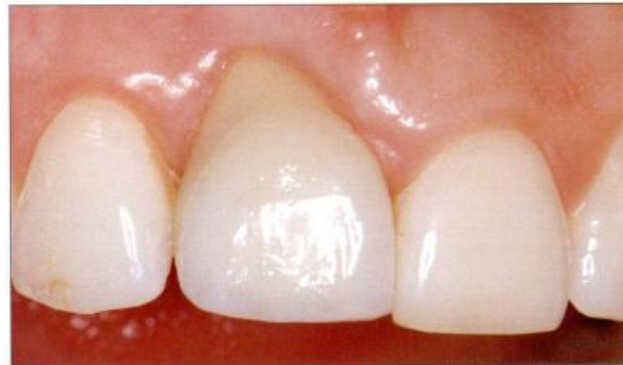
Fig 2 The detail view illustrates the extent of the gingival recession at the implant crown.

The close-up view shows the full extent of the interruption of the harmonious gingival line by a soft-tissue recession at the implant-supported crown (Fig 2). The gingival recession measures approximately 3 mm and developed rapidly within a few weeks after the insertion of the implant crown.

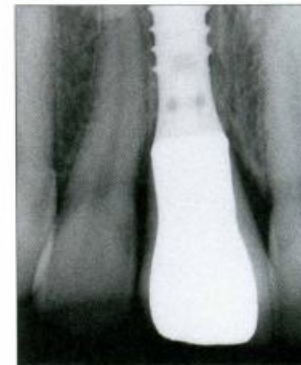
Fig 3 Periapical radiograph showing the malposition of the implant in a coronal and in a mesiodistal direction.

The periapical radiograph reveals the cause for the esthetic failure (Fig 3): The implant shoulder was placed too far apically using an extensive countersinking procedure. In addition, the implant was also malpositioned in a mesiodistal direction, since the implant shoulder almost touched the root surface of the lateral incisor. Both these factors led to bone resorption on the facial aspect of the implant and on the adjacent root surface of the lateral incisor.

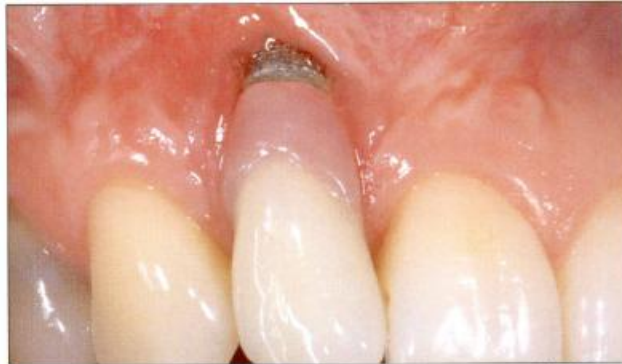
Fig 6 Severe esthetic complication with the implant crown at site 12.

This 40-year-old female patient was referred with a serious esthetic complication. She presented with a major gingival recession at the implant crown in the area of tooth 12. The main cause of this complication was a severe implant malposition in coronal direction. The implant shoulder was positioned about 5 mm apical to the planned soft-tissue margin of the future implant-supported crown. This malposition resulted in severe facial bone resorption and subsequent soft-tissue recession. The use of pink ceramic was necessary to mask the unfavorable esthetic treatment outcome (Fig 6).

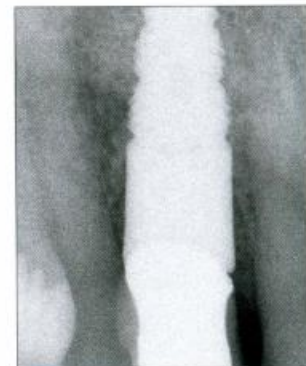
Fig 7 Periapical radiograph demonstrating a well-integrated implant in an apical malposition.

The periapical radiograph reveals the apical malposition of the implant that caused the severe esthetic complication (Fig 7).

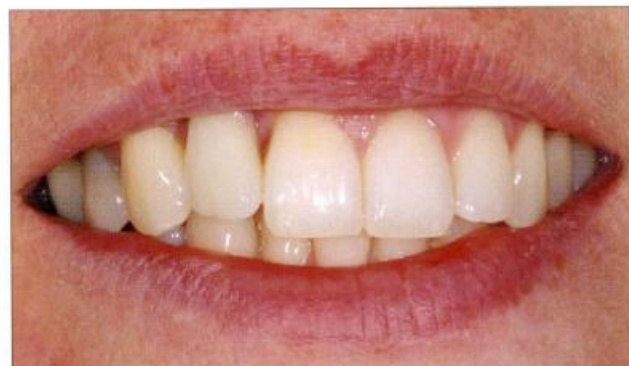
Fig 8 The patient's mid lip-line situation masking the compromised treatment outcome.

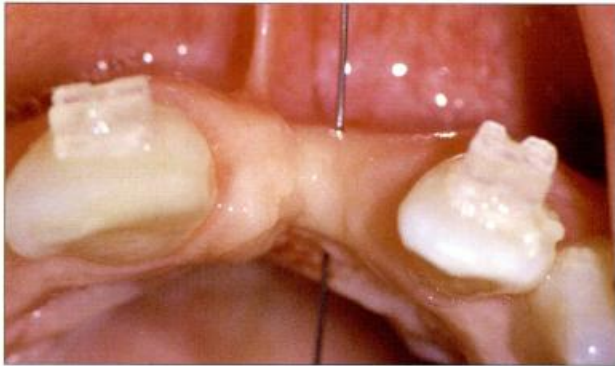
Fig 9 An attempt to "sound" for osseous support revealed a deficiency in vertical and horizontal bone

A 30-year-old female patient presented at the clinic for a consultation to replace a missing tooth (21) lost in a sport accident. Examination of the esthetic risk for her treatment revealed a medium lip line at full smile, exposing three-quarters of the clinical crowns and the tips of the papillae. The gingival biotype was thin, with highly scalloped papillae, tapered clinical crowns, and a thin band of keratinized tissue. The site analysis showed a deficiency in osseous width and height extending apically of the middle third of the adjacent roots (Fig 9).

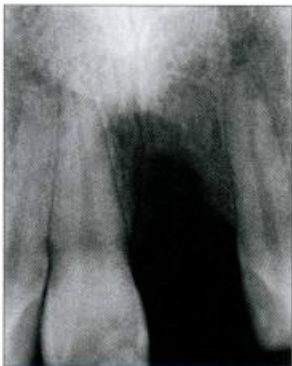
Fig 10 Periapical radiograph confirming bone deficiencies at the proposed implant site and interproximal support on the adjacent roots.

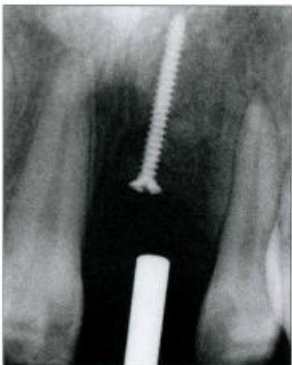
Fig 11 Periapical radiograph with the radiographic template in place.

Based upon the clinical findings, the patient was informed of the high risk of esthetic failure with dental implant therapy. A plan was presented to address the hard-tissue and soft-tissue deficiencies prior to implant placement. Six months after the grafting procedure, a clinical examination revealed successful horizontal bone regeneration, while a deficiency in vertical height remained. The patient declined further tissue-enhancement procedures and desired to proceed with implant placement. A radiographic template was fabricated and a periapical radiograph taken (Fig 11).

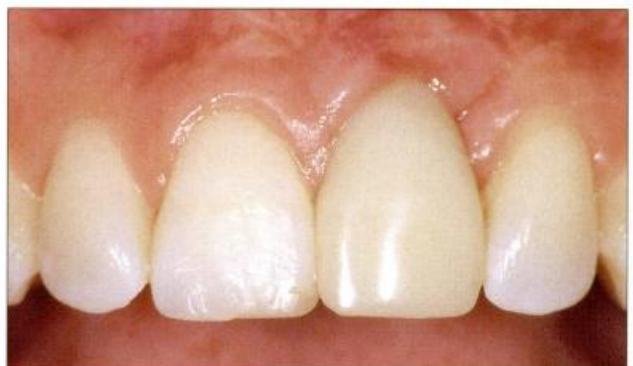
Fig 13 Provisional restoration at site 21 highlighting the apical position of the soft-tissue margin related to the adjacent teeth.

Six weeks later, the implant was restored with a provisional restoration; the clinical result highlighted the apical position of the soft-tissue margin at site 21 related to the adjacent teeth (Fig 13).

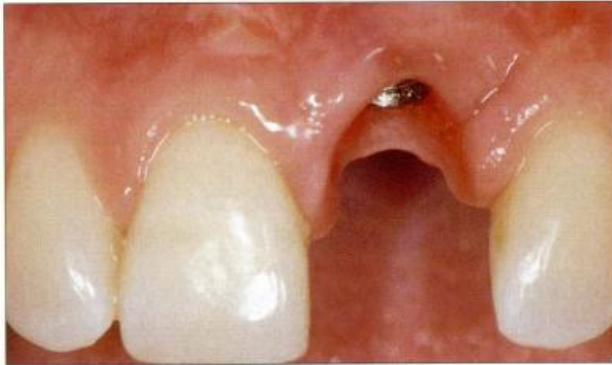
Fig 14 Clinical view of implant 21 highlighting the apical position of the soft-tissue margin relative to the adjacent teeth. The interproximal tissue support was promising.

Upon maturation of the transition zone, there was interproximal tissue support, but a mucosal deficiency on the facial aspect was evident (Fig 14).

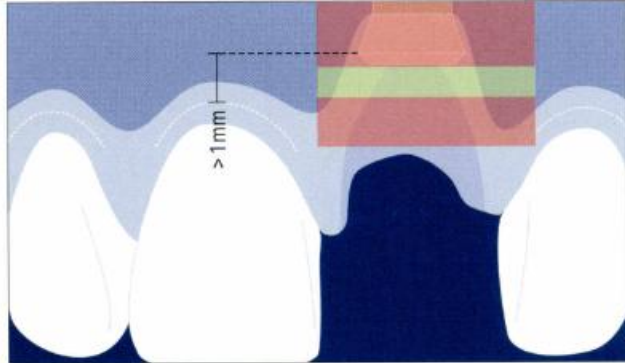
Fig 15 Implant shoulder located in the apical danger zone, with the soft-tissue margin in an apical position.

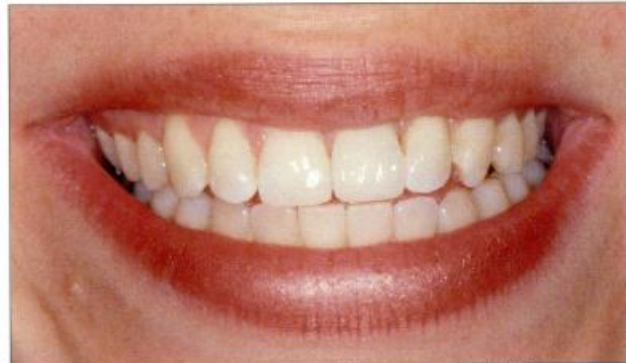
Fig 16 At full smile, the facial tissue deficiency was not visible.

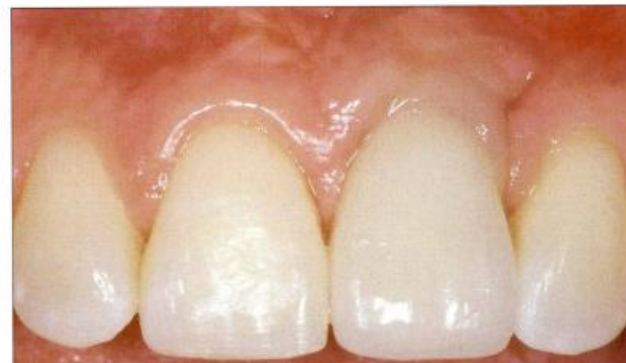
Fig 17 Pink ceramic material helped create the illusion of a harmonious soft-tissue contour.

The esthetic result was acceptable to the patient (Fig 17).

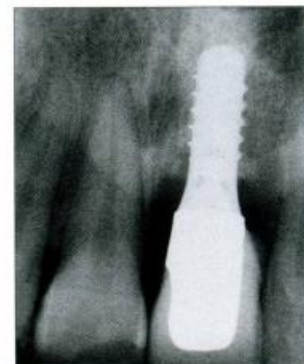
Fig 18 Periapical radiograph after insertion highlighting the final positions of the dental implant and surrounding hard tissues.

The postoperative periapical radiograph highlights the final position of the supporting structures (Fig 18).

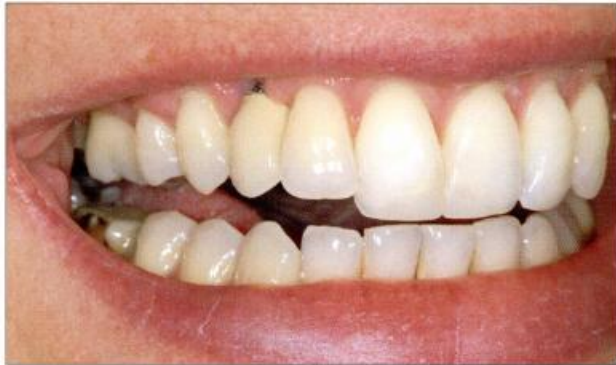
Fig 19 The high lip line exposes the metal margin of the implant crown when smiling.

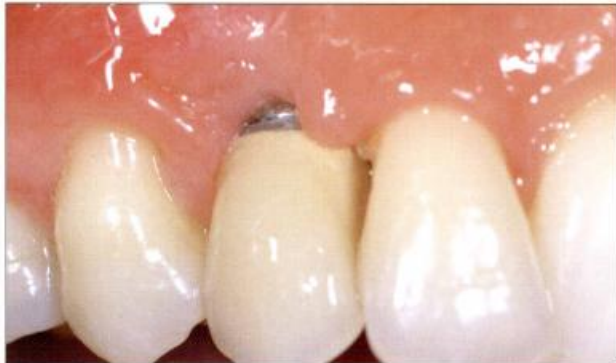
Fig 20 Detail view of the esthetic complication. The metal margin was visible and the mesial papilla was clearly shortened.

The papilla mesial to the implant crown was reduced, and the metal margins of the implant shoulder and of the ceramo-metal crown were visible (Fig 20). Both complications have clear causes. The visible metal margin had been caused by a malposition in the coronapical direction; this implant shoulder was positioned in the coronal danger zone. That the implant was not placed sufficiently deeply into the tissue. In addition, the concavity on the facial aspect gave rise to the assumption that the facial bone wall was lacking in support for the facial soft tissue.

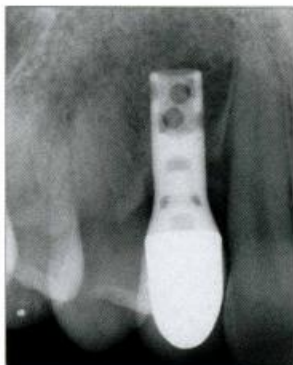
Fig 21 The periapical radiograph reveals the oversized implant that resulted in the implant shoulder being located in the mesial danger zone. As a result, the bone between the implant and the adjacent lateral incisor was resorbed, leading to the reduction of the mesial papilla.

The periapical radiograph showed the cause for the short mesial papilla of the implant crown. The diameter of the implant selected for this single-tooth gap was too large, so the Regular Neck implant had entered the mesial danger zone of the adjacent lateral incisor. This close proximity led to alveolar bone resorption between the implant and root surfaces, followed by the shrinkage of the papilla. To avoid this unpleasant complication, orthodontic treatment would have been required to open the mesiodistal space in this single-tooth gap, allowing for an appropriate placement of a Regular Neck implant. The use of a Narrow Neck implant to replace an upper canine is contraindicated.

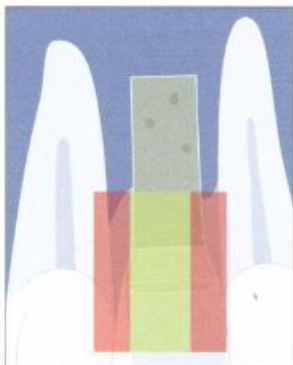
Fig 22 The implant invades the mesial danger zone, leading to the resorption of alveolar bone at the adjacent lateral incisor.

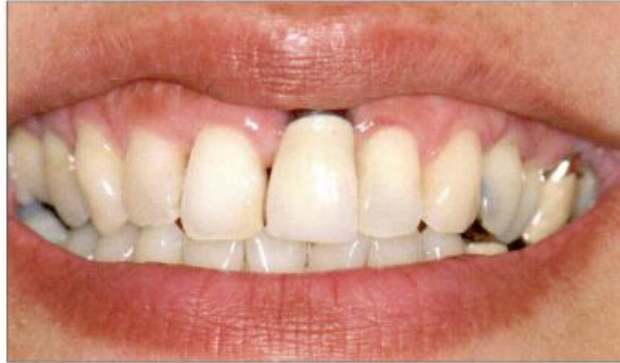
Fig 23 The patient's high lip line exposed the esthetic failure when she smiled.

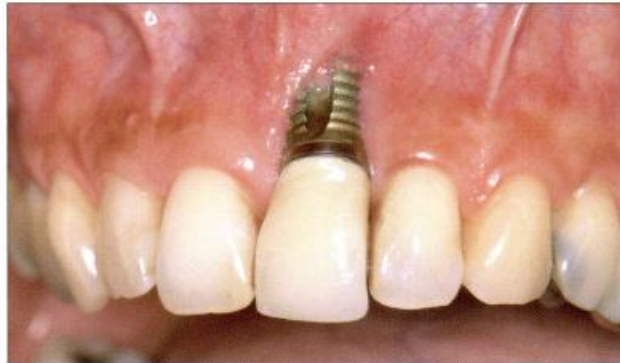
Fig 24 Close-up view showing the extent of the soft-tissue recession.

Following implant placement, a severe soft-tissue recession developed within a few months, exposing a significant portion of the implant surface (Fig 24). On the day of examination, the implant showed slight mobility and had to be removed.

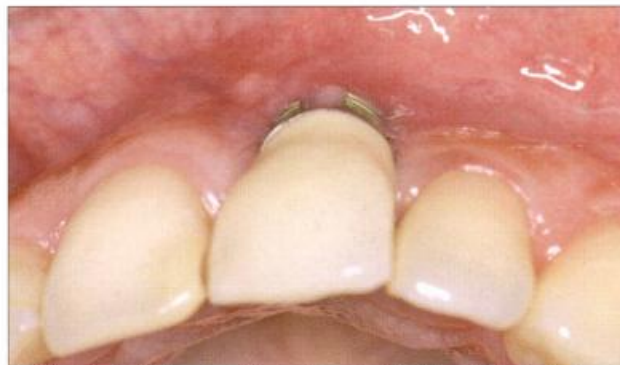
Fig 25 Occlusal view revealing the facial malposition of the implant.

The implant shoulder was located too far facially, drastically invading the facial danger zone (Figs 25, 26). This is partly due to the selection of an oversized implant. Such an implant position can be also caused by the anatomy of the alveolus in immediate implants, since the alveolus guides the drills too far facially.

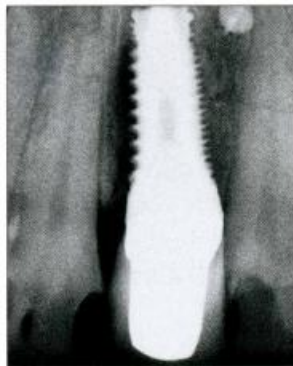
*Fig 27 The implant is clearly too large in relation to the gap size, resulting in bone resorption.*

The periapical radiograph illustrated the oversized implant in the area of the central incisor (Fig 27). The use of a wide-platform implant aggravated the effect of the malposition.

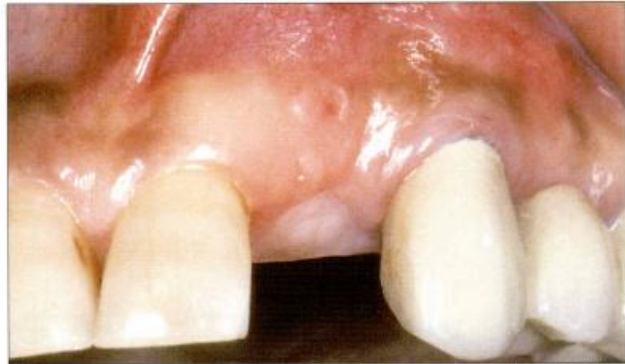
Fig 28 Frontal view before implant surgery. Interproximal tissue deficiencies are evident adjacent to site 22.

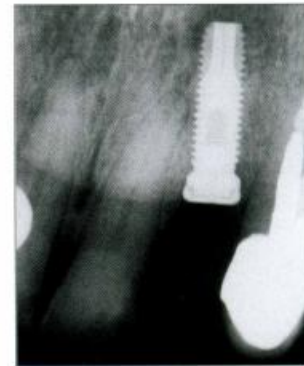
Fig 29 Postoperative periapical radiograph highlighting the "deep" placement of the dental implant compared to the adjacent teeth. Deficiencies in interproximal bone support were evident on the teeth adjacent to site 22.

The postoperative periapical radiograph revealed that the implant had been placed in the apical danger zone (Fig 29).

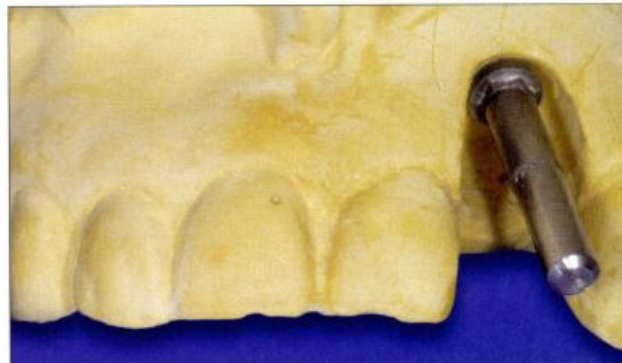
Fig 30a Master cast highlighting the extreme facial and apical position of the implant.

In the laboratory, the surgical index was used to confirm the position of the dental implant (Figs 30a, b).

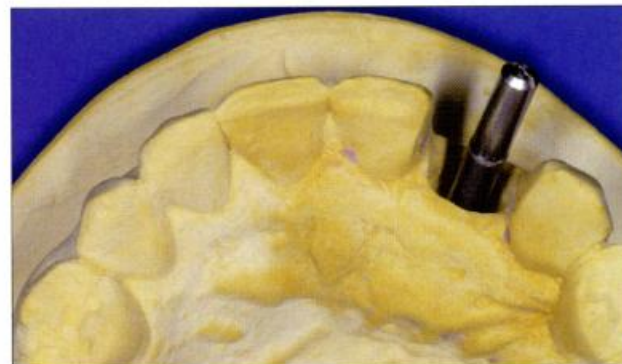
Fig 30b An angle correction of 25 degrees was needed to restore the implant.

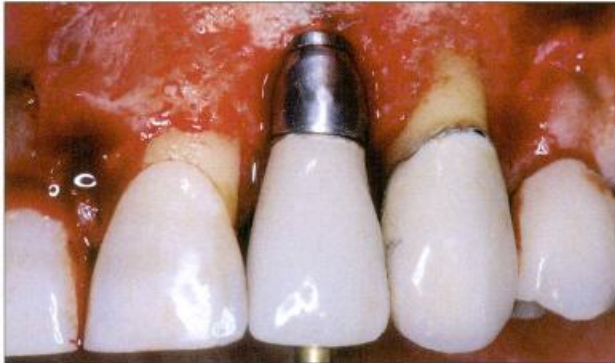
Fig 31 A 25-degree abutment and a screw-retained restoration were delivered during second-stage surgery.

It was decided to fabricate a definitive screw-retained restoration for insertion during second-stage surgery (Fig 31).

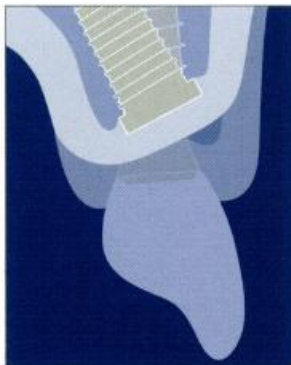
Fig 33 The invasion of the facial danger zone aggravated the resorption process.

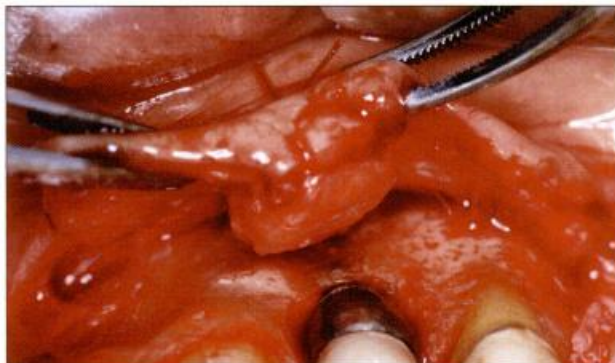
Fig 34 During second-stage surgery, a subepithelial connective-tissue graft was used in an attempt to increase the soft-tissue volume.

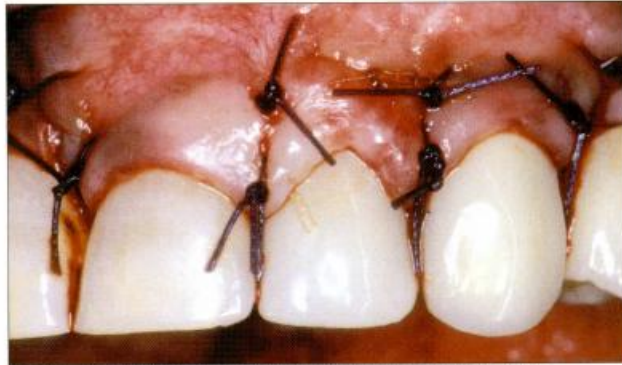
Fig 35 Postoperative frontal view showing an acceptable result.

The clinical result immediately after surgery was favorable (Fig 35).

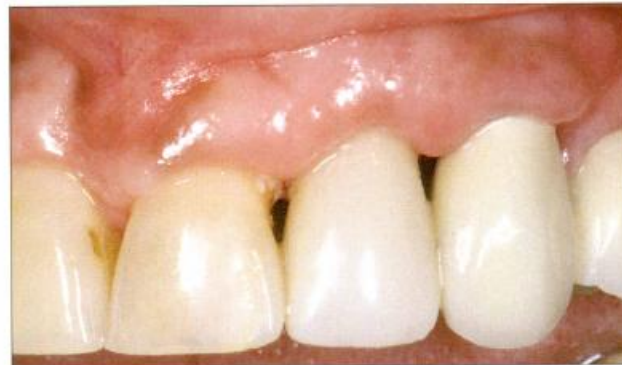
Fig 36 One-year follow-up revealing the side effects of inadequate peri-implant hard-tissue support.

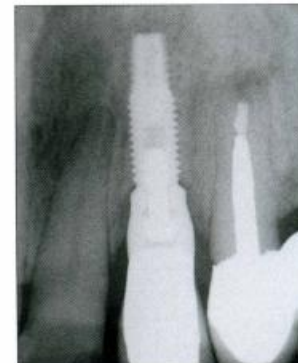
Fig 37 Periapical radiograph at one-year follow-up. Poor implant-to-crown ratio.

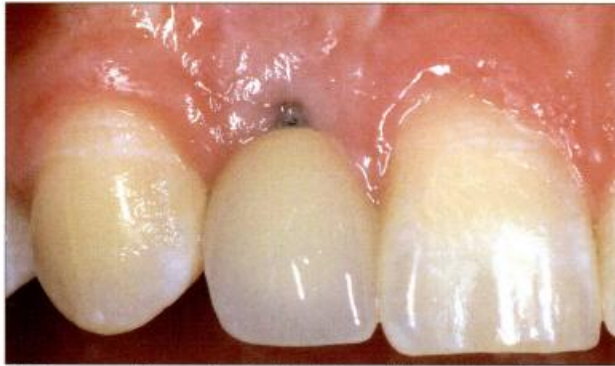
Fig 38 Lateral view at site 12 with titanium visible at the soft-tissue margin.

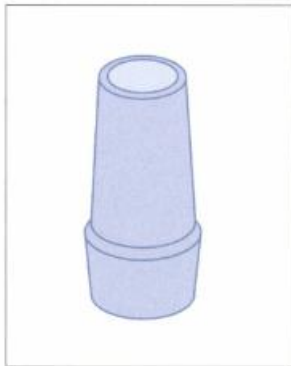
Fig 39 Narrow Neck titanium coping.

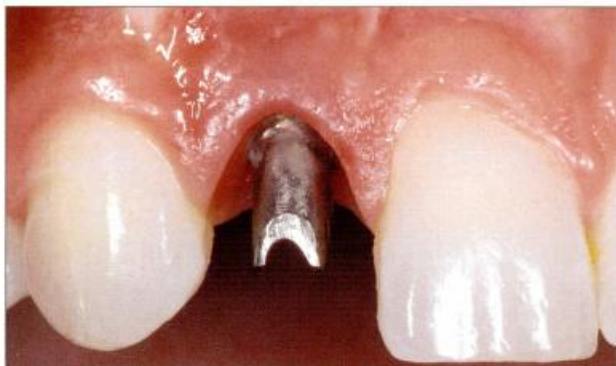
Fig 40 A modified titanium coping with a submucosal margin.

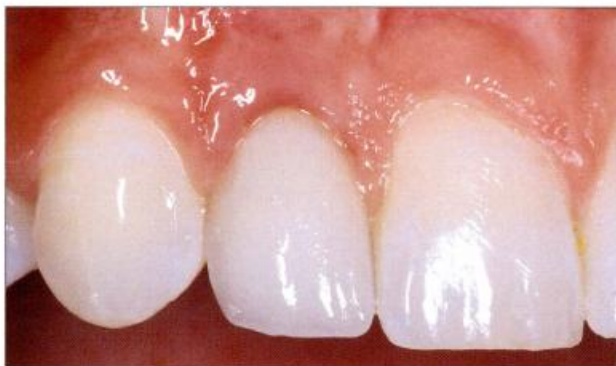
Fig 41 A pleasing esthetic result with a properly restored implant at site 12.

An esthetically pleasing result was obtained (Fig 41). A periapical radiograph was taken to confirm full seating of the restoration (Fig 42).

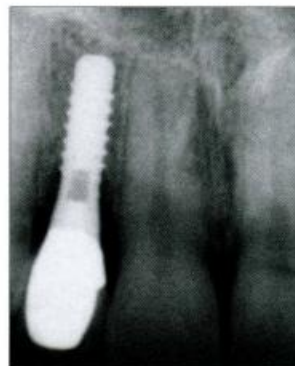
Fig 42 Periapical radiograph taken after insertion of the definitive restoration.
